Faulty procedures were partly to blame for the failure to reinstall the center wing fuel tank purge door in a Boeing 777 after maintenance, the U.K. AAIB says.

# OPEN DOOR

*This article is based on AAIB accident report no. 2/2007, “Report on the Serious Incident to Boeing 777-236, G-YMME, on Departure From London Heathrow Airport on June 10, 2004.”*

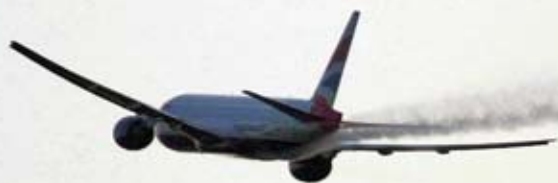
Leaking fuel trails the British Airways Boeing 777 after takeoff from London Heathrow Airport.

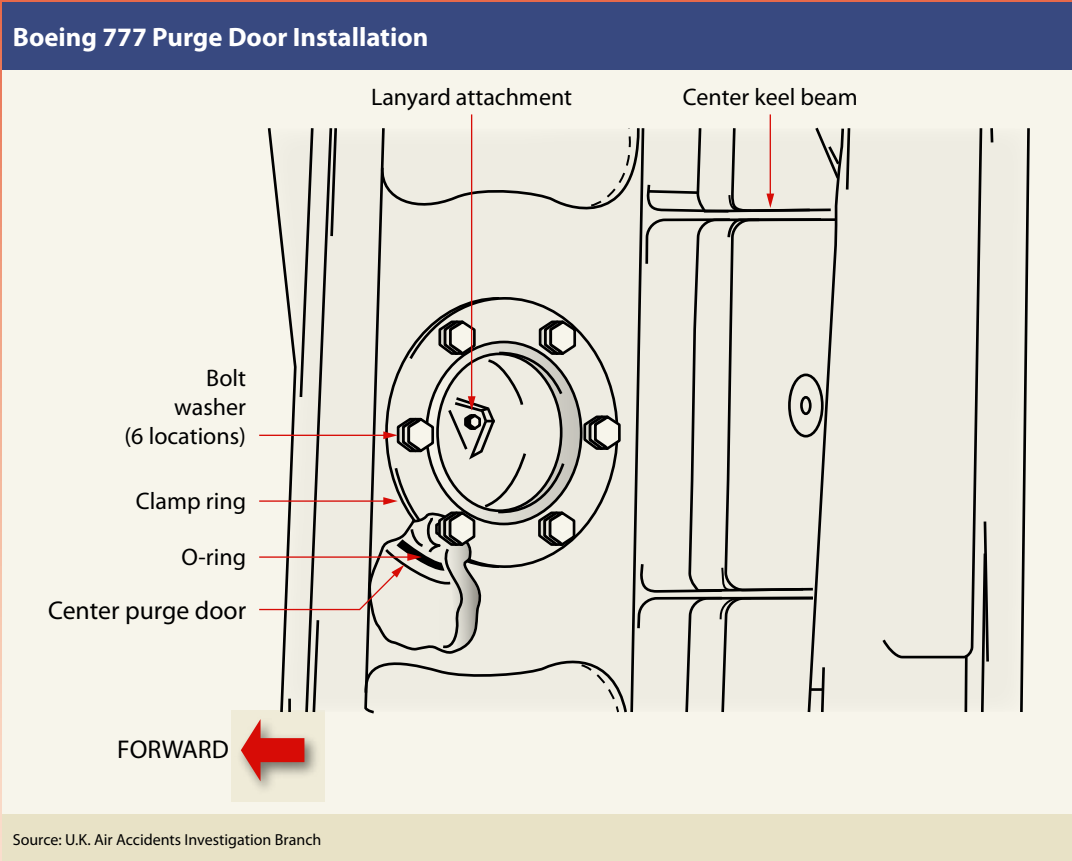
Figure 1

When a maintenance technician inspected the airplane after its arrival at the gate, he “noticed a few drips of fuel on the left main landing gear but none on the ground,” the report said. “After opening the left inboard main gear door, he detected a distinct smell of fuel. An inspection inside the gear bay revealed that the center fuel tank purge door was not in place [Figure 1, page 44]. The purge door was hanging on a lanyard inside the fuel tank, and a plastic bag was attached to the purge door opening. The bag contained fuel

and the screws that would normally hold the purge door in place.”

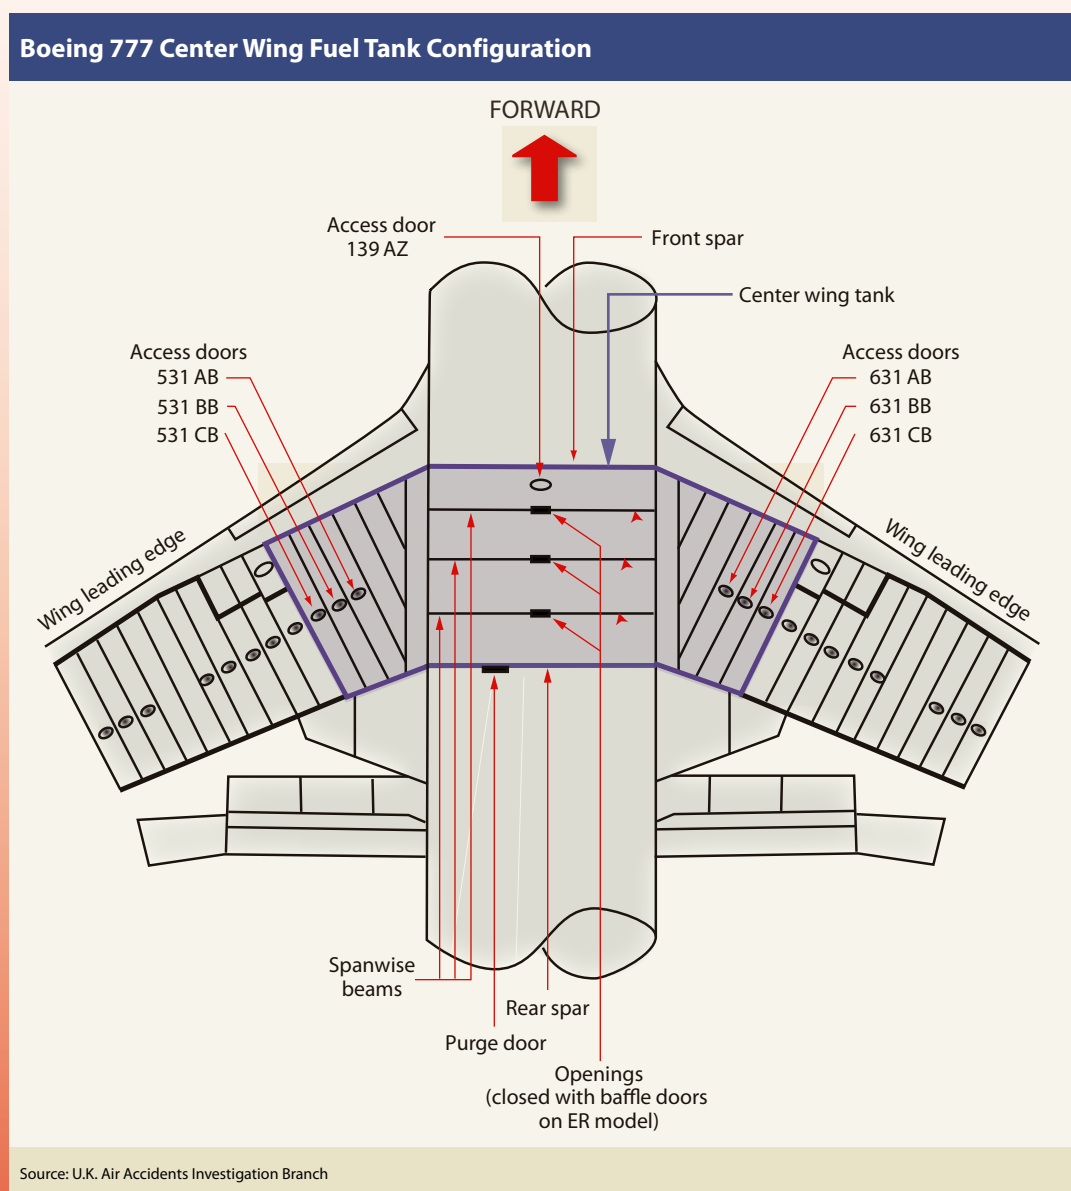
Figure 2

never conducted a similar inspection and had never been inside a 777 center wing fuel tank. He complied with the incorrect illustration on the job card, and, as a result, he did not enter the rear section of the center wing tank where the purge door was located or remove three baffle doors, which were designed to limit rapid fuel movement within sections of the center wing fuel tank as a result of changes in the airplane's attitude and which should have been removed to perform the inspection.

"A potential opportunity to detect the open purge door was lost when the rear spar inspection was carried out in the wrong location because of an error in a diagram in the ... AMM," the report said. "The maintenance organization was aware of the error in the AMM diagram and had notified the aircraft manufacturer, but no action was taken to communicate this fact to production staff."

Boeing published several documents discussing the purge door, including an all-operator message, and revised several sections of the AMM — including discussions of purge door removal and reinstallation, and rear spar inspection — and related task cards.
