Off-Balance

Nose-heavy Challenger would not rotate for takeoff.

The flight crew's failure to calculate the airplane's weight and balance, and the charter operator's failure to ensure compliance with safety regulations were blamed for the Feb. 2, 2005, crash of a Bombardier Challenger 600 during takeoff at Teterboro (New Jersey, U.S.) Airport.

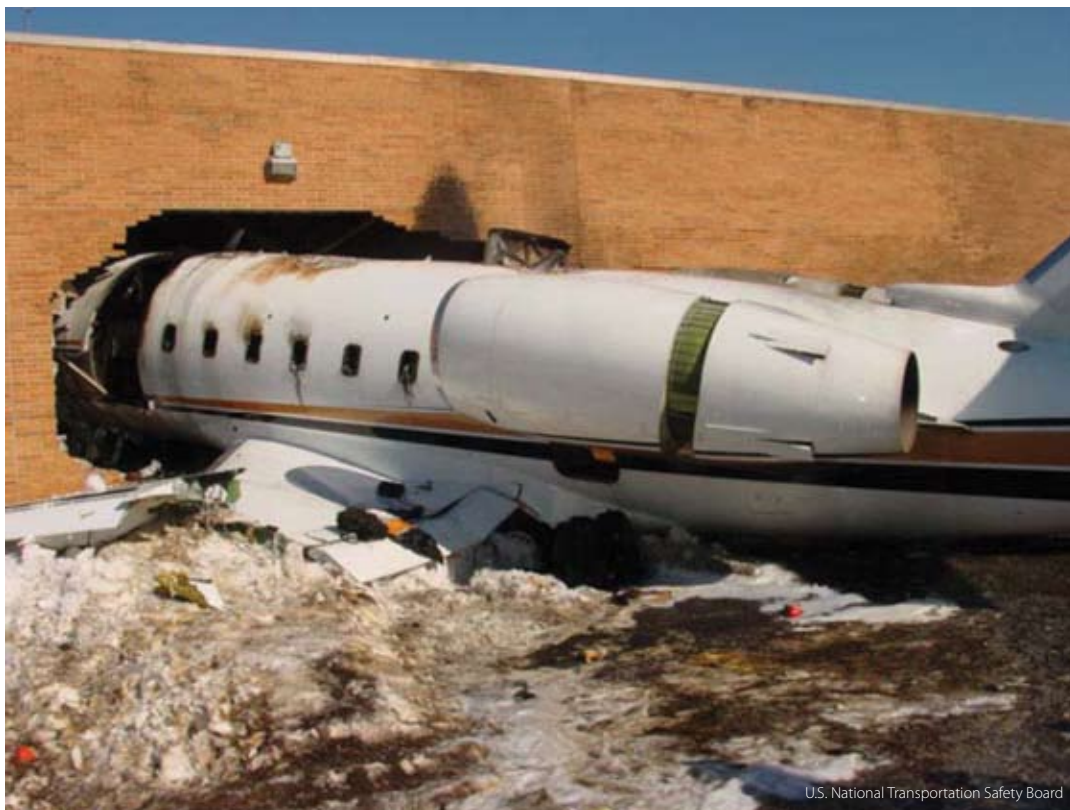
The Challenger struck a building after running off the end of the runway and over a six-lane highway.

The airplane came to a stop with the forward fuselage, to near the wing root, embedded in the building. The pilots initially were trapped in their seats by wreckage that entangled their legs. The report said that their injuries included fractures, dislocations and lacerations of their lower limbs.

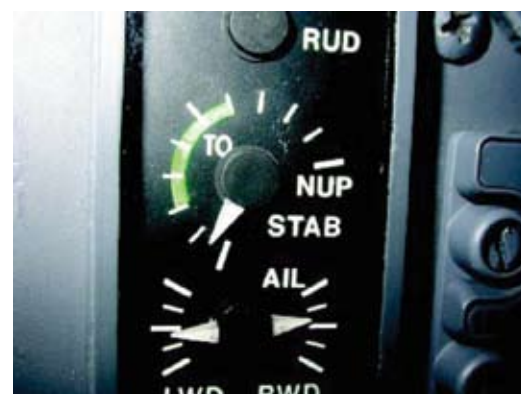
The airplane flight manual (AFM) for the Challenger includes stabilizer-trim — pitch-trim — settings for approved CG locations. The first officer did not consult the AFM when he selected a setting appropriate for a mid-range CG. “The captain told investigators that he checked the pitch-trim setting selected by the first officer while they taxied and that he believed that the trim setting was satisfactory,” the report said. “The captain stated that he recalled a table in one of the airplane’s manuals that specified trim settings but that he thought the trim could be adjusted to various settings depending on the pilot’s preference.”

This trim indicator is similar to the one in the accident airplane, in which stabilizer trim had been set for a mid-range, rather than a forward, center of gravity.

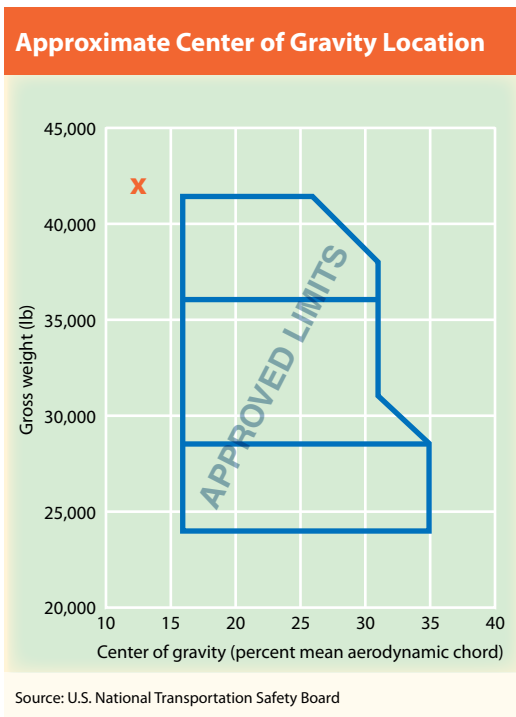
Figure 1

According to investigators' calculations, the airplane's takeoff weight was 41,320 lb (18,743 kg) — 70 lb (32 kg) over maximum takeoff weight. The CG was 12.47 percent mean aerodynamic chord (MAC), which exceeded by 3.53 percent MAC the forward CG limit of 16 percent MAC (Figure 1, p. 34).

"Review of weight-and-balance materials for the accident airplane indicated that, under many loading configurations, the airplane could not be loaded with fuel without exceeding its forward CG limit," the report said. "Further, investigators found that this fuel-loading characteristic appeared common among corporate

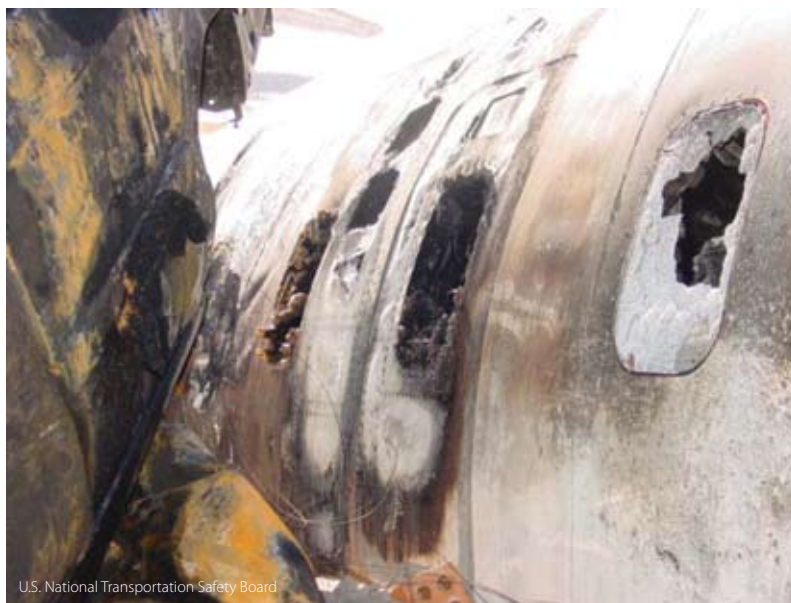
The burned-out hulk of one of the six vehicles struck during the overrun rests near the airplane’s left overwing exit.
