Too Long at the Wheel

BY MARK LACAGNINA

Fatigue factors in a runway excursion.

This article is based on AAIB Iceland “Report on Serious Incident, Runway Excursion, M-03707/AIG-19; JetX; Boeing 737-800, TF-IXF; Keflavik, Iceland; October 28, 2007.”

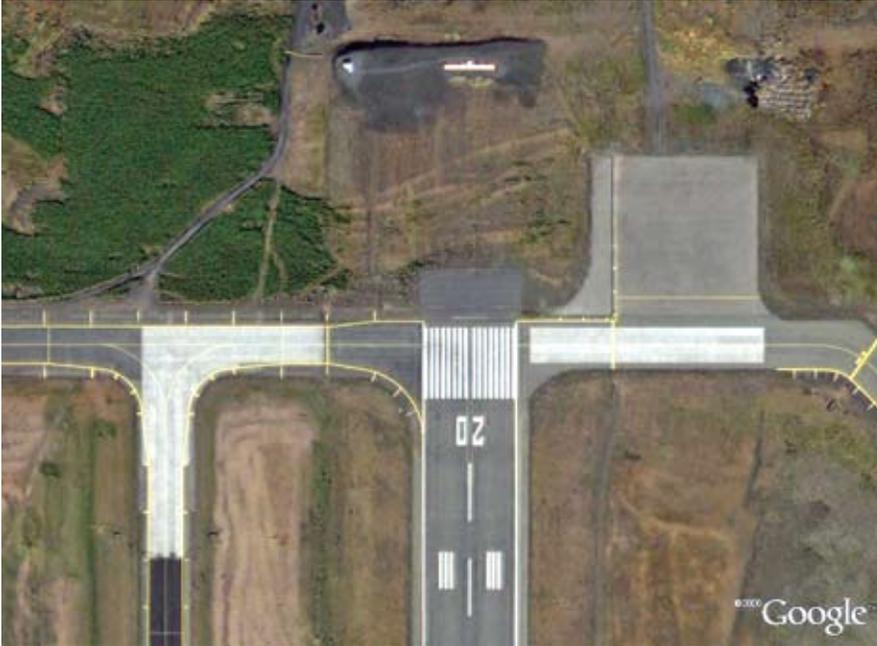
Groundspeed was 35 kt when the pilots turned left off of Runway 02 onto the final taxiway.

Groundspeed was 35 kt when the crew began to steer the aircraft left onto Taxiway N-4. They increased reverse thrust to 80 percent N_1 to help slow the 737. “The aircraft came to rest on a final heading of 288 degrees with the right main landing gear and nosewheel off the paved surface of Taxiway N-4,” the report said.
