# LEFT BEHIND

**The ATR 42 pilots were unaware of current procedures for recovering from an ice-induced upset.**

*This article is based on AIBN Report SL 2009/02, “Report on the Serious Incident Over Glacier Folgefonna, Norway, on 14 September 2005 with ATR 42-320, LN-FAO, Operated by Coast Air AS.”*

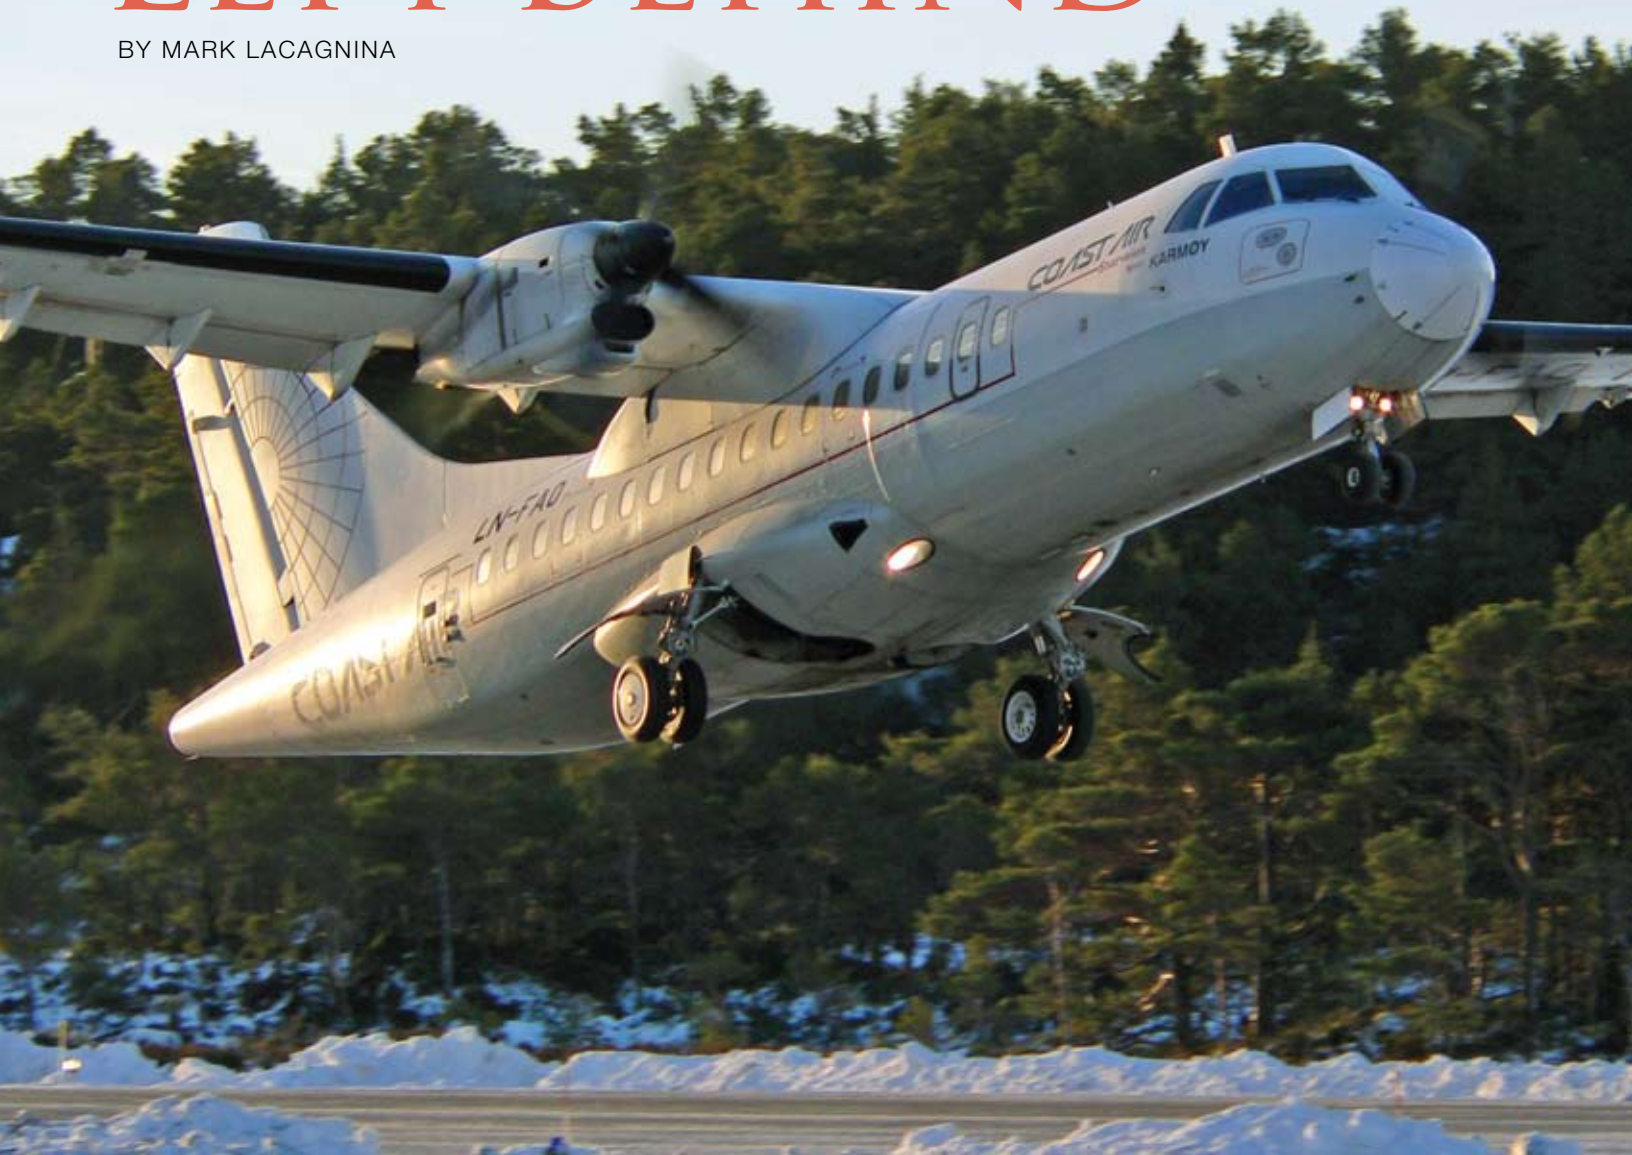
The flight crew struggled to regain control of this ATR 42 after an ice-induced stall.

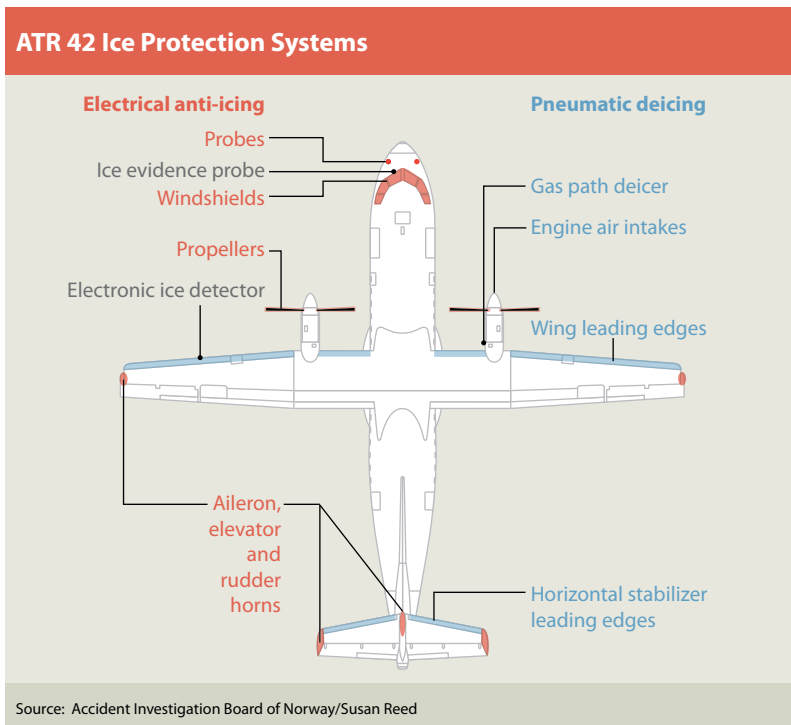
**Figure 1**

Before departing with 24 passengers at 0710, the flight crew activated the anti-ice systems for the probes and windshields (Figure 1). The first officer, 29, was the pilot flying. He had been employed by Coast Air in 2003 and earned an ATR 42 type rating the same year. He had 2,980 flight hours, including 1,350 hours in type.

The aircraft entered icing conditions shortly after takeoff, and the crew activated the anti-icing systems for the aileron, elevator and rudder horns, propellers and side windows. Activation of the horn ice protection system also armed the stick shaker (stall warning) system to activate — and

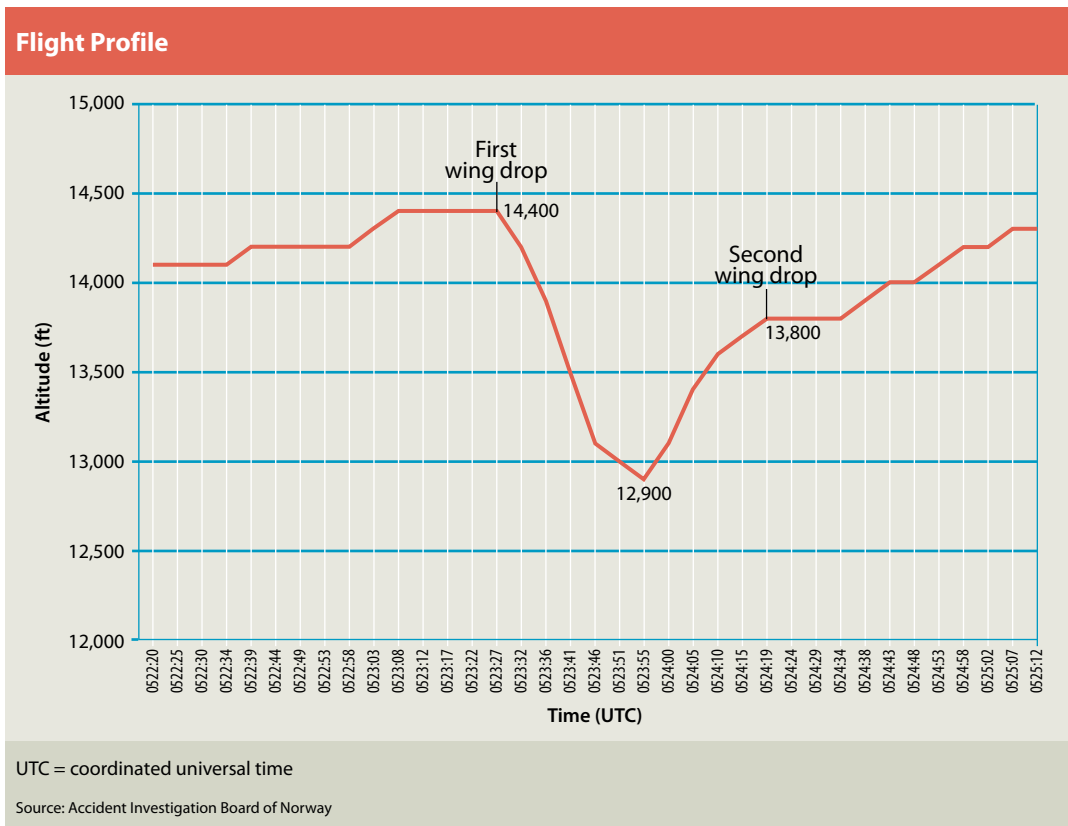
**Figure 2**

The aircraft stopped climbing at 14,400 ft. The first officer placed his hand on the control column and felt the stick shaker activate. He was about to disengage the autopilot when it disengaged automatically. "A second or two after this, the aircraft suddenly rolled, uncommanded, approximately 45 degrees to the right at the same time the nose dropped to approximately 7–8 degrees below the horizon," the report said (Figure 2, p. 36).

of approximately 3,200 fpm for the 28 seconds that passed before the aircraft again commenced climbing,” the report said. “At its steepest, the descent was around 5,000 fpm.”

Recorded ATC radar data indicated that the upset had begun at 0723 (0523 coordinated universal time) and that the aircraft had descended 1,500 ft before the first officer regained control. “It is equivalent to an average descent speed
