THIN *but* DEADLY

Another hard lesson that even a little ice can be dangerous.

Noncompliance with procedures for the use of a Citation's deice boots led to an ice-induced stall.

This article is based on U.S. National Transportation Safety Board Accident Report NTSB/AAR-07/02, “Crash During Approach to Landing, Circuit City Stores, Inc., Cessna Citation 560, N500AT, Pueblo, Colorado, February 16, 2005.” The 86-page report contains appendixes.

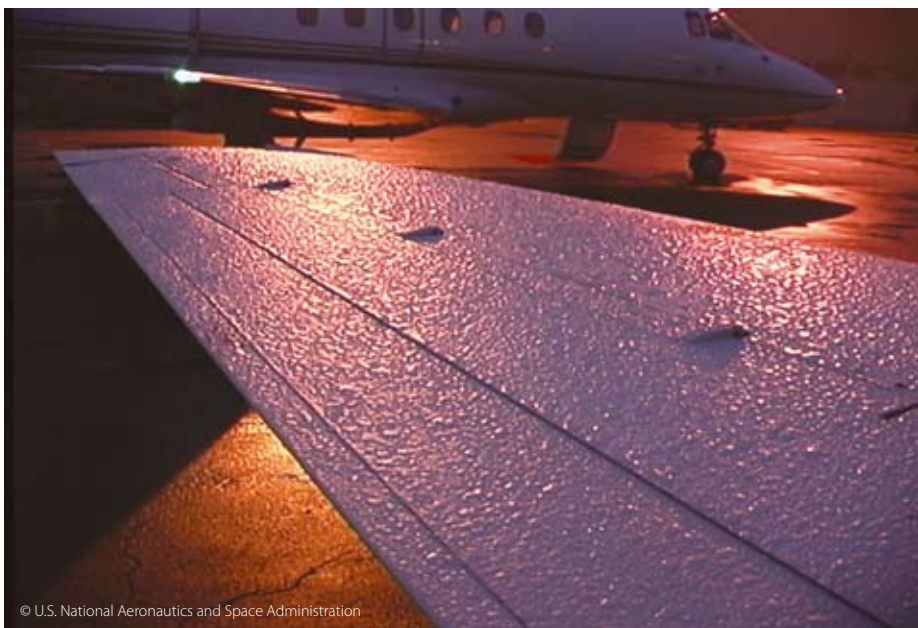
Supercooled large droplets typically splash and freeze relatively slowly on contact with an aircraft.

A study of meteorological data by the National Center for Atmospheric Research (NCAR) found that the airplane likely encountered supercooled large droplet (SLD) conditions while descending from 9,400 ft to 6,100 ft, where the upset occurred. An SLD is a water droplet that remains liquid at a temperature below freezing until it strikes or is struck by something solid; it then freezes relatively slowly.

"SLD conditions can cause [thin, rough] ice accretions that are more aerodynamically detrimental than those that were considered during the initial certification of many existing airplanes for flight in icing conditions," the report said.

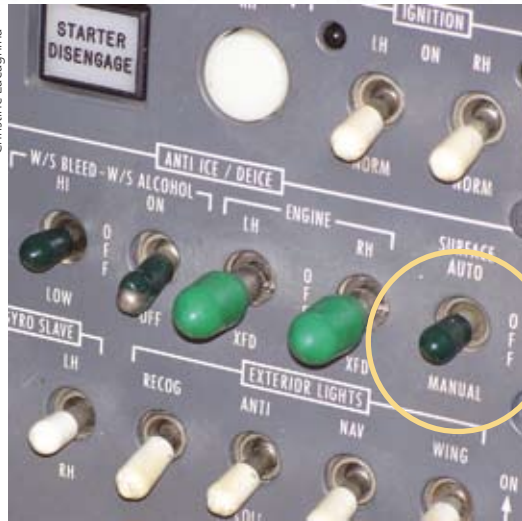
When the surface-deice switch in the Citation V is selected to 'AUTO,' the boots cycle once; in 'MANUAL,' all the boots inflate and remain inflated until the switch is released.

The report noted that the spring-loaded surface-deice switch in the Citation V has two positions: "MANUAL" and "AUTO." When the switch is held in the "MANUAL" position, all of the deice boots inflate simultaneously and remain inflated until the switch is released. Selection of "AUTO" initiates an 18-second cycle in which the various deice boots are inflated and deflated in a specific sequence. After the cycle is completed,

the boots remain deflated until the surface-deice switch is selected to “AUTO” again.

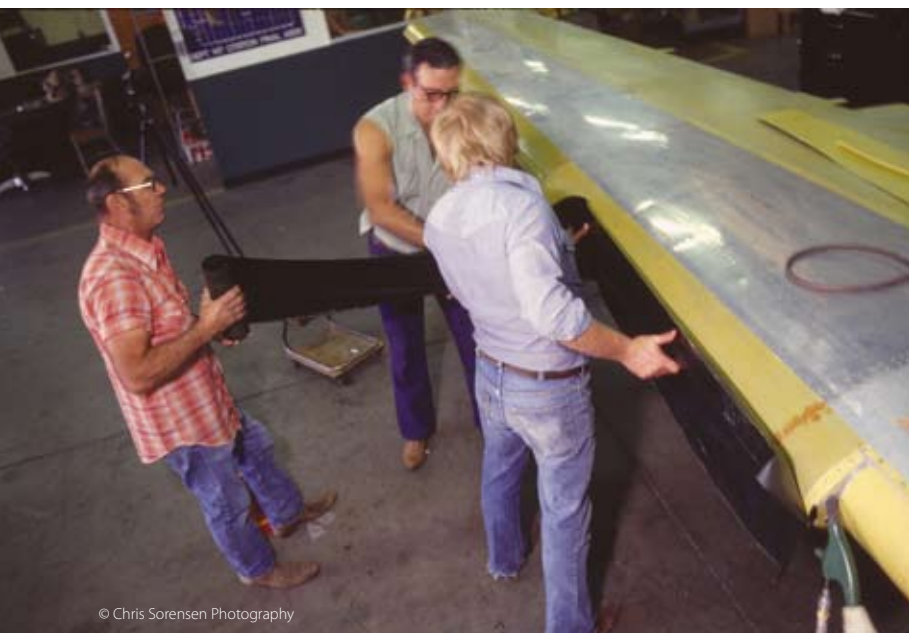
With deice boots of modern design on the airplane, pilots do not need to worry about the phenomenon of 'ice bridging.'

“Ice bridging is a phenomenon in which ice in the shape of an inflated deice boot forms after the boot is cycled,” the report said. “Ice bridging had been known to occur on older deice boot designs that used larger tubes and lower pressures, resulting in slower inflation and deflation rates.”

However, research has shown that ice bridging is not a risk for modern turbine airplanes equipped with segmented, high-pressure deice boots that inflate and deflate quickly, the report said.

In Advisory Circular 25.1419-1A, issued in May 2004, the FAA says that pilots should not wait for a specific amount of ice to accumulate before activating deice boots. “Although the ice may not shed completely with one cycle of the boots, this residual ice will usually be removed during subsequent boot cycles and does not act as a foundation for a bridge of ice to form,” the FAA said.

The report said that concern about ice bridging is no reason for pilots of modern airplanes to delay activation of deice boots. “Activating the deice boots as soon as an airplane enters icing conditions provides the greatest safety measure,” the report said.

- “Require manufacturers and operators of pneumatic-deice-boot-equipped airplanes to revise the guidance contained in their manuals and training programs to emphasize that leading edge deice boots should be activated as soon as the airplane enters icing conditions. (A-07-14) ... ;
