Pilots at several airports have reported navigation problems that involve erroneous heading information. Authorities blame magnetic anomalies in areas on the ground.

AIRPORT MAGNETISM

This article is based on U.K. AAIB Aircraft Incident Report No. 1/2008 (EW/C2006/10/10).

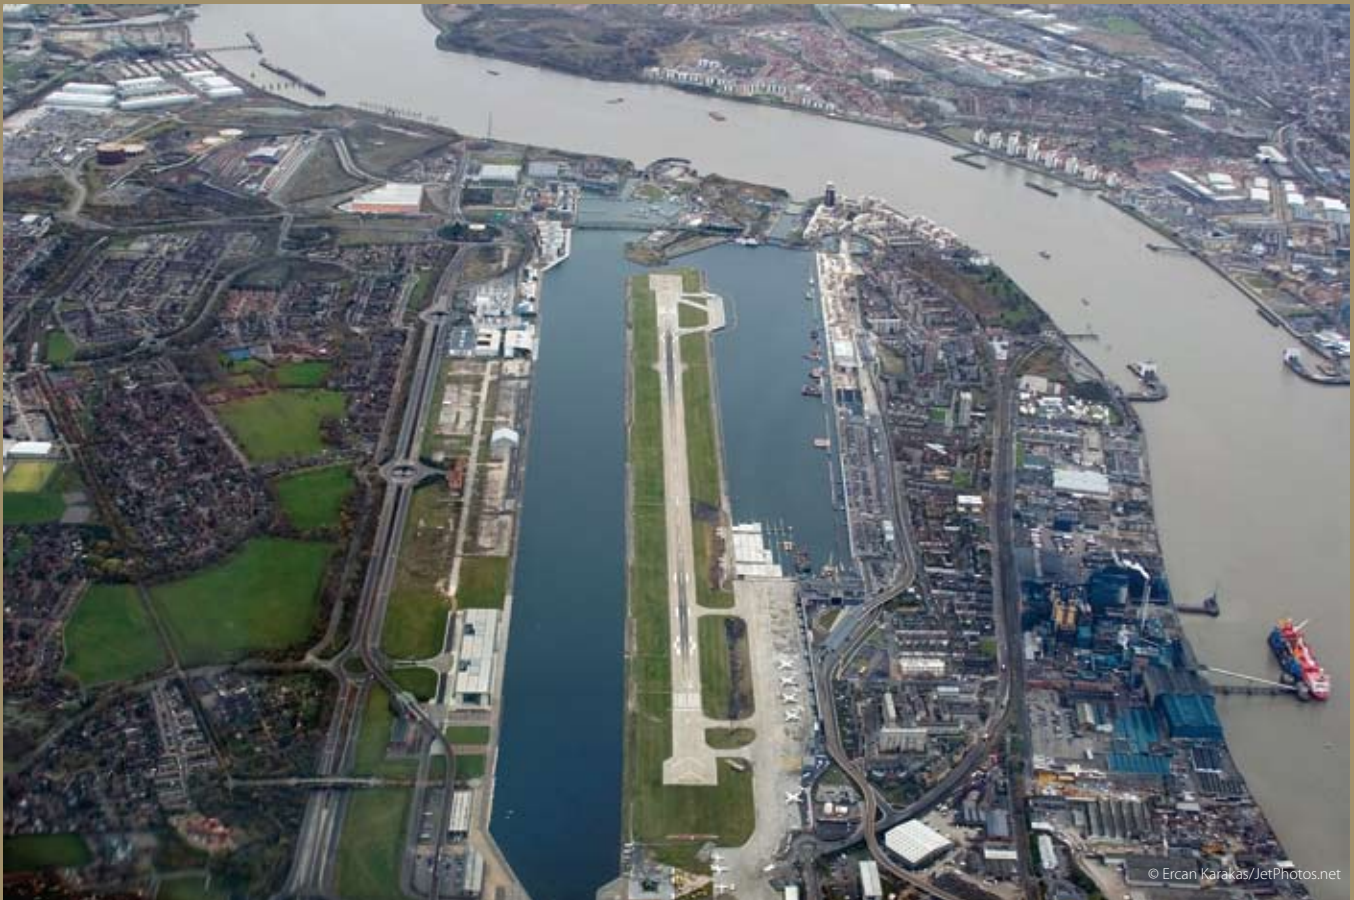
At London City Airport, the remains of bollards like this one have been linked to magnetic anomalies and aircraft navigation problems.

In addition, large cast iron bollards — used to tie up ships — had been mounted along the dock walls. The report said, “These bollards were similar to icebergs — what was visible above the dock wall was about a fifth of the size of what was below the wall.” When the airport was built, the sections of the bollards that were above the dock wall were removed, but the sections below the wall remained.

In addition, the surveys identified other sources of magnetic anomalies from the remains of the bollards under the holding area, from steel-reinforced concrete in the holding area and from the railway lines below the holding area.

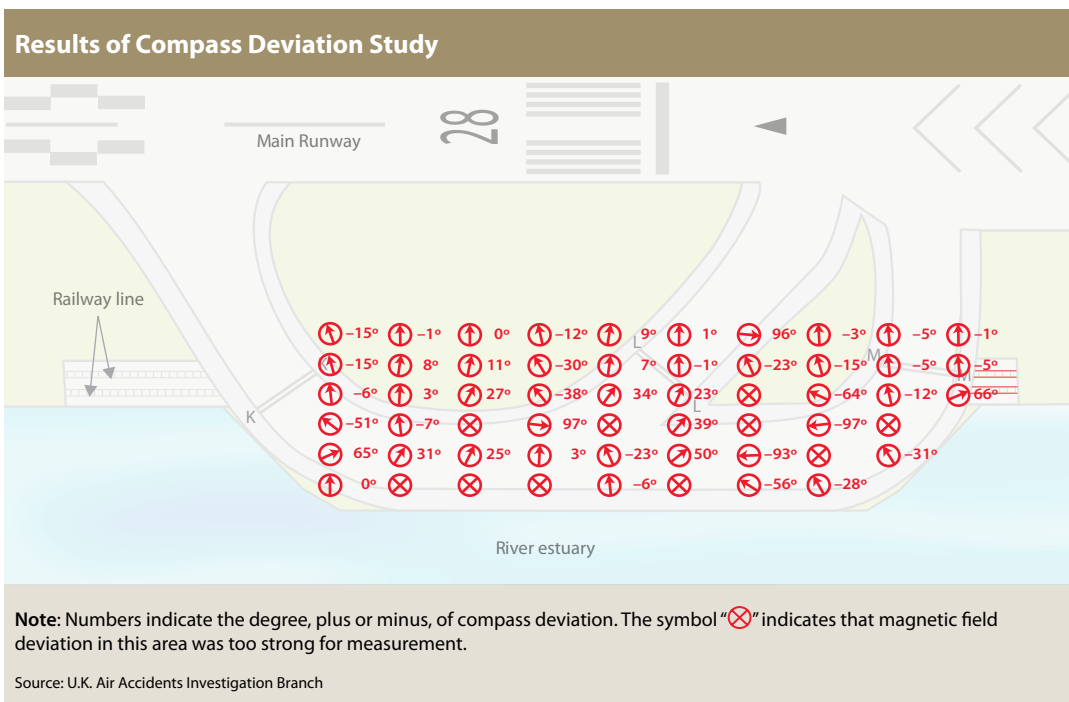
Figure 1

Engineering surveys were conducted within the Runway 28 holding area, 1.4 m (4.6 ft) above the surface, to measure “magnetic signature” — characteristics including the intensity and orientation of the magnetic field at a specific site — and compass deviation — the number of degrees that a magnetic compass deviates from magnetic north — at dozens of points within the Runway 28 holding area. The survey

found compass deviations of as much as 97 degrees (Figure 1, p. 19).

The surveys concluded that the compass deviation problems at LCY are “caused by several ferrous magnetic signature anomalies, primarily emitted as a vertical component from the 68 piled-beam structures situated under [the] Runway 28 holding area.”
