The NTSB says an operating radio altimeter likely could have prevented the fatal crash of a Eurocopter EC 135P2 on an EMS repositioning flight.

Dark-Night EMS

This article is based on NTSB Aviation Accident Brief NYC05MA039.

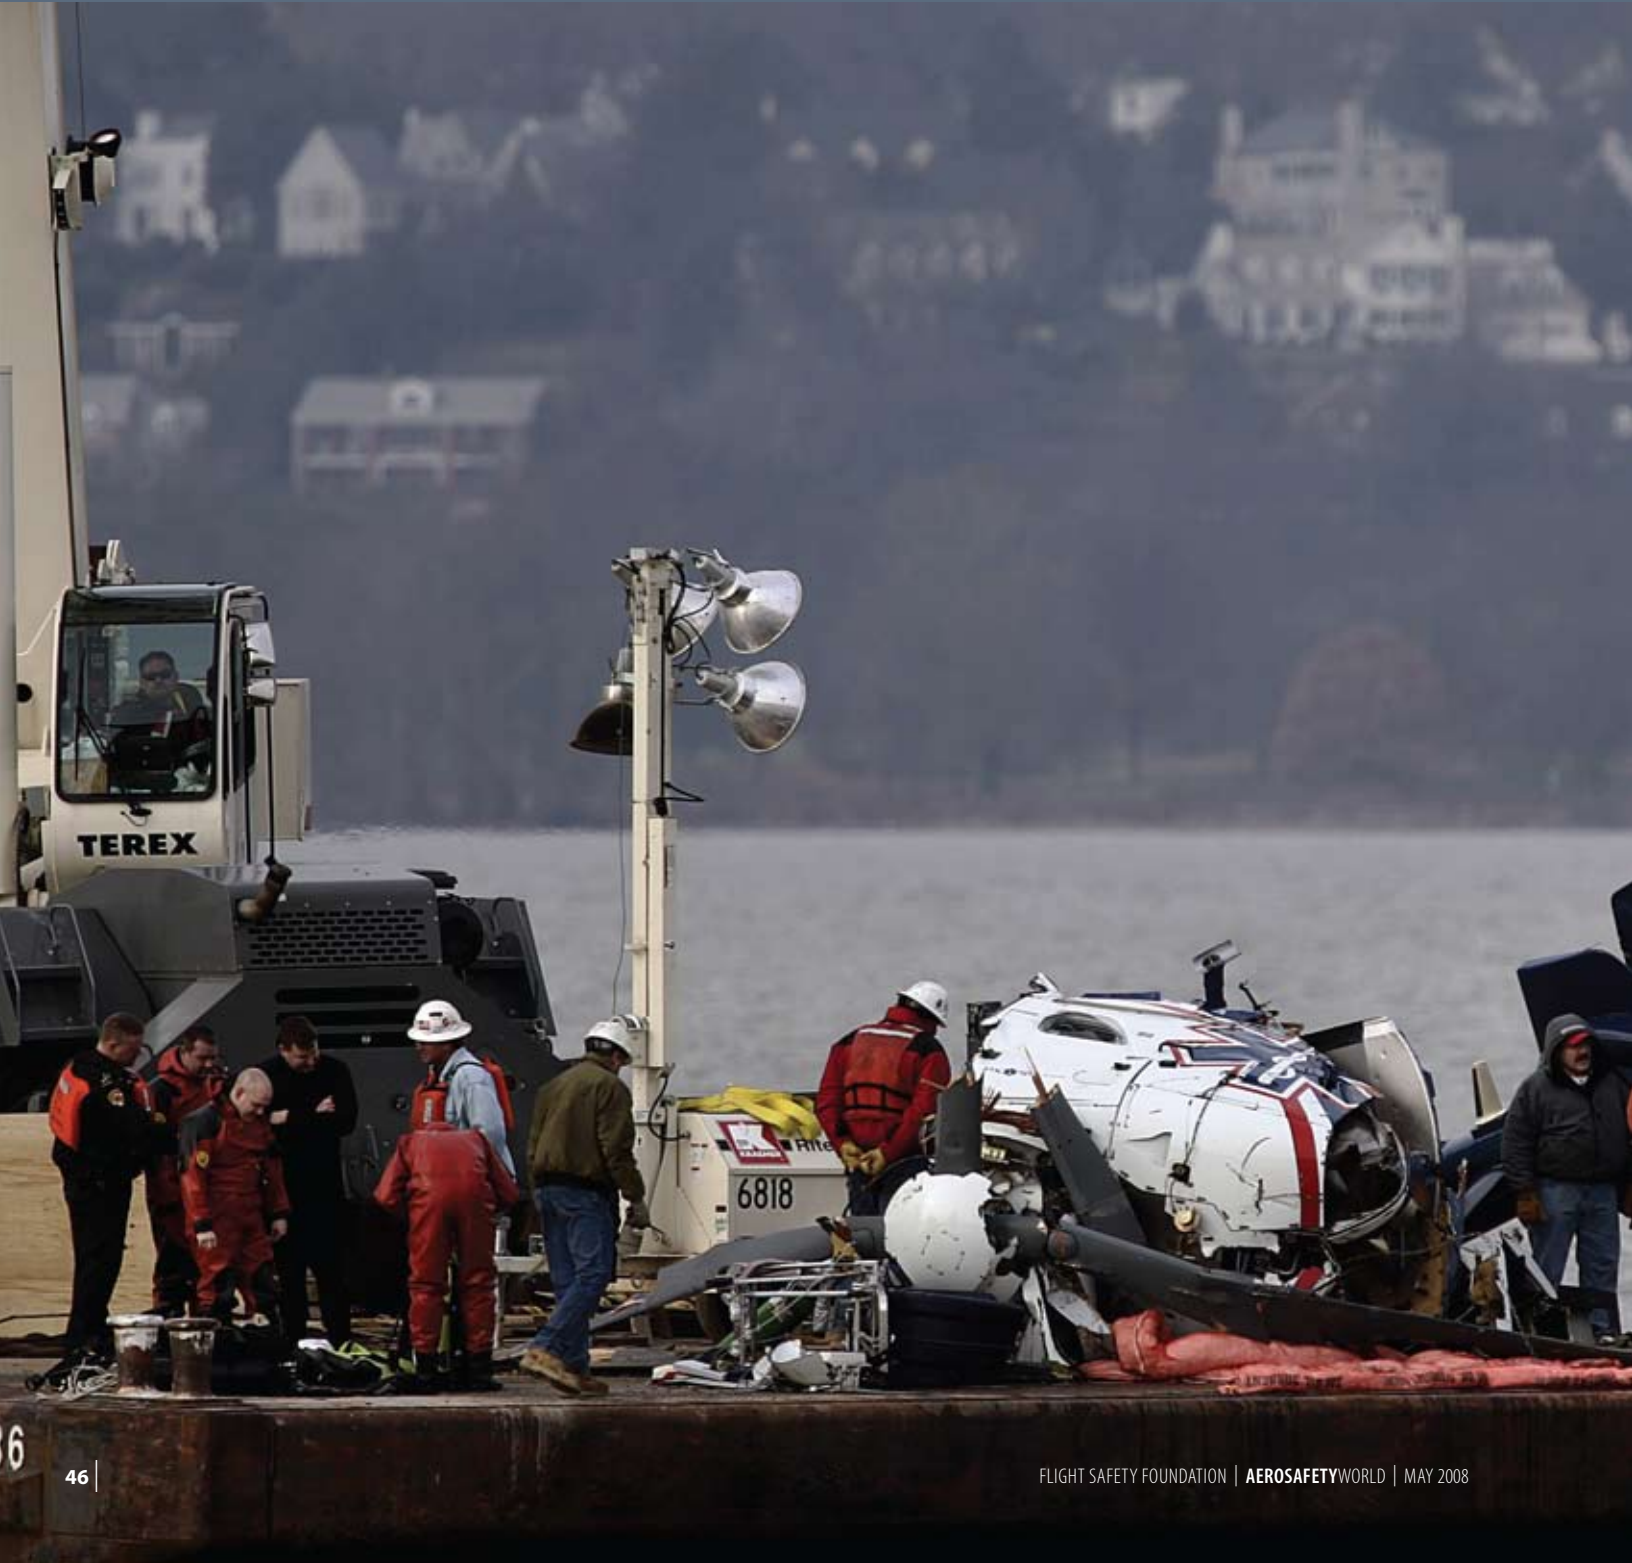
The wreckage of the EMS helicopter was pulled from the Potomac River south of Washington after the January 2005 accident.

The U.S. National Transportation Safety Board (NTSB) in its final report said that the probable cause of the Jan. 10, 2005, accident was “the pilot’s failure to identify and arrest the helicopter’s descent, which resulted in controlled flight into terrain.” Contributing factors were “the dark-night conditions, limited outside visual references and the lack of an operable radar [radio] altimeter in the helicopter,” the NTSB said.

As a result of the investigation of this accident and a 2004 Bell 206L-1 EMS accident,² the NTSB issued two safety recommendations emphasizing the critical role of radio altimeters in EMS operations. The recommendations said that the FAA should require the installation of radio altimeters in all helicopters used in EMS night operations and should ensure that the MELs for these helicopters require that radio altimeters be operable during night operations.
