SHORT FLIGHT,

BY MARK LACAGNINA

LONG ODDS

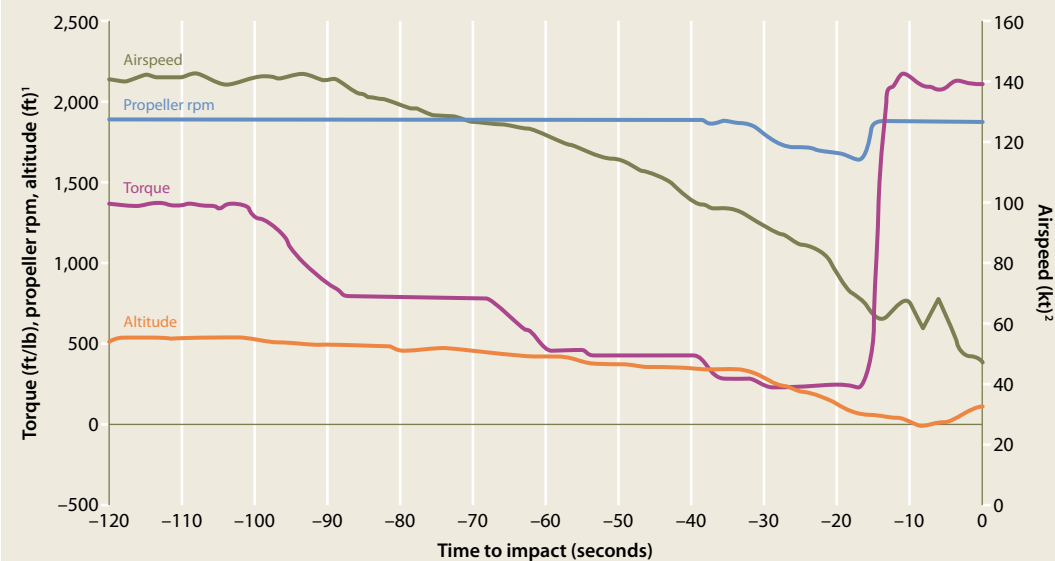
Figure 1

The report said that the pilot likely initiated a go-around when he realized that he would not be able to stop the aircraft on the runway. His rapid application of power caused torque to increase within two seconds from 376 ft/lb to 2,060 ft/lb, exceeding the limit by 13 percent (Figure 1).

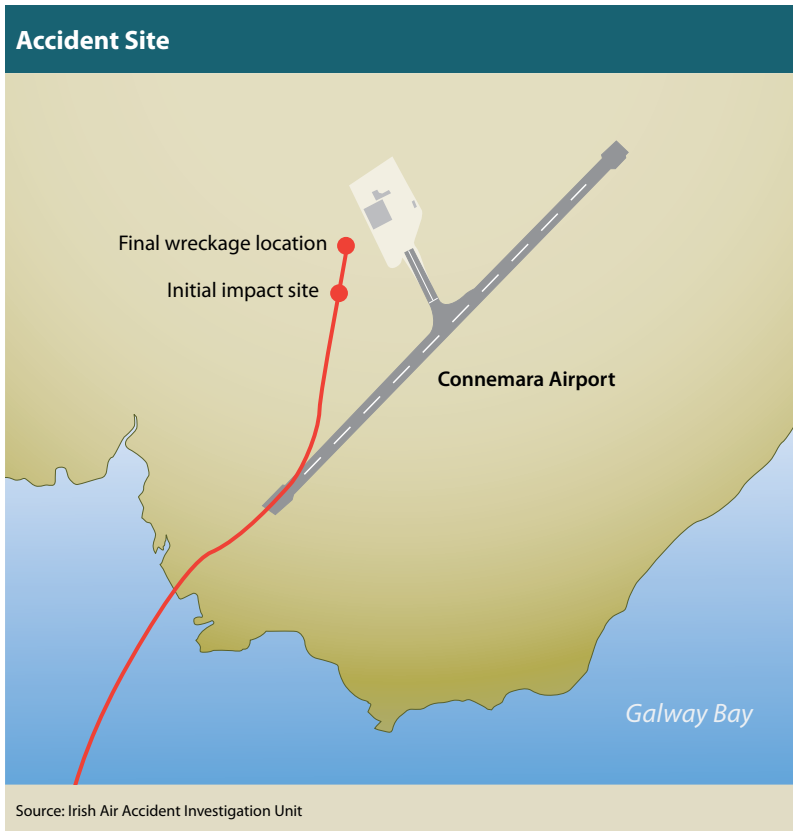
Figure 2

There was a clearway off the end of Runway 05 and terrain sloping down to the sea to the right, but torque effect caused the aircraft to roll left in the direction of terrain that sloped up toward the airport buildings (Figure 2, page 42).
