Hydraulic Failings

Conducting its investigations of six events since 2002, including two fatal accidents, the U.S. National Transportation Safety Board (NTSB) has identified hydraulic problems that led to “concern regarding the safe operation of Eurocopter AS 350-series helicopters.”¹

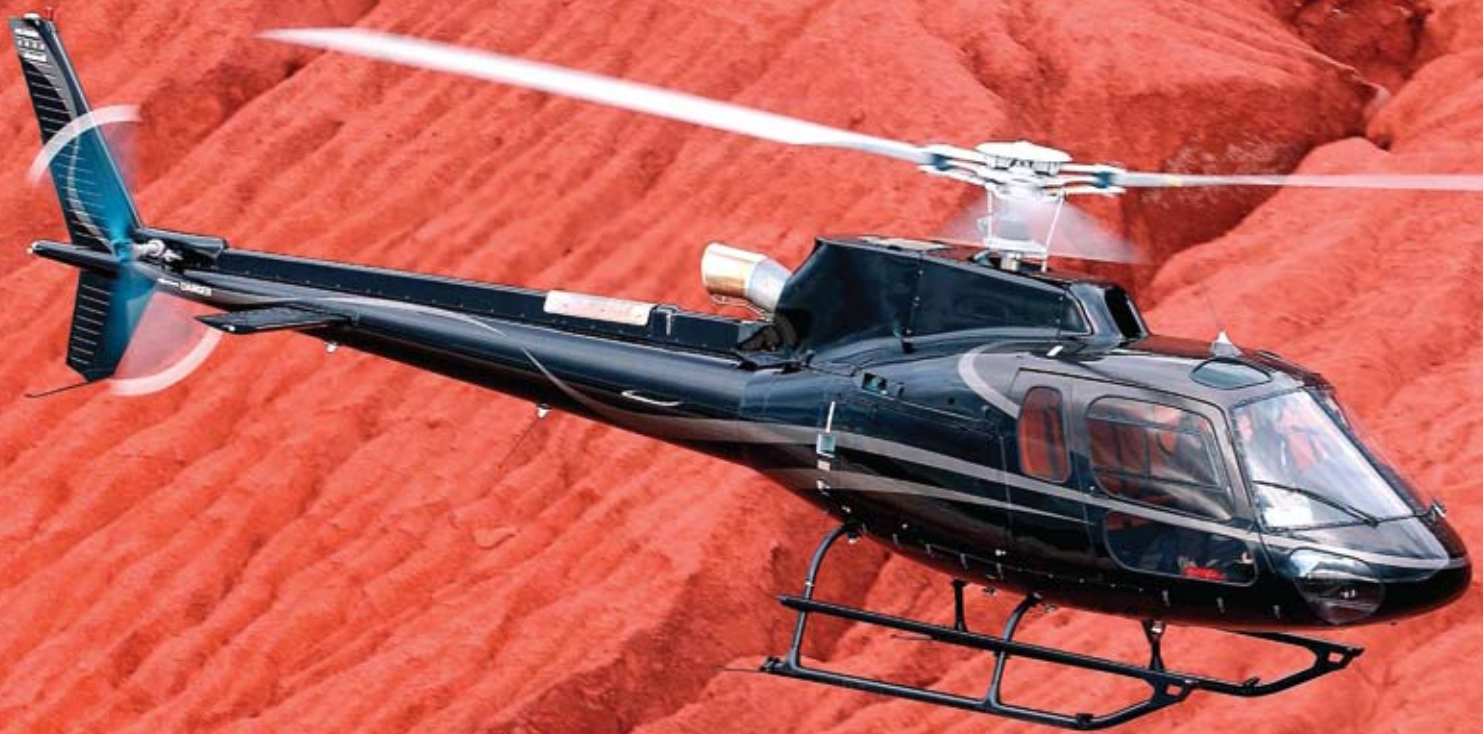
The NTSB's discovery of excessive wear in AS 350 hydraulic connectors has prompted a call for replacement of faulty components.
