IMC in the Mountains

The pilot of a Bell 412SP emergency medical services (EMS) helicopter was navigating through dark night conditions and intermittent fog on a positioning flight when the helicopter struck a Southern California mountainside, killing the pilot and two medical crewmembers.

The U.S. National Transportation Safety Board (NTSB) said the probable cause of the Dec. 10, 2006, accident in Hesperia, California, U.S., was “the pilot’s inadvertent encounter with instrument meteorological conditions [IMC]

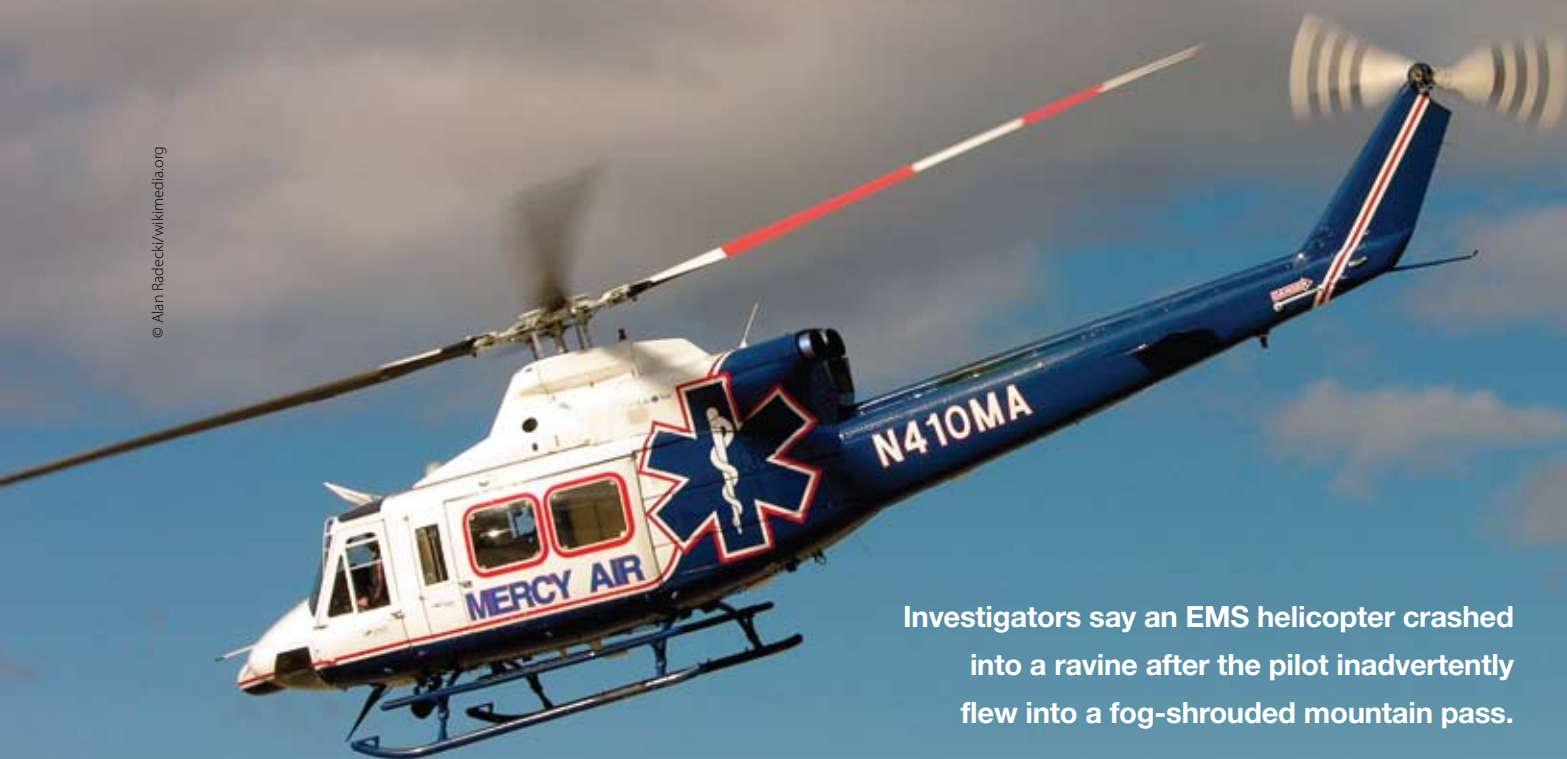
Investigators say an EMS helicopter crashed into a ravine after the pilot inadvertently flew into a fog-shrouded mountain pass.

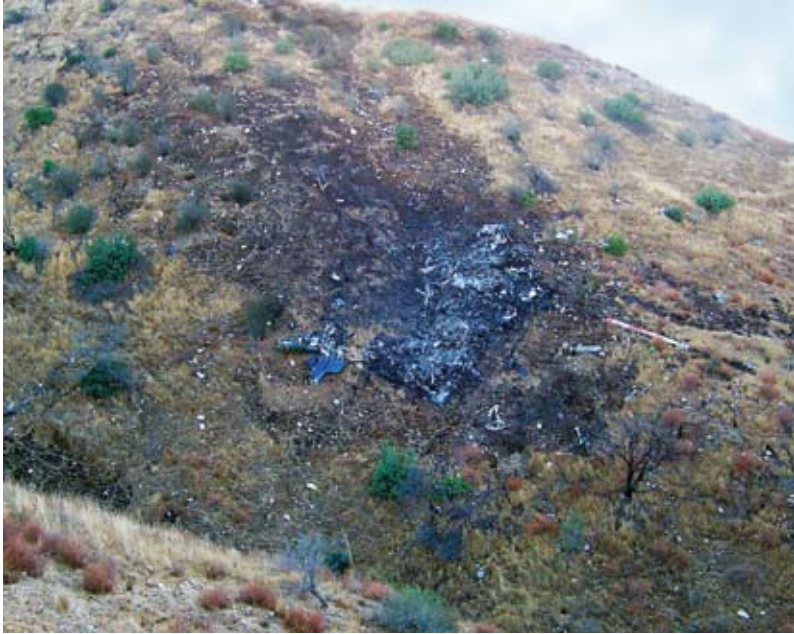
The wreckage was found on a mountainside in Southern California's Cajon Pass.

that the helicopter was 0.4 nm (0.7 km) east of I-15. Wreckage was found 0.7 nm (1.3 km) east of the highway in a ravine on the mountainside at 4,026 ft MSL; it was at the base of a 100-ft (31-m) electrical transmission tower — one of a series of electrical towers depicted on aeronautical navigation charts east of the Cajon Pass running from north-northeast to south-southwest.
