# FATAL Calculation

Failure of the flight crew to detect a computer programming error led to inadequate takeoff performance by their 747.

BY LINDA WERFELMAN

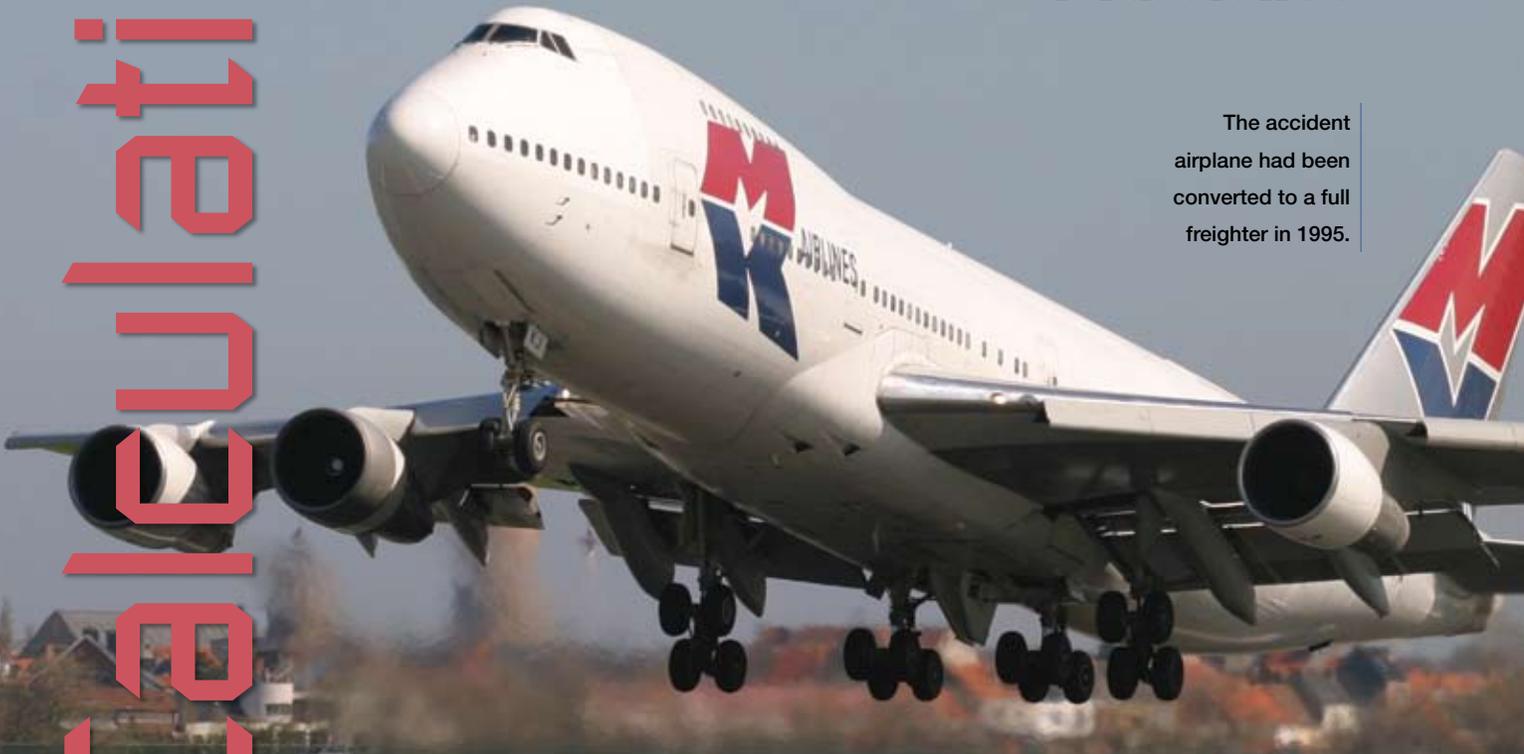
The accident airplane had been converted to a full freighter in 1995.

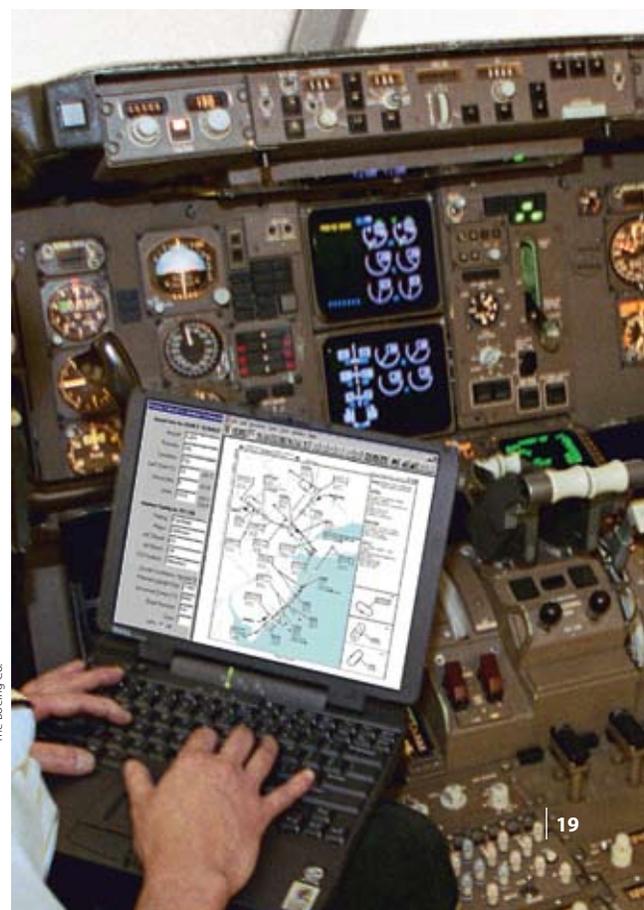
The Boeing Laptop Tool is used in calculating takeoff and landing performance data.

The BLT included a weight-and-balance summary page on which the computer's user could enter passenger weights, cargo zone weights and fuel; using this data, the BLT updated the takeoff weight at the bottom of the summary page. The updated weight was then "passed back to the planned weight field on the main input dialogue screen, and would automatically overwrite any entry in the planned weight field, without any notification to the user."

The report said that this feature was "believed to be a key element in how the incorrect takeoff performance data were generated."

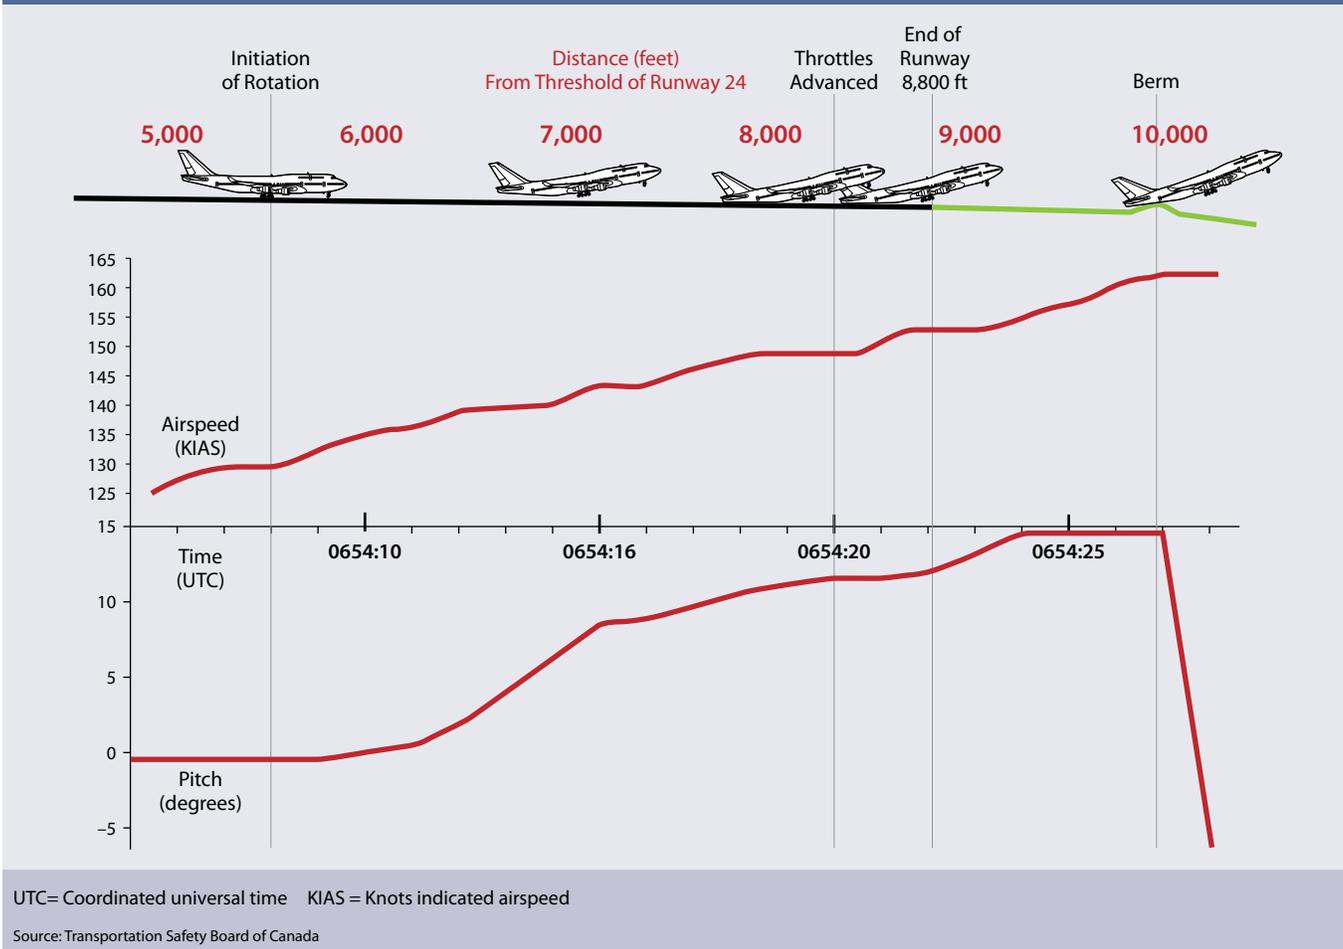
Figure 1

At 0653 UTC, the crew began the takeoff roll on Runway 24. The airplane's lower aft fuselage struck the runway during rotation and again several seconds later; the airplane remained in contact with the ground until it was 825 ft (252 m) beyond the end of the runway. It then flew 325 ft (99 m) before the lower aft fuselage struck an earthen berm supporting an instrument landing system localizer antenna. The airplane's tail separated on impact, and the rest of the airplane continued in the air for 1,200 ft (366 m), then struck the ground and burned (Figure 1, page 20).

## Takeoff Sequence
