# INTO THE BLACK SEA

A go-around goes awry in Sochi, Russia.

Spatial disorientation, inadequate control inputs by the captain, lack of monitoring by the copilot and the failure of both pilots to respond to a terrain awareness and warning system (TAWS) warning were among the factors that led to the crash of an Airbus A320 during a missed approach to Sochi (Russia) Airport, according to the final report by the Russian Air Accident Investigation Commission (AAIC).

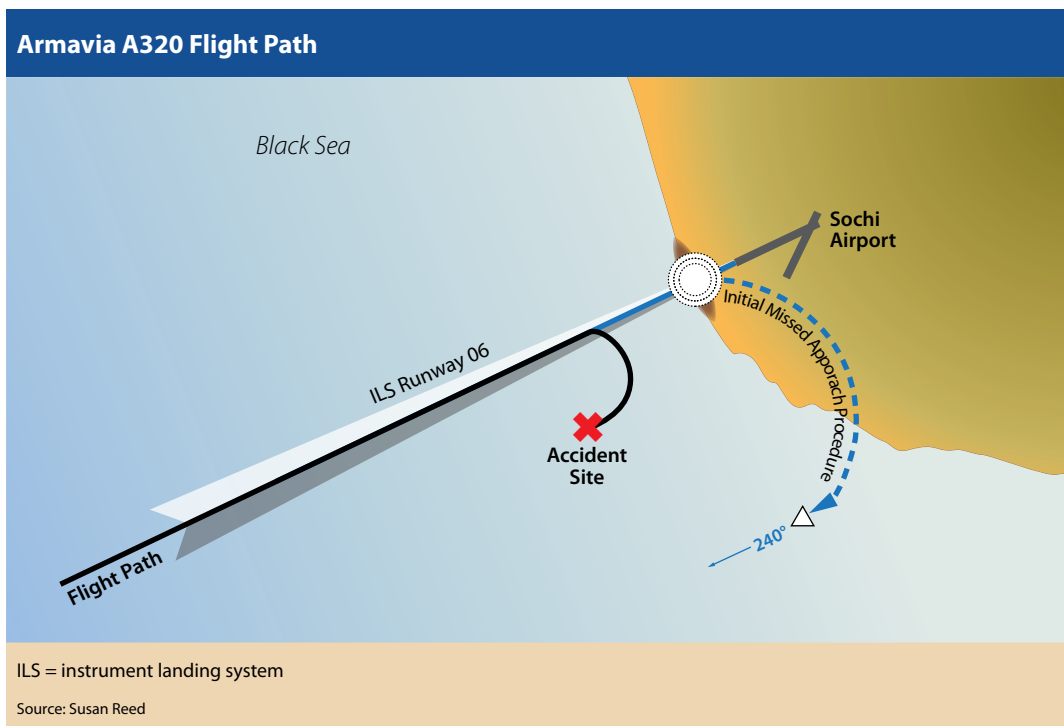
**Figure 1**

Instead, the crew used the push-to-level-off button on the flight control unit to stop the descent and selected a heading of 172 degrees. “As a result, the aircraft entered a turn to the right with a roll angle up to 25 degrees, maintaining an altitude of 1,114 ft (340 m),” the report said. Figure 1 shows the aircraft’s flight path.

The crew then set 3,200 ft in the altitude selector and engaged the autopilot’s open-climb mode. As a result, the aircraft pitched nose-up and began to climb at about 2,400 fpm.

The aircraft was in a climbing turn, in landing configuration, at 1,150 ft when an aural low-energy warning was generated at 0212:04. The report said that the crew responded by moving the thrust levers to the TOGA position. This resulted in deactivation of the autothrust system and engagement of the autopilot go-around modes.

At 0212:20, the altitude-selector setting was changed to 1,969 ft (600 m), and the captain began to move his sidestick forward. The report said that the captain might have overreacted to the downward movement of the flight director pitch-command bars in his primary flight display (PFD) when the selected altitude was reduced. The sensation of acceleration and the absence of external visual cues might have caused

The aircraft was descending through 1,626 ft in a steep right turn when the captain told the copilot to retract the flaps and slats. Indicated airspeed was 186 kt and increasing.

At 0212:45, the captain made sidestick inputs that increased the aircraft’s nose-down pitch attitude and right bank angle. Two seconds later, a TAWS “pull up” warning was generated, and the copilot said, “Level off.” The aircraft was descending at about 4,300 fpm, and bank angle had increased to 39 degrees.
