Easy Does It

TCAS resolution advisories require rapid — but not radical — response.

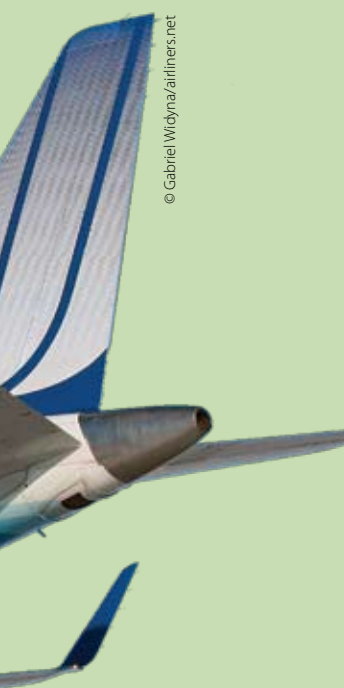
Recorded flight data indicate that the first officer increased the pitch attitude to 14 degrees nose-up, resulting in a peak vertical acceleration of +2.0 g — that is 2.0 times standard gravitational acceleration. NTSB said that the “excessive maneuver” was the probable cause of serious injuries, including a broken leg, sustained by a cabin crewmember. The 170 was not damaged.

A flight attendant suffered a broken leg when this Embraer 170 pulled 2 g during an excessive RA maneuver.

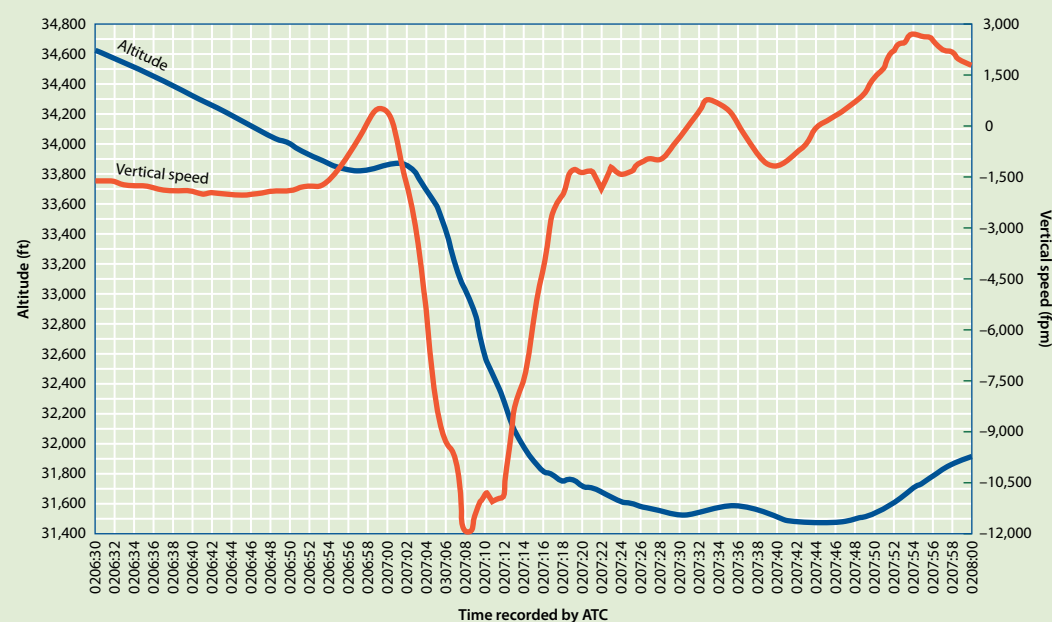
Figure 1

Recorded flight data indicated that the 757’s pitch angle changed from +4 degrees to –18 degrees in four seconds. “The maximum vertical acceleration [was] –1.06 g,” the report said. Descent rate peaked at 12,000 fpm (Figure 1).

The report indicated that the captain’s recovery also was excessive, resulting in a peak vertical acceleration of +2.58 g for two seconds as the 757 was leveled at FL 310.

Boeing 757 Response to RA

Based on the findings of the accident investigation, the ASC recommended that “all operators review their training programs to ensure
