SAFE WITH THREE

A 747 flight of nearly 11 hours with an engine shut down has touched off an international debate and a call for clear guidance for airlines.

BY MARK LACAGNINA

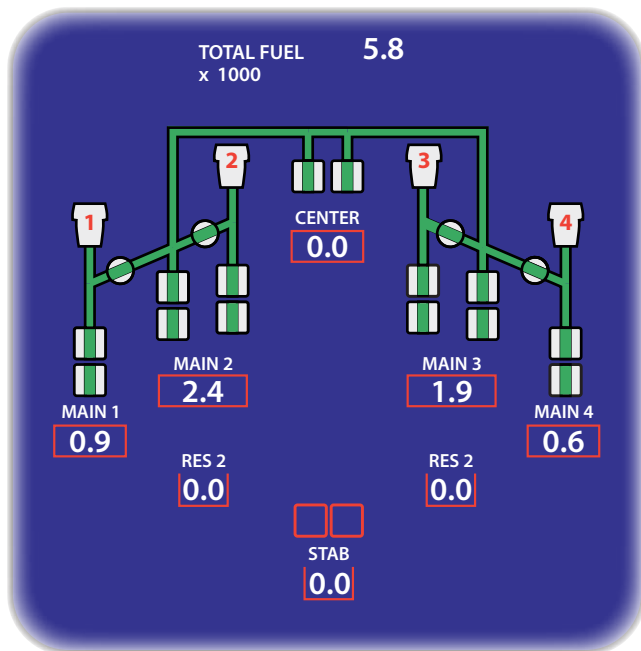
Fuel quantities shown on this EICAS display are approximately what the crew would have seen after landing.

Inbound to Manchester, the EICAS generated a low fuel warning. The crew conducted the QRH procedure, activating all main fuel pumps and opening all crossfeed valves, and declared an emergency. The commander took control and landed the aircraft at 1604 UTC without further incident. The EICAS showed 5.8 tonnes (12,787 lb) of fuel remaining in the tanks.

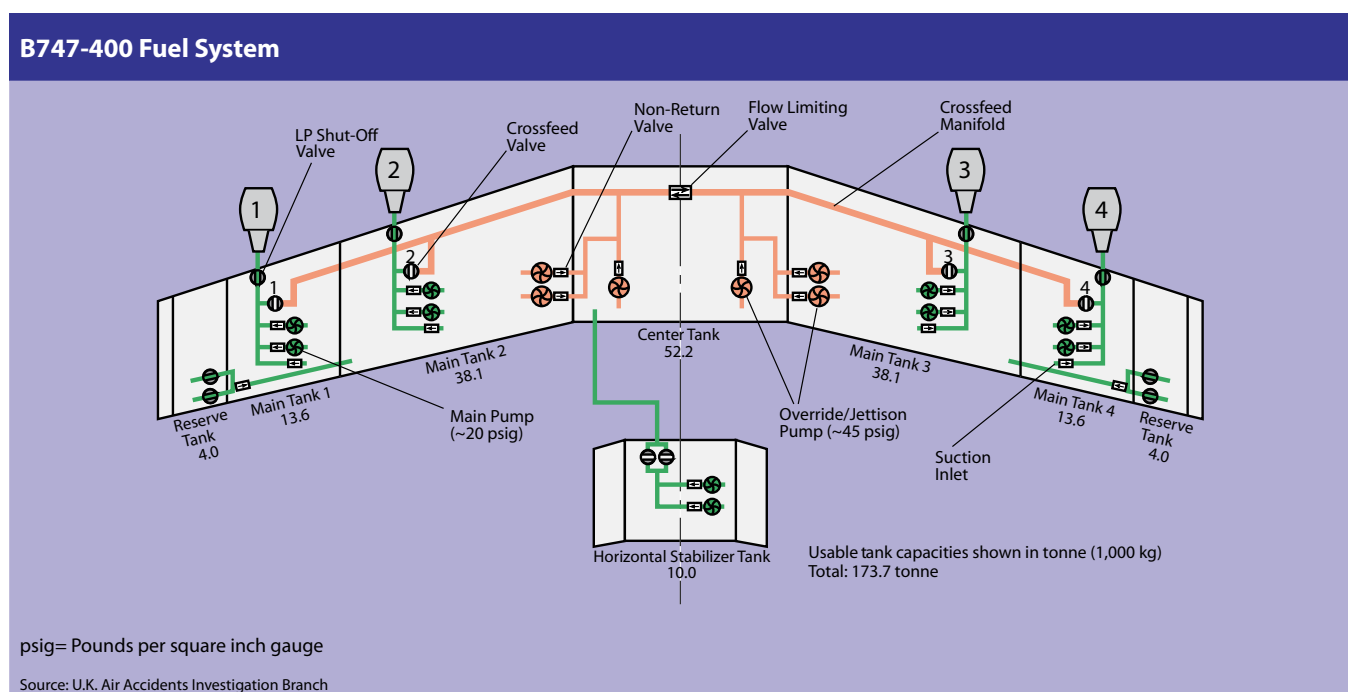
Figure 1

The fuel system in a 747-400 comprises two main tanks and a reserve tank in each wing, a wing center-section tank and a horizontal stabilizer tank (Figure 1). In each main tank are two “main” pumps that operate in parallel and supply fuel to the respective engine and/or the crossfeed manifold. The inboard main tanks, which hold almost three times more fuel than the outboard main tanks, also have two override/jettison pumps that provide

more than double the flow rate of the main pumps and supply fuel only to the crossfeed manifold.

In normal operation, all the pumps are activated and all crossfeed valves are opened before takeoff. During flight, the horizontal stabilizer tank is emptied first, followed by the wing center-section tank and the reserve tanks. Fuel in the inboard main tanks then is crossfed to the engines until fuel quantity in the inboards matches the quantity in the outboard main tanks; total fuel quantity at this point typically is 55 tonnes (121,254 lb). An engine indicating and crew alerting system (EICAS) message then prompts the crew to discontinue crossfeeding by deactivating the override/jettison pumps and closing the crossfeed valves in the outboard main tanks. Each main tank now feeds fuel only to its respective engine, and no further crew action is required for fuel management unless a fuel imbalance or a low-fuel condition occurs.

Because the no. 2 engine was inoperative, a fuel imbalance did occur after the crew discontinued crossfeeding. The fuel quantity in the left inboard main tank, which normally would have been supplying fuel to the no. 2 engine, did not decrease as rapidly as the fuel quantities in the other main tanks. The crew, following the procedure in the airline's operations manual, periodically activated the override/jettison pumps in the left inboard main tank to balance the fuel in the main tanks.

The report said that the crew's concern that fuel would not be available from the left inboard main tank indicated that their knowledge of the fuel system and their training on fuel management were deficient. The fuel quantity in that tank had stopped decreasing when the standpipe inlets for the override/jettison pumps were unported. This is a fuel-system feature designed to prevent fuel quantity in either inboard main tank from being reduced below about 3.2 tonnes (7,055 lb) when the override/jettison pumps are used to jettison fuel.

Based on these findings, AAIB recommended that the airline include "relevant instruction on three-engined fuel handling during initial and recurrent training." Among actions taken in response to the recommendation, British Airways revised fuel-management procedures in relevant manuals and training courses, provided additional engine-out fuel-management training to all 747-400 flight crews and added three-engine fuel-management and low-fuel procedures to its recurrent training programs.
