Learning From Experience
Incident No. 3

Delayed

Pull-Up

Third in a series focusing on approach-and-landing incidents that might have resulted in controlled flight into terrain but for timely warnings by TAWS.

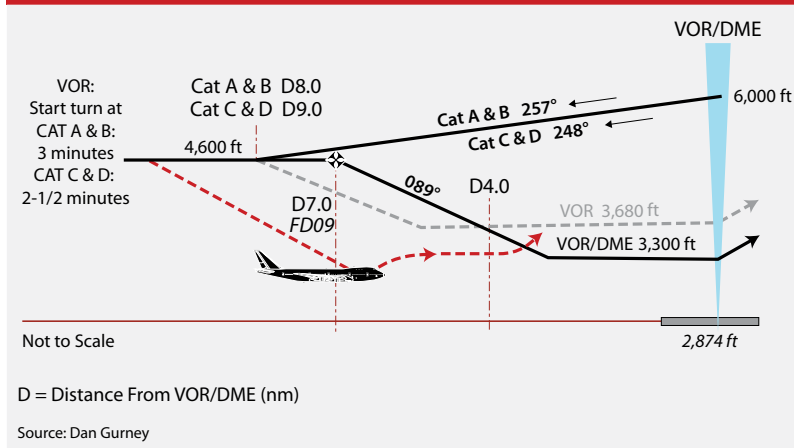
Figure 1

The chart for the VOR/DME (VHF omnidirectional radio/distance measuring equipment) approach, which the crew apparently was conducting in nighttime visual meteorological conditions (VMC) with visibility restricted by haze, shows that a minimum altitude of 4,600 ft should have been maintained until reaching the final approach fix (FAF), 7.0 nm DME from the station. However, the crew began the descent for the final segment of the approach two nm before reaching the FAF, from there flying a three-degree descent path (Figure 1).

The aircraft was about 1,300 ft too low when it crossed the FAF. The descent was continued below the minimum descent altitude (MDA) for the VOR/DME approach, 3,300 ft, likely because the flight crew had the ground environment in sight and was continuing the flight by reference to external visual cues. The crew received a “TERRAIN, PULL UP” warning from the TAWS

when the aircraft was 250 ft above ground level — a city in this case — and 6.7 nm from the station (about 6.0 nm from the runway threshold). The crew stopped the descent and began a climb, but leveled the aircraft at the MDA. Not having reached the charted step-down fix for descent to the MDA, 4.0 nm, the aircraft was 380 ft below the appropriate minimum altitude and about 100 ft below the top of a nearby obstacle.

The aircraft was in level flight at the MDA for about 1.5 nm before the TAWS generated a “TOO LOW, TERRAIN” warning, which apparently prompted the crew to conduct a missed approach.

Approach Profile View and Aircraft Flight Path

In the author's opinion, the crew should have continued the climb to 6,000 ft, the sector safe altitude — also called minimum safe altitude — shown on the approach chart.

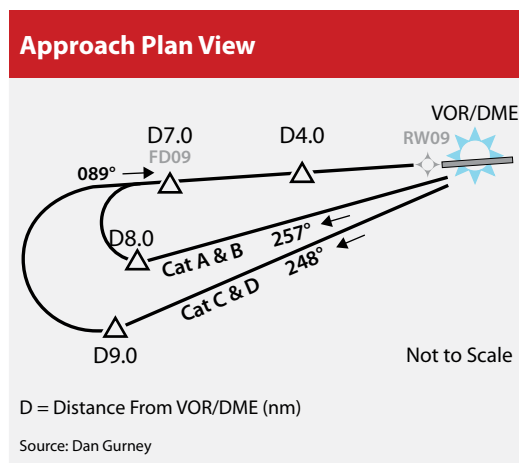
Figure 2

- The chart includes information for a VOR approach as well as the VOR/DME approach to Runway 09. In the charted profile view, a dashed line depicting the glide path for the final segment of the VOR approach indicates that the descent from 4,600 ft is initiated *before* reaching the FAF. Furthermore, this pre-FAF descent point is identified on the chart by a listing of the turn-in points for the procedure turn — 8.0 nm for Category A and B aircraft and 9.0 nm for Category C and D aircraft (Figure 1 and Figure 2). Thus, the crew might have mistakenly identified the descent point for the VOR/DME approach as the 9.0 nm turn-in point rather than the required 7.0 nm.
