Failure to Look

The pilot of an EC 130B4 was killed in a collision with another helicopter during a nighttime approach to a busy heliport.

BY LINDA WERFELMAN

This article is based on U.S. National Transportation Safety Board accident brief no. MIA06FA022A and the accompanying public docket.

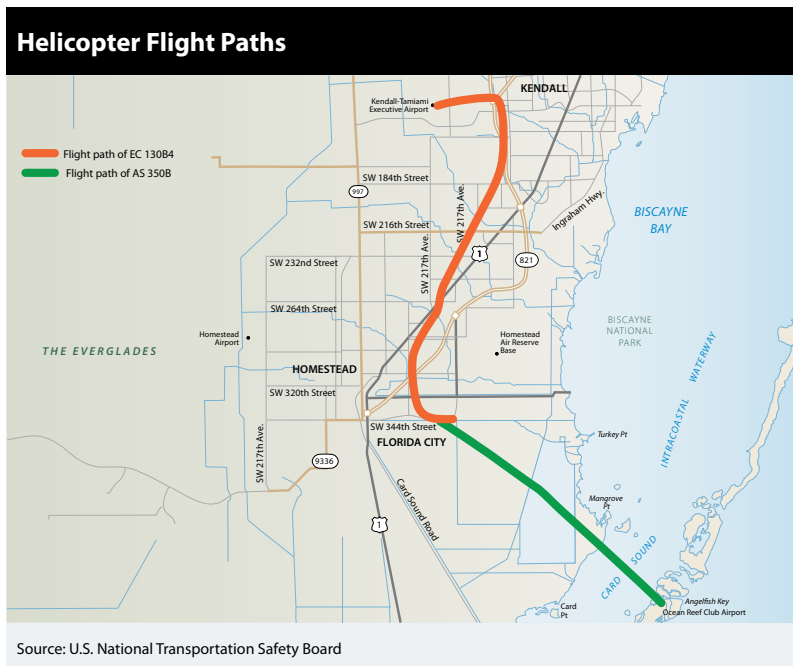
Figure 1

The flight of the AS 350B originated about 2043 from Ocean Reef Club Airport in Key Largo; the EC 130B4 departed at 2038 from Kendall-Tamiami Executive Airport in Miami (Figure 1, p. 35).

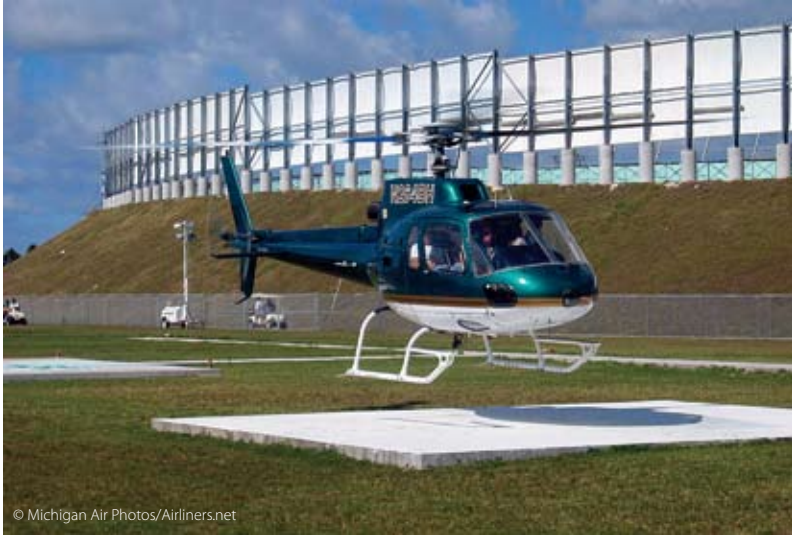
The report said that the EC 130B4’s main rotor blades struck the left skid of the AS 350B. The EC 130B4 descended immediately, and the pilot of the AS 350B flew the helicopter east to land on grass at the heliport.

The pilot of this AS 350B — photographed at the racetrack heliport before the accident — said he felt significant vibration as he landed the aircraft after the midair collision.
