Teamwork in Motion

Flight crews play a pivotal role in safety during business jet towing and parking.

BY WAYNE ROSENKRANS

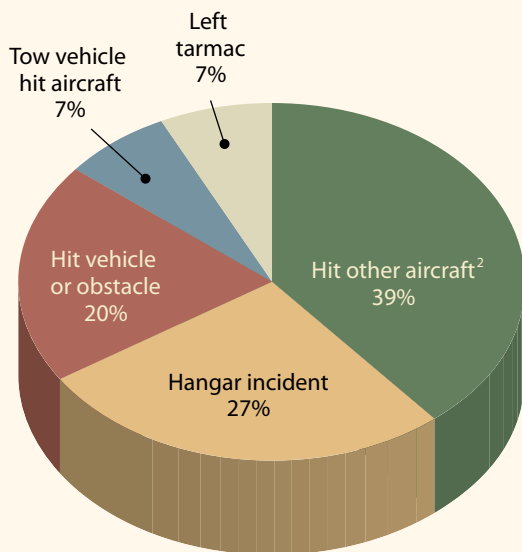
Figure 1

- The most common example of 24 *maneuvering error* events was a towed aircraft striking a parked aircraft (Figure 1) — often inside a hangar. Variations included the towed aircraft striking the hangar door or a parked vehicle or the tow vehicle striking the towed aircraft, or the tow vehicle operator moving the towed aircraft off the tarmac.
- When the 22 *torque-link connected* events occurred, the nose

2. Assigned subcategories of maneuvering error were: *hit other aircraft*, which means the towed aircraft struck another aircraft that was parked, and damaged parts often were the wing tips, but sometimes were the horizontal stabilizer tip, gear door, etc.; *hangar incident*, which means all events occurring in a hangar, including striking another aircraft, and in most cases, the aircraft struck the hangar door or struck another part of the hangar itself; *hit vehicle or obstacle*, which means that the aircraft struck a vehicle such as a car or fuel truck or an obstacle such as a fence; *tow vehicle hit aircraft*, which means any event in which this was the type of contact; and *left tarmac*, which means that the towed aircraft departed from the tarmac because of error by ground personnel.
