The runway was in and out of sight, but the crew pressed ahead.

# SNOWED

BY MARK LACAGNINA

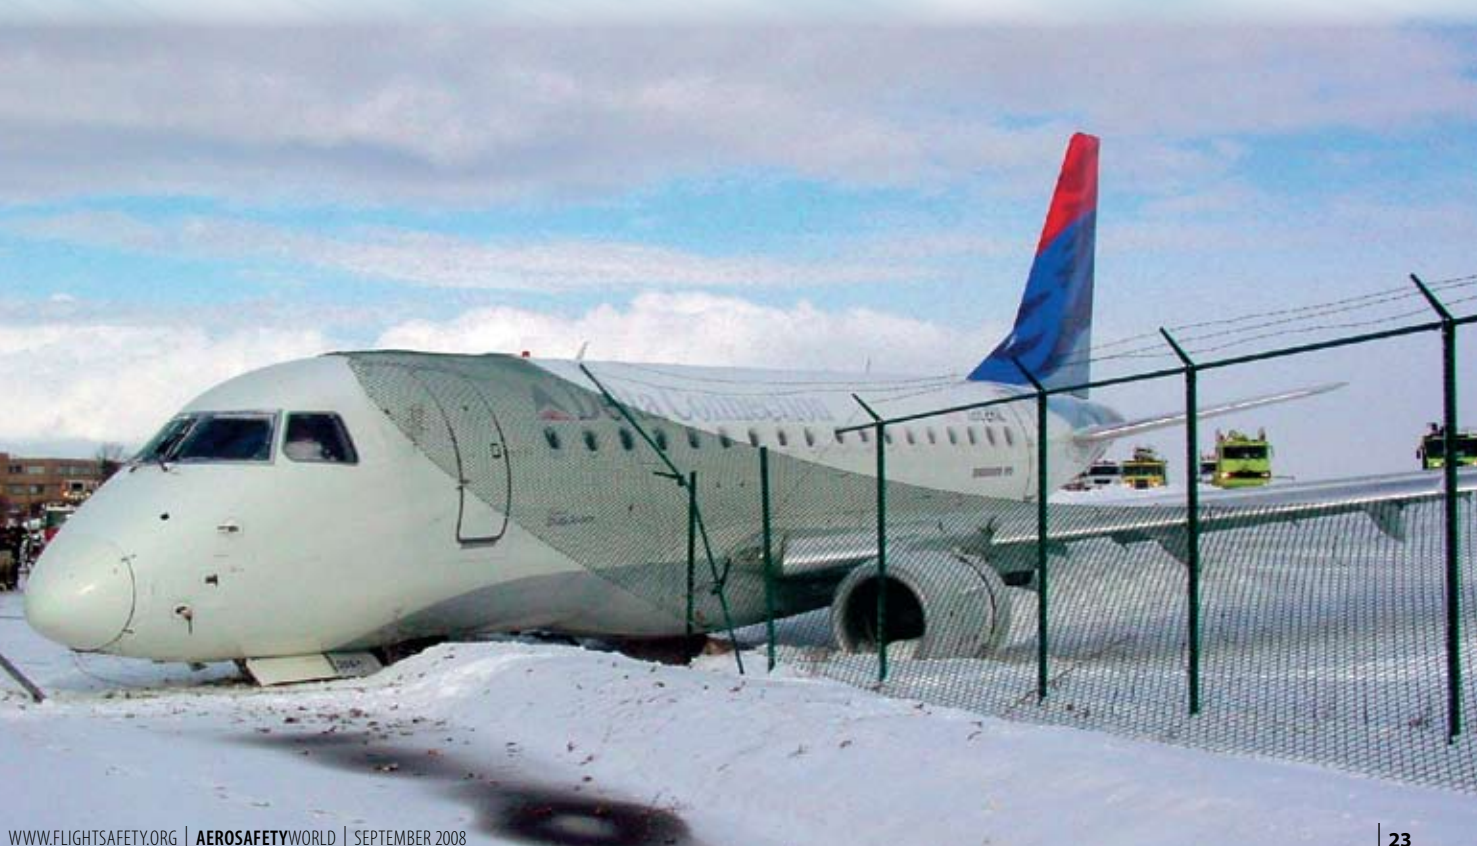
After landing long and overrunning the short, contaminated runway, the Shuttle America ERJ 170 became entangled in the airport perimeter fence, its nose gear broken.

After confirming that no fire or fuel leaks existed, and that no one was seriously injured, the captain decided to keep everyone aboard the airplane until buses arrived to transport them to the terminal. The nose gear had collapsed, and the occupants were evacuated through the front cabin door with the aid of a stepladder.

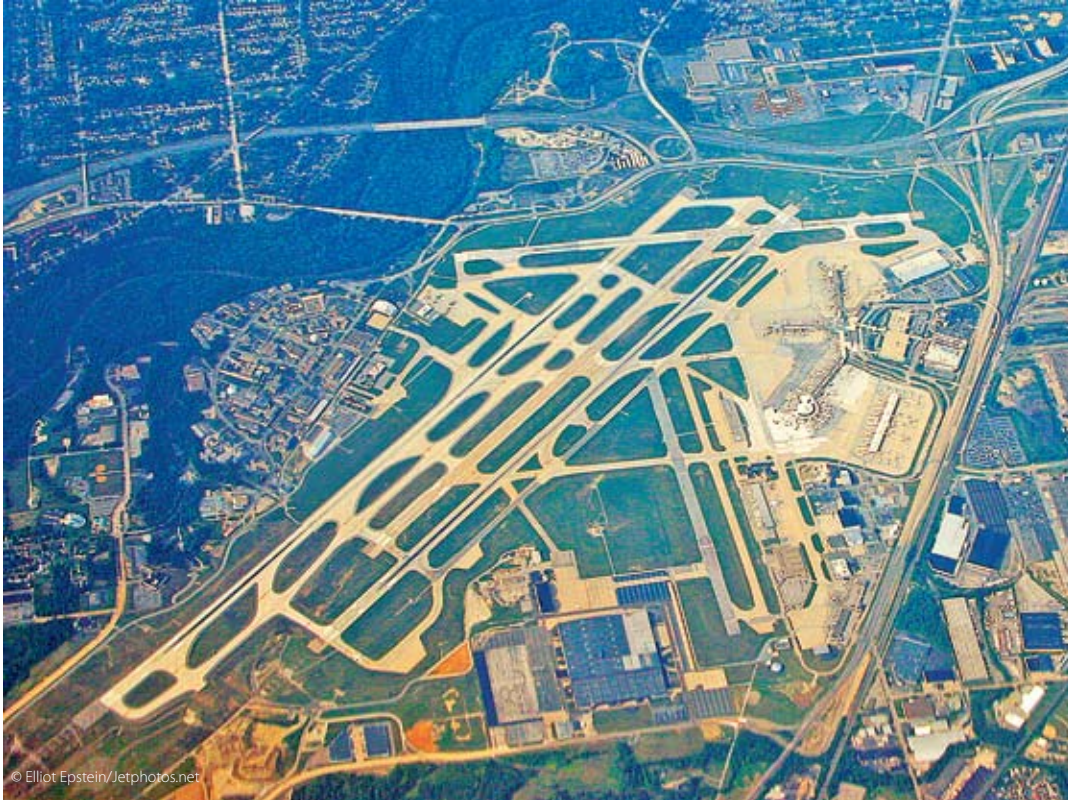
After Runway 24R at Cleveland Hopkins was closed for snow removal, the flight crew attempted to land on Runway 28, the crosswind runway at the top of the photo.

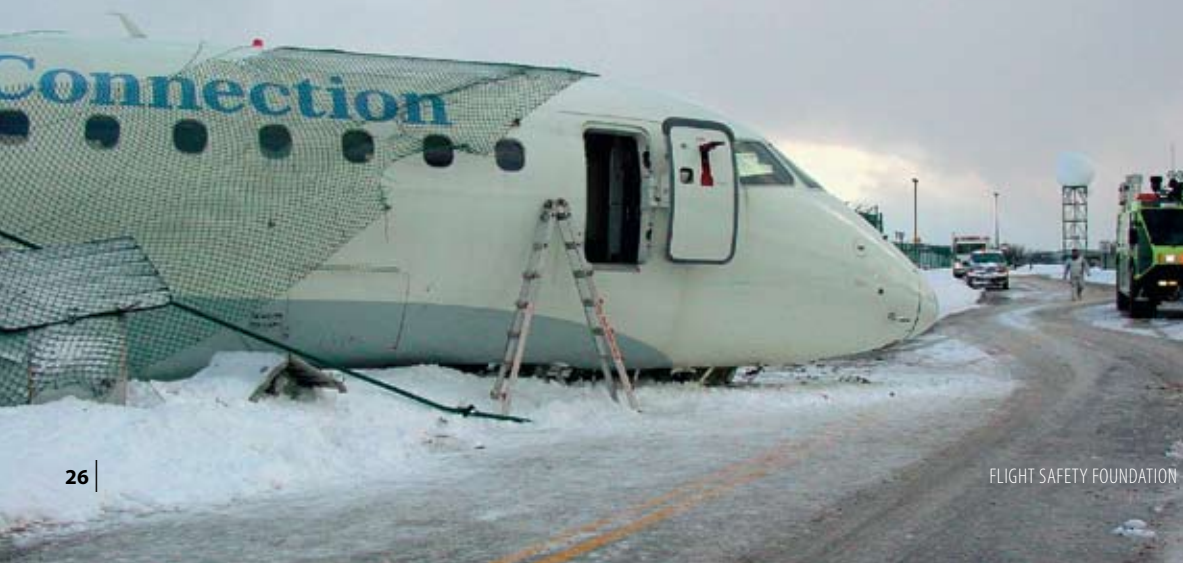
No one was hurt while deplaning, but NTSB said that using the evacuation slide, rather than a step ladder, would have been safer.
