Uncontained Engine Failure and Subsequent Fire  
American Airlines Flight 383  
Boeing 767-323, N345AN  
Chicago, Illinois  
October 28, 2016

NTSB/AAR-18/01  
PB2018-100344

# Aircraft Accident Report

**Abstract:** This report discusses the October 28, 2016, accident involving American Airlines flight 383, a Boeing 767-323, which experienced an uncontained failure of the right engine and subsequent fire during its takeoff ground roll at Chicago O'Hare International Airport, Chicago, Illinois. Of the 2 flight crewmembers, 7 flight attendants, and 161 passengers on board, 1 passenger received a serious injury and 1 flight attendant and 19 passengers received minor injuries during the emergency evacuation. The airplane was substantially damaged from the fire. Safety issues identified in this report include the lack of recent guidance comparing production inspection processes for nickel alloy engine components, the need for improved in-service inspection techniques for critical rotating parts of all engines, the lack of recent guidance about design precautions to minimize hazards resulting from uncontained engine failures, the need for separate engine fire checklist procedures for gr

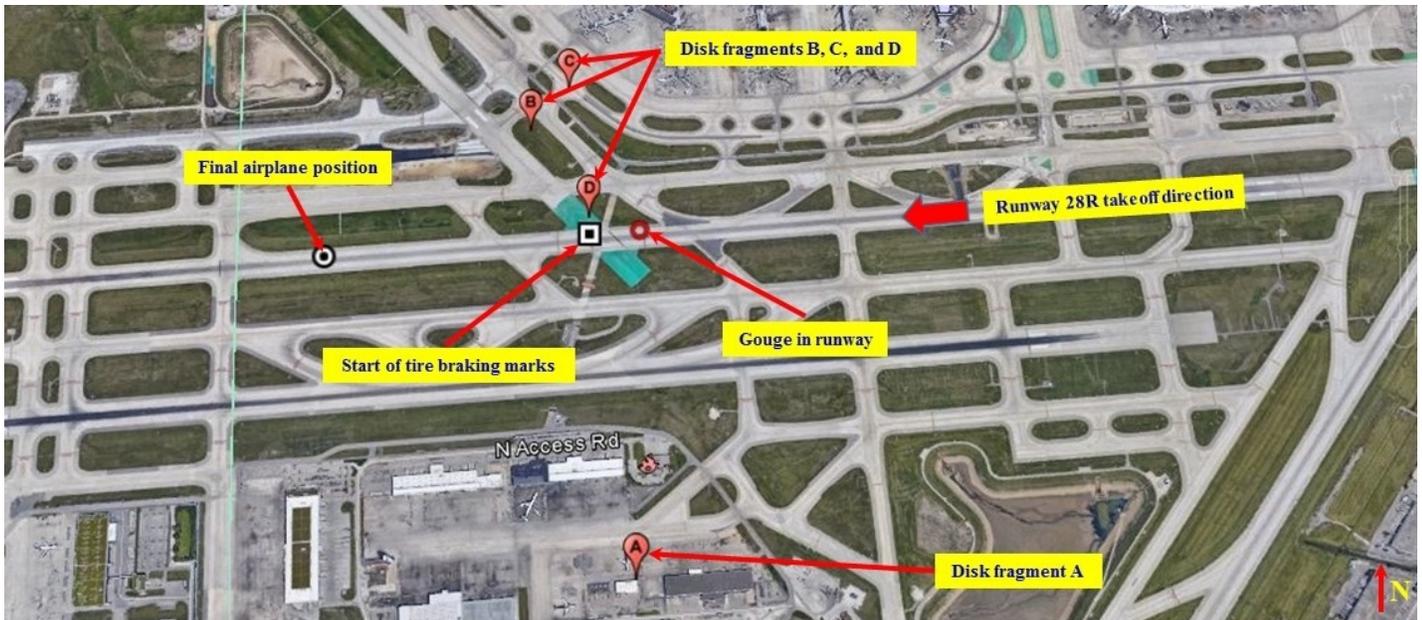
The other three disk fragments (labeled “B,” “C,” and “D” in figure 5) were recovered on the airport property north of runway 28R. These three disk fragments were located 475 ft (fragment D), 1,365 ft (fragment B), and 1,500 ft (fragment C) from the airplane’s location on the runway where the uncontained engine failure occurred. Specifically, fragment B, which weighed about 83.1 pounds, was recovered in the grassy area near a taxiway; fragment C, which weighed about 6.6 pounds, was recovered on another taxiway; and fragment D, which weighed about 0.2 pound, was recovered on the overrun area at the departure end of runway 15.<sup>38</sup> Figure 6 shows the disk fragment locations overlaid on a map of the airport.

**Figure 6.** Disk fragment locations.

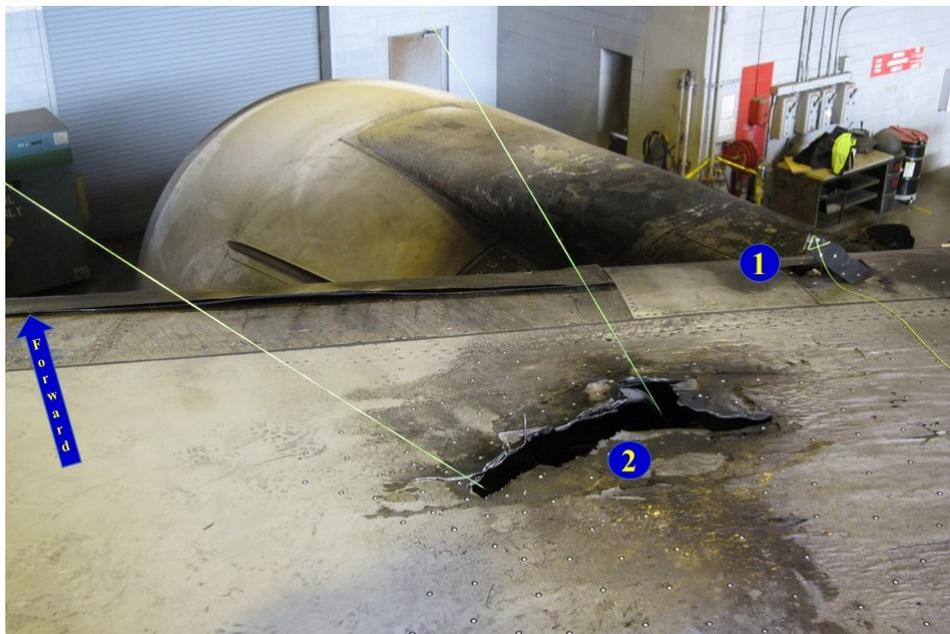
On-scene examination of the right wing (inboard of the right engine pylon) revealed two distinct penetration holes.<sup>39</sup> One hole (referred to as hole 1) was located forward of the front spar in the leading-edge panel; the other hole (referred to as hole 2) was located aft of the wing front spar. Figure 7 shows holes 1 and 2.

**Figure 7.** Holes located forward and aft of the right wing front spar.

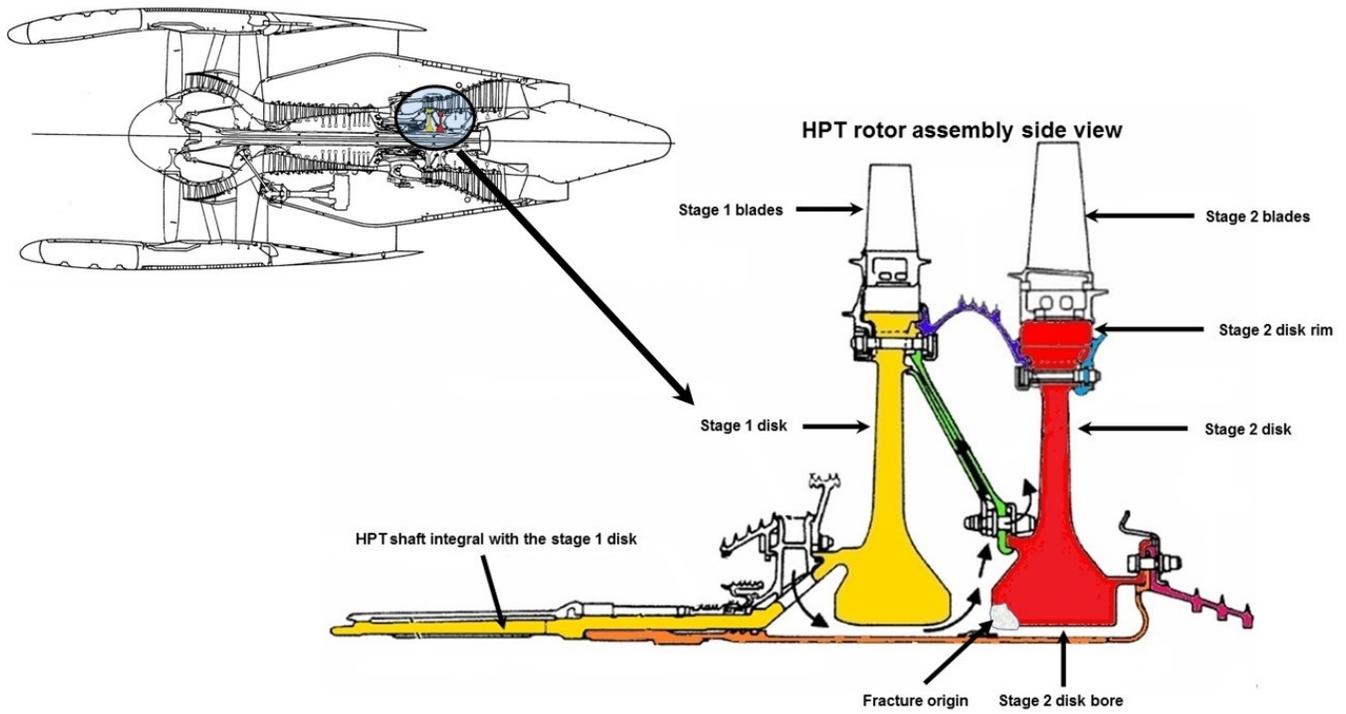
The NTSB's Materials Laboratory in Washington, DC, examined the three largest HPT stage 2 disk fragments (A, B, and C; see figure 5). Visual examination found a discolored (heat-tinted) region on the fracture surfaces separating fragments A and B.<sup>41</sup> The discolored region was at the forward end of the disk bore region, as indicated in figures 8 and 9, and this region was identified as the location where the fracture originated.

Figure 8. Engine cross-section and fracture origin location.
