Terrain awareness warning system alert involving Eurocopter BK 117C-2, VH-SYB

near Crookwell, New South Wales | 21 October 2016

ATSB Transport Safety Report
Aviation Occurrence Investigation
AO-2016-160
Final – 6 November 2018

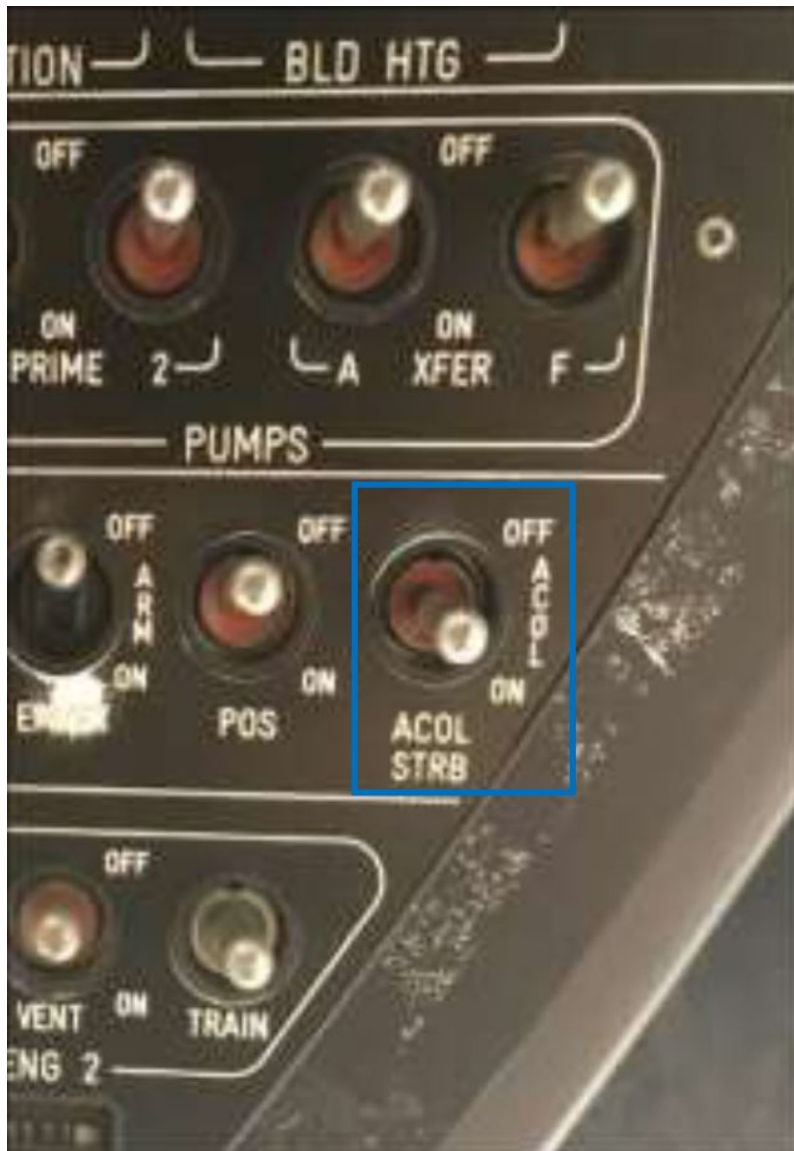
Figure 2: VH-SYB's anti-collision / strobe light switch

In an attempt to reduce the distracting effect of the anti-collision light, the pilot asked the ACM to turn the light off. The ACM removed her NVG, took a few seconds to locate the switch and, not realising the switch had three positions, inadvertently moved the anti-collision/strobe light switch from the ACOL (anti-collision light) position to the ON (anti-collision and strobe light) position. This changed the reflected light from red to bright white, which the pilot subsequently reported had a blinding effect on her vision while wearing NVG. The pilot again asked the ACM to turn the light off, which the ACM then actioned.

- OFF
- ACOL, which operated the helicopter's red anti-collision light only
- ON, which operated the red anti-collision light and white strobe light.

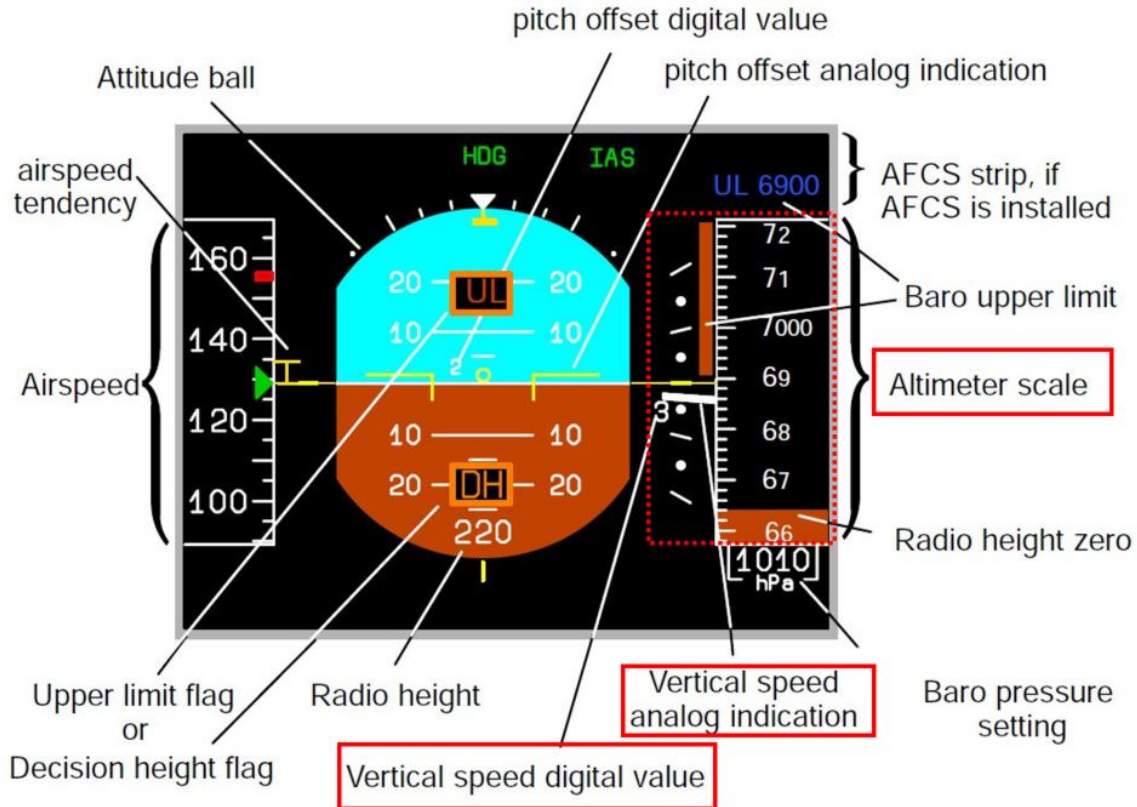
Figure 3: VH-SYB's primary flight display

The BK 117 C-2 flight manual noted a limitation of the accuracy of the VSI, which stated:

Vertical speed indication may be unreliable in gusty conditions and at airspeeds around 30 kt during fast transition from hover flight into steep descent and from level flight to hover during rapid pull up's.

As noted in *Departure from Crookwell*, the ACM recalled seeing the VSI indicate a rate of descent of 3,000 ft/minute at the time of the EGPWS alert. She also recalled seeing a rate of climb of 2,900 ft/minute during the initial unusual attitude recovery. The ACM stated she read these figures from the digital VSI display.
