# Lessons Learned From Recent Incident

Singapore Aviation Safety Seminar 2019

Air turn back due to fuel discrepancy

# **LESSONS LEARNED FROM A RECENT INCIDENT**

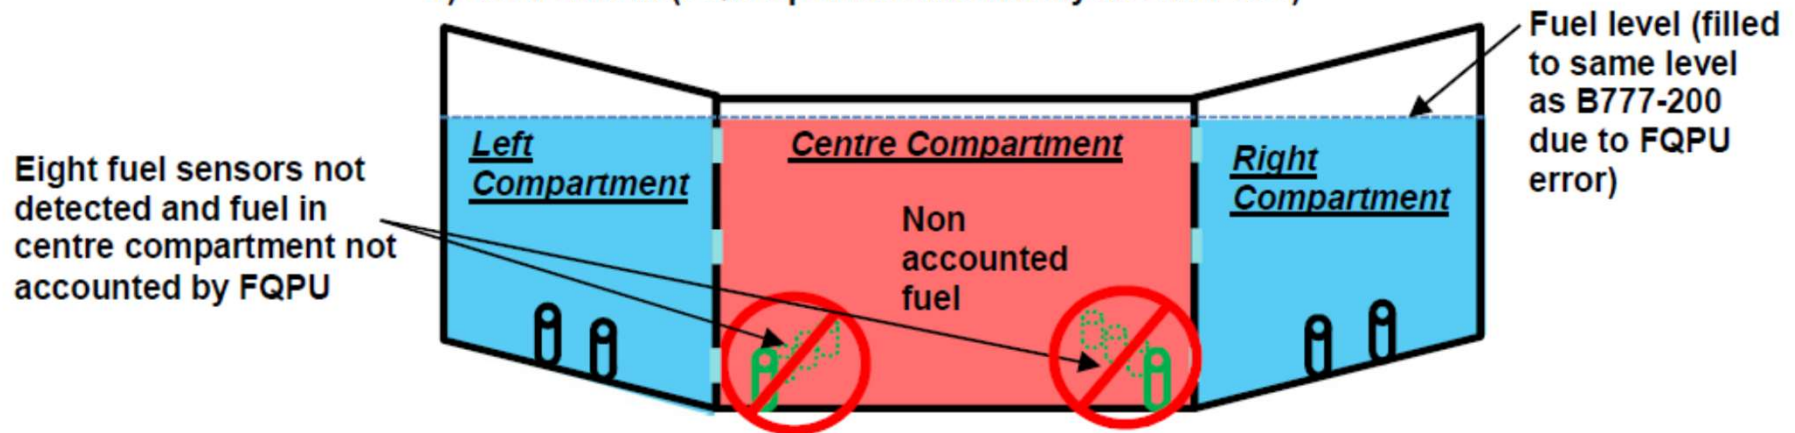
# Fuel sensors not detected

3) B777-200ER (FQIS operated incorrectly as B777-200)

- Aircraft FQPU was likely operating in B777-200 mode instead of the B777-200ER
  - 40.5 tons of fuel uplifted into center tank was not calculated by FQIS
- Manual fuel quantity check (Magnastick) was not carried out properly by ground staff
  - Refueling training was only carried in out theory during initial training, no recurrent training
  - No practical training on Magnastick check
- Bowser operator not familiar with bowser operation

- MRO conducted a once off refueling refresher training and competency assessments for their personnel
- Practical training on taking magnastick reading also provided using a fuel tank simulator training tool
- Ground staff were reminded to consult their managers whenever they were not familiar with any tasks assigned
- Boeing upgraded subsequent versions of the FQPU to be able to detect and prevent incorrect program pins configuration of the PSM
