# Static Electricity in Flight Threatens Aircraft Safety

*John F. O'Neill Jr.  
JAYFON Enterprises  
Aerospace Consultants*

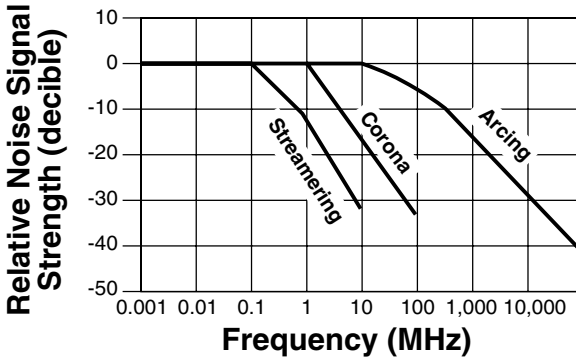
Figure 1

Aircraft accumulate electrical charges created by static electricity under various flight conditions and discharge of that electricity can generate radio frequency interference (RFI). RFI can threaten the safety of flight because it can interfere with aircraft communications and navigation equipment that operate in very low frequency (VLF), high frequency (HF) and very high frequency (VHF) ranges (Figure 1, page 2) by increasing equipment ambient noise levels and making reception difficult or impossible.

When the charge on an aircraft reaches 100,000 to 200,000 volts, the electrical fields on the aircraft become concentrated on its extremities — wing tips, tail surfaces, etc. (The voltage is not lethal because the current level is extremely low.) Air is ionized at the sharpest points on these surfaces and current discharges into the surrounding air, resulting in RFI that causes a hissing noise in a radio receiver.
