For Everyone Concerned with the Safety of Flight

April 2000

Floatplane Strikes Ridge During Sightseeing Flight

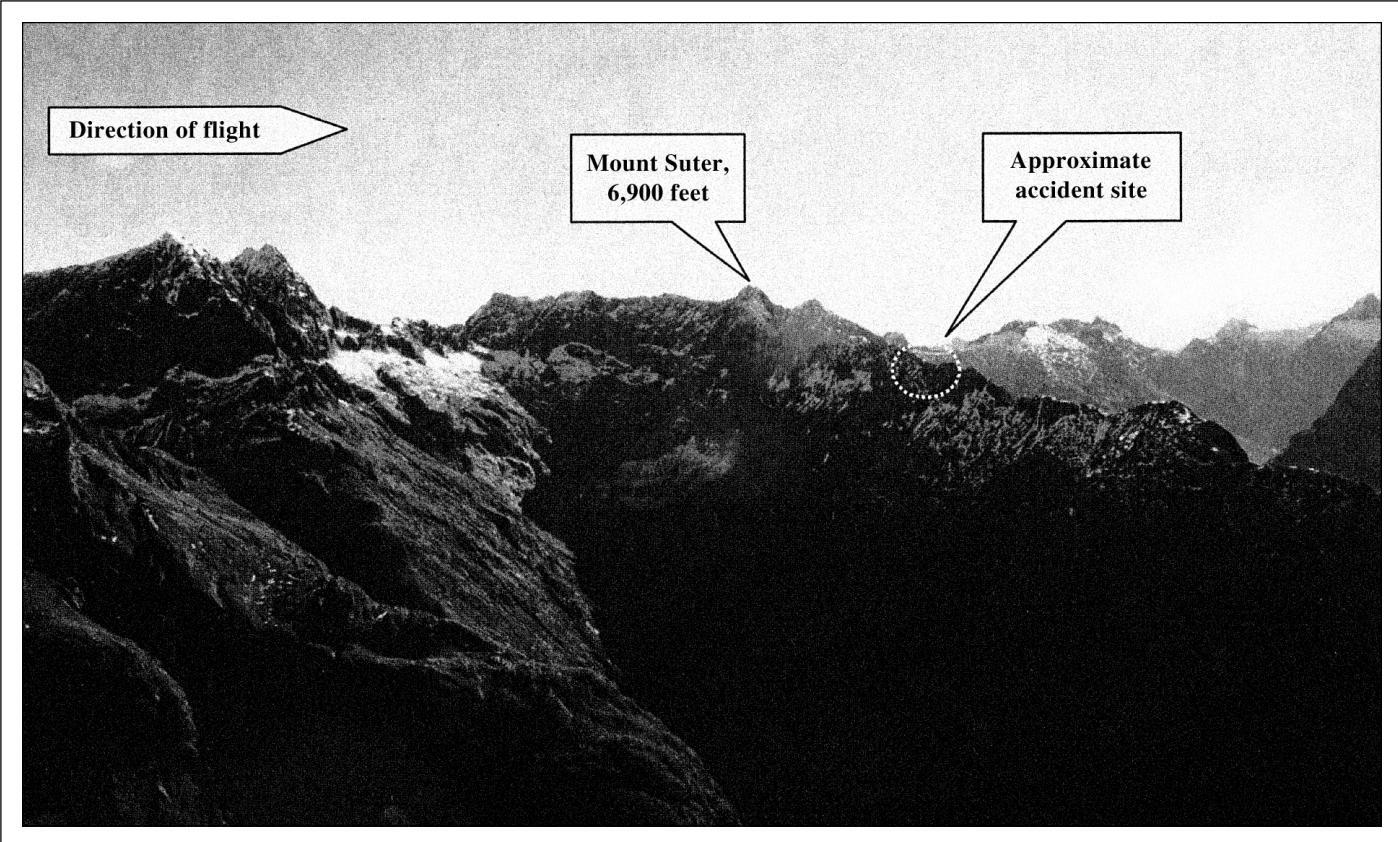
The floatplane had struck a 6,400-foot ridge approximately 60 feet (18 meters) below the crest (see photograph, page 4). The ridge formed the northern boundary of a valley. The floatplane's emergency locator transmitter was destroyed during the impact.

The floatplane was in a straight-and-level attitude and on a true heading of about 015 degrees when it struck the ridge.

"There was no evidence of any significant nose-low [attitude] or nose-high attitude at impact," the report said. "Fragmentation of the aircraft indicated that it had hit the ridge at high speed. Most of the wreckage then tumbled some 3,000 feet [915 meters] down the near-vertical mountain face, almost directly beneath the impact point. No fire occurred."

The accident airplane was in straight-and-level flight when it struck a 6,400-*foot ridge approximately* 60 *feet (18 meters) below the crest.* (Photo: New Zealand Transport Accident Investigation Commission)
