# FLIGHT SAFETY

## Mixed-crew Operations Require Special Consideration In Company Flight Manuals

Vol. 17 No. 4

April 1998

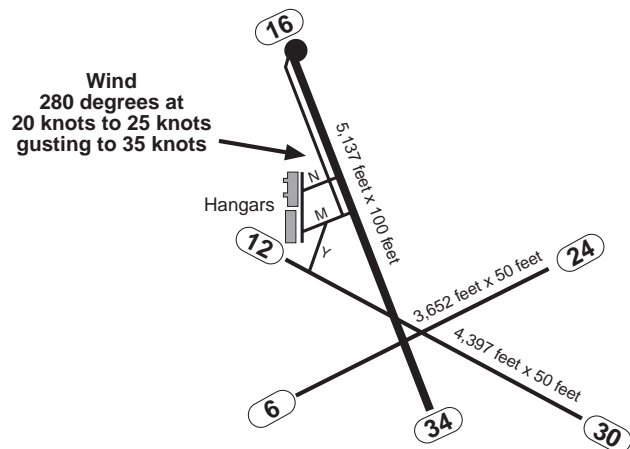
**Figure 1**

The G-IV's tire tracks on the runway, examined in the investigation, indicated that the aircraft began to veer to the left as it passed the intersection of Runway 12-30 (Figure 1). The nose-gear tire tracks then ended but main-gear tire tracks continued through the grass beside the runway. The tire marks did not indicate braking action.

**Palwaukee (Illinois, U.S.)  
Municipal Airport,  
Oct. 30, 1996**
