CRM ON DEMAND

Air taxi pilots targeted for crew resource management training.

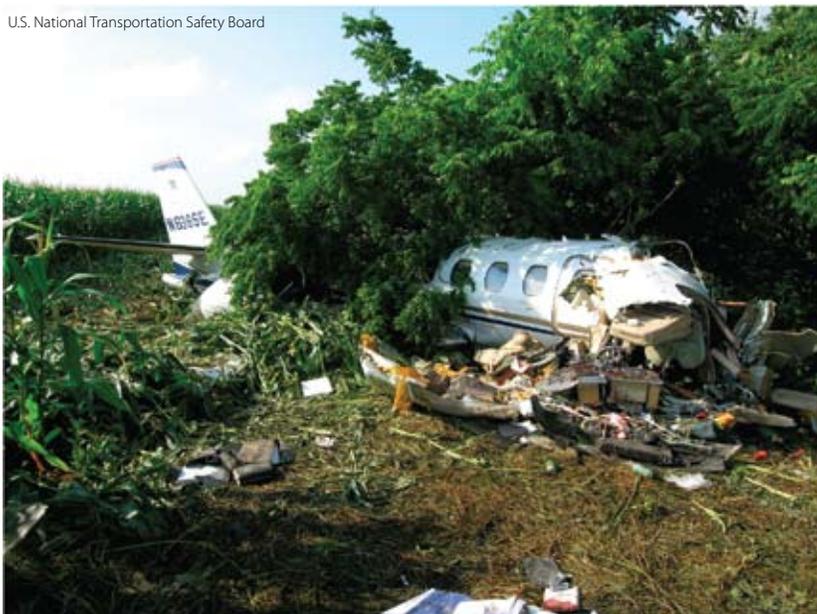
The cockpit burst on impact with a tree after the Citation overran the short runway at Cresco, Iowa. The accident report blamed 'poor CRM.'

Soon before the airplane overran the runway, the copilot called for a go-around and the pilot called for full power. The Citation crossed a road and came to a stop when it struck a tree in a cornfield about 1,700 ft (518 m) from the end of the runway.

NTSB said that the probable causes of the accident were “the flight crew’s inadequate aeronautical decision making and poor CRM.” The board said that a contributing factor was inadequate CRM training for on-demand Part 135 pilots.
