AeroSafety WORLD

THE JOURNAL OF FLIGHT SAFETY FOUNDATION

JUNE 2012

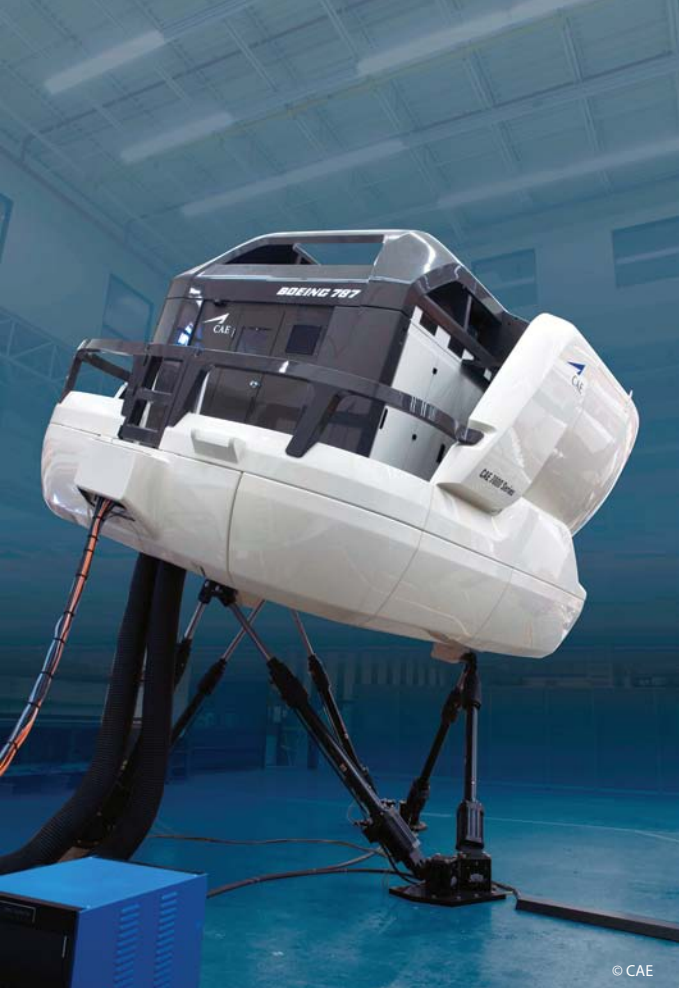
Current proposals call for upset prevention and recovery training in all-attitude, all-envelope airplanes (left) at the commercial pilot licensing level and in flight simulation training devices (above) at defined intervals throughout the careers of airline transport pilots.

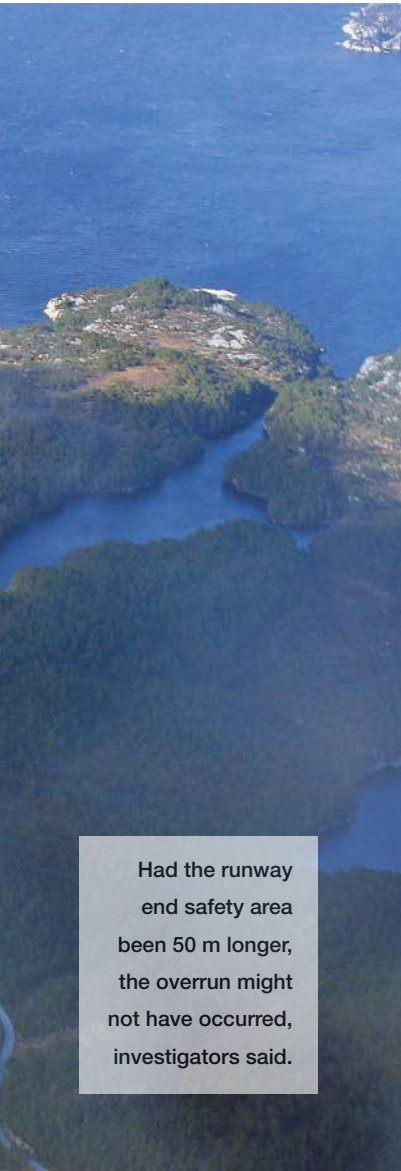
Had the runway end safety area been 50 m longer, the overrun might not have occurred, investigators said.

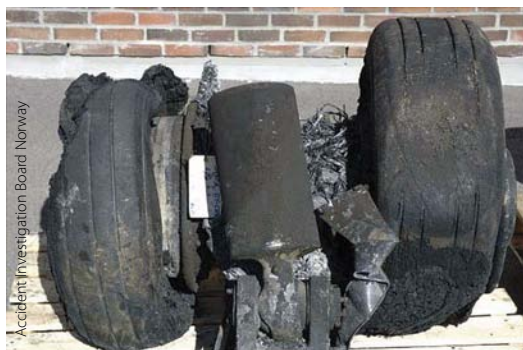
Left main
landing gear tires
show damage
consistent
with reverted rubber
hydroplaning.

period ending at 0700, and AIBN investigators who arrived at the airport about 6 1/2 hours after the accident found dark patches of moisture remaining on the runway. Nevertheless, “since the crew were not otherwise informed, the runway was assumed to be dry, and this was the basis for their landing calculations,” the report said.

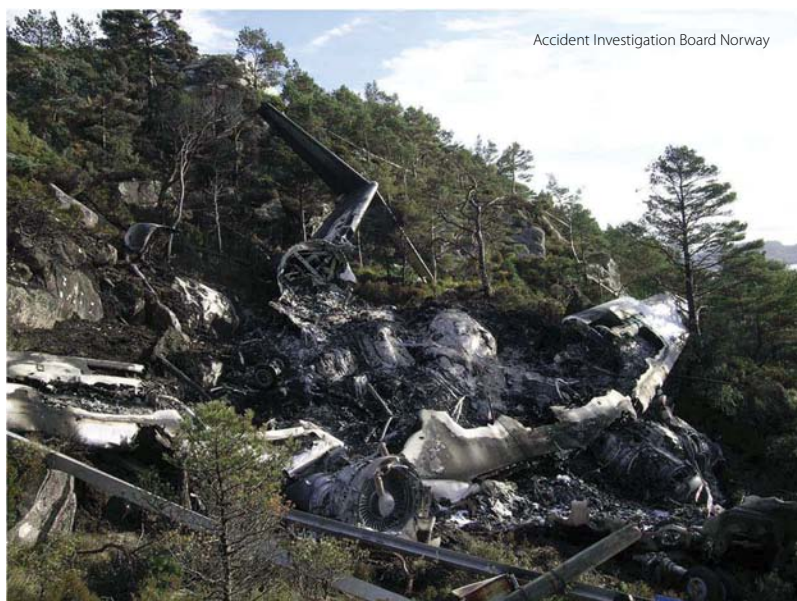
Fire consumed
most of the aircraft
after it plunged
down the rock- and
tree-covered slope.

adjacent terrain, were decisive for the severity of the accident,” the report said.
