FLIGHT SAFETY FOUNDATION
Aviation Mechanics Bulletin

Corrosion and Fatigue-crack Detection Remains Critical to the Continued Airworthiness Of Aging Aircraft

March–April 1998

Vol. 46 No. 2

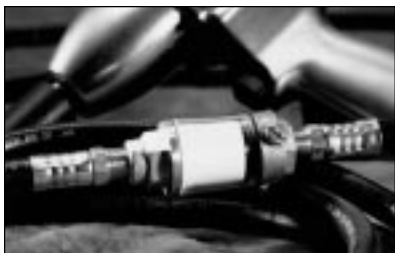
The Pneugard Oiler has a maximum airflow capacity of 20 standard cubic feet per minute and a maximum pressure of 150 pounds per square inch gauge. The device is available with a transparent Lexan lubricant reservoir that permits the oil level to be monitored visually.

Pneugard Oiler by LA-MAN Corp.

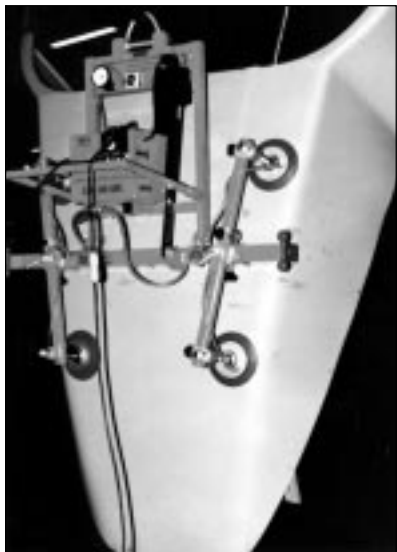
Anver Powered Tilters and Rotators are vacuum lifters that, in combination with a hoist, allow one person to lift, tilt or rotate large parts without recourse to ropes, straps, hooks

*Powered Tilters and Rotators
by Anver*

The lifters are designed around lightweight frames and vacuum cups that can be designed for manipulating loads, particularly molded plastic or fiberglass, between (23 kilograms and 4,536 kilograms) 50 pounds and 10,000 pounds. Anver Powered Tilters and Rotators are available in electrically or pneumatically powered models or manual models. The frame, cross-beams, vacuum-cup placement and design, and material can be tailored to the user's needs.

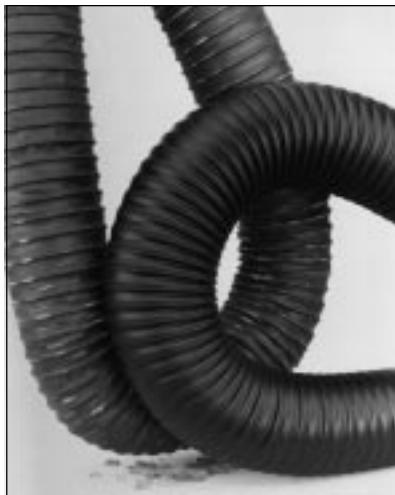
Hi-Tech Hose Inc. offers a wire reinforced thermoplastic rubber hose that is said to outlive two-ply neoprene fabric hose under conditions requiring continual flexing.

Wire-reinforced Thermoplastic Rubber Hose by Hi-Tech Hose Inc.

Hi-Tech RFH Hose is manufactured without solvents, chemicals, glues or adhesives that could make it vulnerable to extreme temperatures or

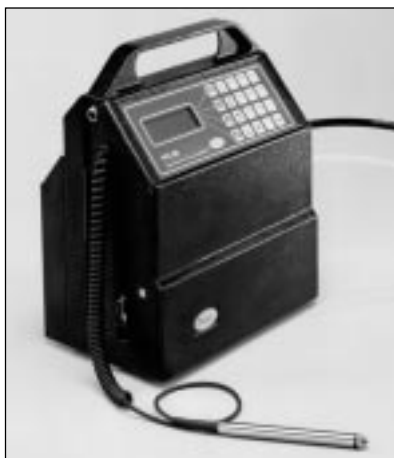
The PFC 200 has three sampling modes: high pressure, for sources at 50 pounds per square inch (psi) to 5,000 psi; low pressure, for sources less than 50 psi; and bottle sampling. Particle-counting sizes range from two microns to 100 microns.

PFC 200 Portable Particle Counter by Pall Aeropower Corp.

Sample identification and sampling parameters can be entered on the PFC 200's microprocessor using a keyboard, or for greater speed and consistency via bar codes. The unit includes bar code-generating software. Results of the particle sampling can be viewed on a liquid-crystal display, printed or transferred to a personal computer.
