Mechanics Bulletin

May–June 2003

Vol. 51 No. 3

Metal Fatigue — What It Is*

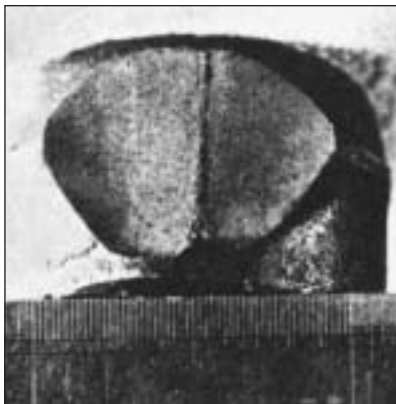
Figure 1 shows the failure, after many thousands of miles of running, of the steering drop arm of a popular motorcar. On the occasion on which it broke, the car was being driven at a moderate speed along a straight road having an excellent surface — that is to say, failure took place under normal conditions. It will be noticed that there appears to be a dividing line across the fractured area. Reference will be made to this later.

Figure 1. The fracture of the steering drop arm of a motorcar. The width of the arm is approximately one inch.

The answer is that the circumstances under which disintegration took place in the different areas were themselves different. The fractures in the smoother zones of both photographs occurred slowly, possibly very slowly indeed, over a long period of time. A crack spread progressively from the outside, or region of high stress, toward the middle — which, in a beam or rotating shaft, would be one of lesser stress.

Now before we leave these fractures, let us again look at the fracture of the motorcar component. If one were to take the part which is shown and fit it to the other part, it would be found that with their centerlines in the same plane, there would be contact only over the central area. There would be a gap all the way round. The explanation of this is that the center region being one of *tensile failure*, the metal has here been drawn out. If, having established the existence of this plastic flow, this zone is ground down, then, when the two parts are fitted together, there will be reasonably good contact all over the area of so-called crystalline fracture. This is the region of *fatigue failure*, and our simple experiment has established that it occurs without any gross dimensional change. Under the influence of relatively small stresses repeated perhaps many, many millions of times, a ductile metal may fail, giving but little evidence of its ductility.

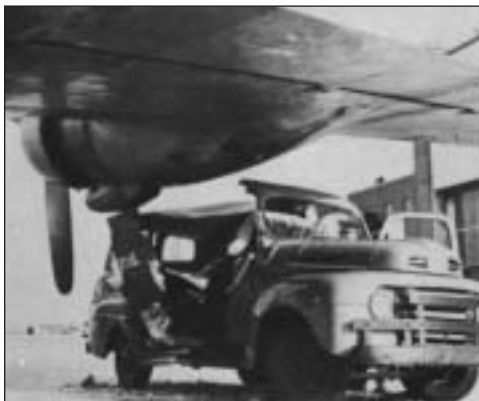
No. 6 was the cause of this particular accident, but whatever your guess, you might have been right. There have been similar accidents and similar pictures

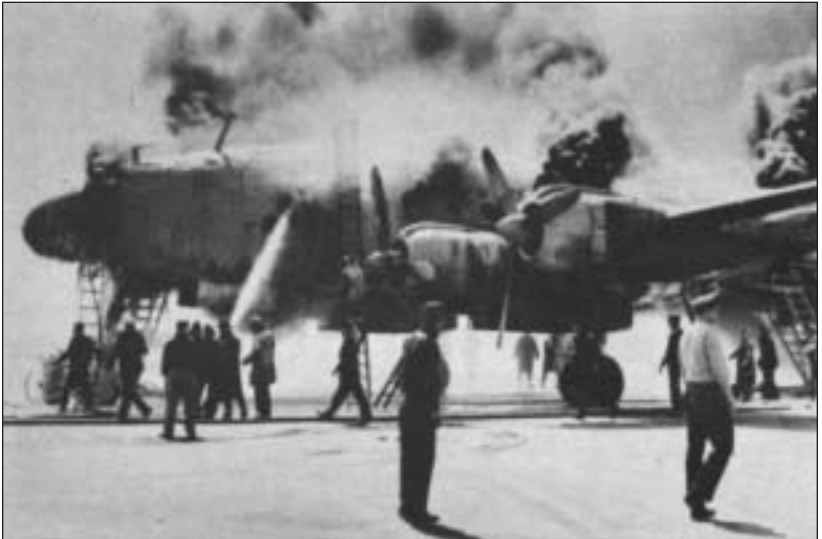
Improper maintenance is credited by the National Fire Protection Association for the fueling fire pictured above. The flames gutted the aircraft and fused the skin of the fuselage. Structural members were warped and twisted by the heat. The wing sections and powerplants were relatively unaffected, but the direct damage amounted to \$700,000, and the aircraft was out of service for eight months.

While fueling the left wing tanks of a Constellation from a tank truck, the gasoline hose of the fueling truck burst at a point just inside the truck's pumping compartment. The resulting fuel spill and fire involved about 150–200 gallons of gasoline.

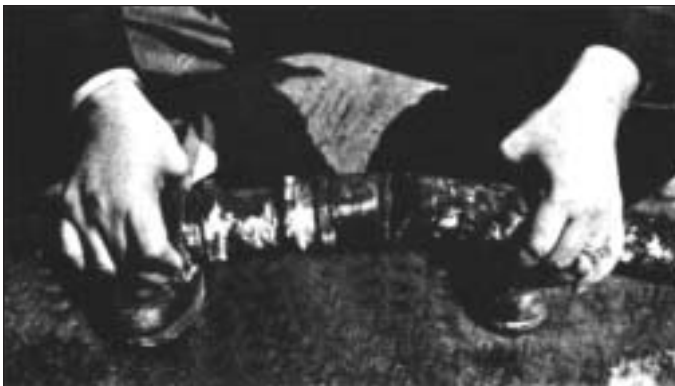
Figure 2. Where fuel hose burst. Note short section of rigid iron pipe which placed strain on hose when reeled.

Picture 2 shows a closeup of the broken hose. Note the short section of rigid iron pipe which was used to connect two 50-foot sections of the hose, both of which had female-type connections. It is easy to understand why the break occurred at this point, as continual winding and rewinding of the hose on its reel placed severe strains on the hose at this location.

Improper vehicle maintenance, in broad terms, and improper hose maintenance, specifically, caused this \$700,000 damage and cost the airline the services of the aircraft for eight months.
