# FLIGHT SAFETY

## Flight Test of Takeoff Performance Monitoring System Indicates Successful Use in Research Vehicle

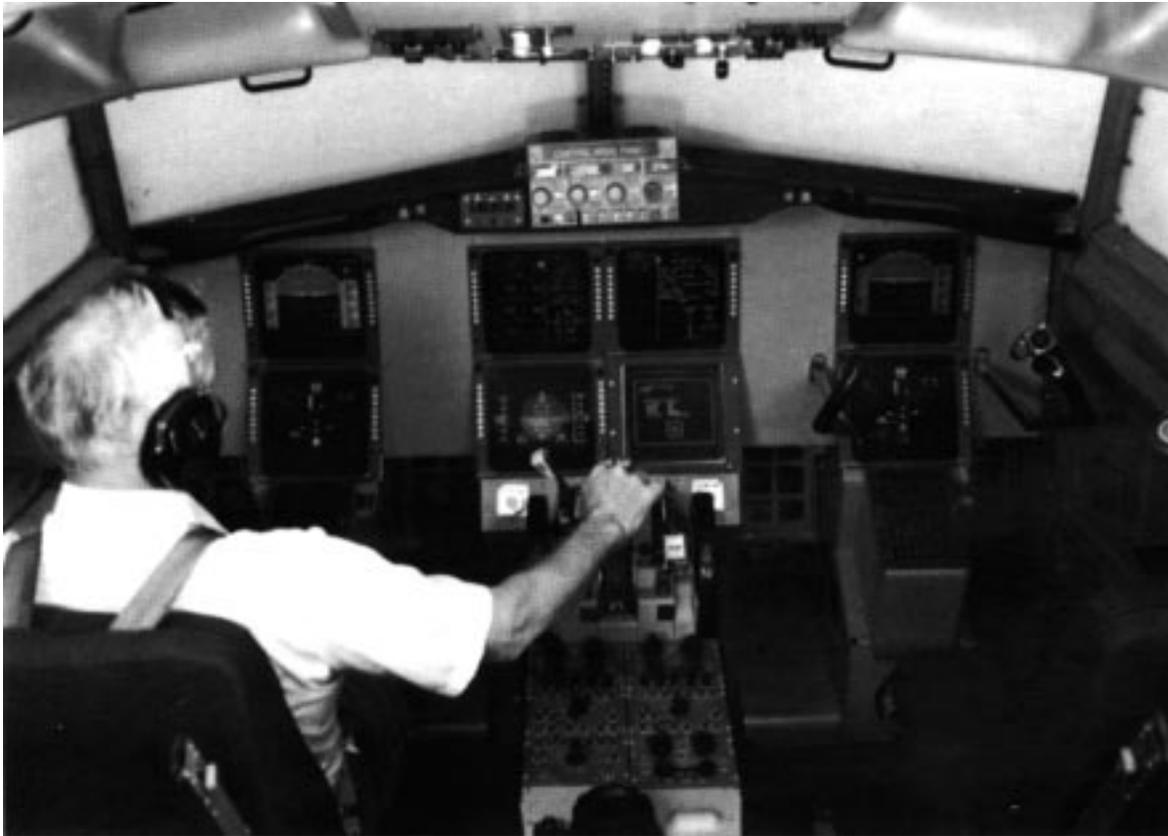
**Figure 2**

## TSRV Research Flight Deck

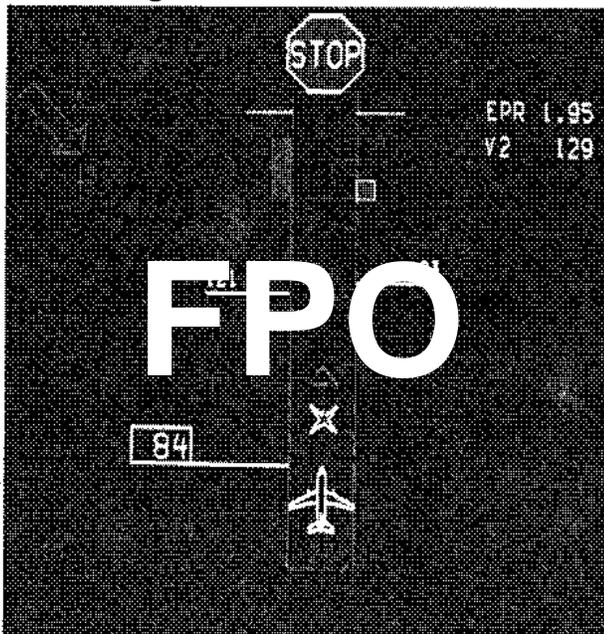
*Engine failure during low-throttle takeoff roll.* If an engine fails during a reduced-thrust takeoff-roll situation, the TOPMS display will be similar to the graphic shown in Figure 13 (page 12). An engine failure is declared by the algorithm when the engine EPR has degraded by more than a specified amount (10 percent in this study) from the value normally produced for the measured throttle position. For the situation in Figure 13, the under-advanced throttles are commanding both engines to produce EPRs of approximately 1.7 rather than the scheduled 1.95. The left engine is apparently producing the commanded EPR value of 1.7; however, the EPR bar for the failed right engine is clearly less than 90 percent of the length of the apparently correct left EPR bar and has turned red. Concurrently, a red SAF (STOP sign) and a predicted stop-point x have appeared and the  $V_R$  triangles have separated by more than 1,000 feet (305 meters). If the performance of the faulty

### TOPMS Display for Engine Failure During Reduced-throttle Takeoff

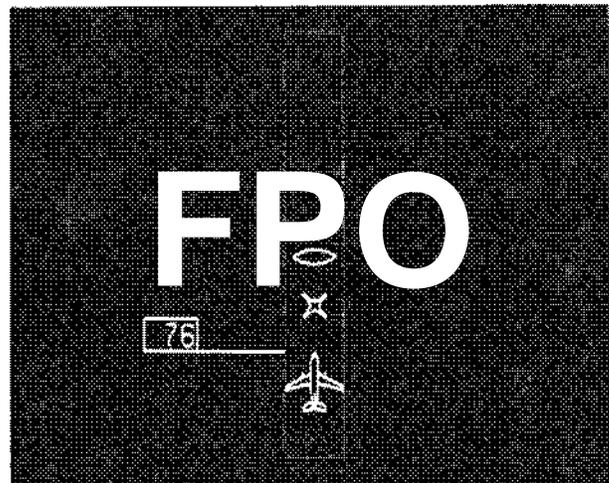
Figure 19 (page 15) shows photographs of abort displays for three situations. Each display contains two computer-predicted stop-point symbols — the x that is carried over from the takeoff display and the football-shaped symbol that appears on the runway graphic as soon as the brakes are applied. The football locates where the stop point will be, based on the currently computed position, speed and measured acceleration. The display in Figure 19(a) shows the football ahead of the x, which indicates that less than full braking is being applied. The display

### TOPMS Displays for Three Braking Levels

(a) Partial braking

(b) Full braking, without reverse thrust

(c) Full braking, including reverse thrust
