# BREAK, DISTORT or YIELD

Updated approach lighting system standards address risks during the 100-millisecond impact of an airplane.

BY WAYNE ROSENKRANS

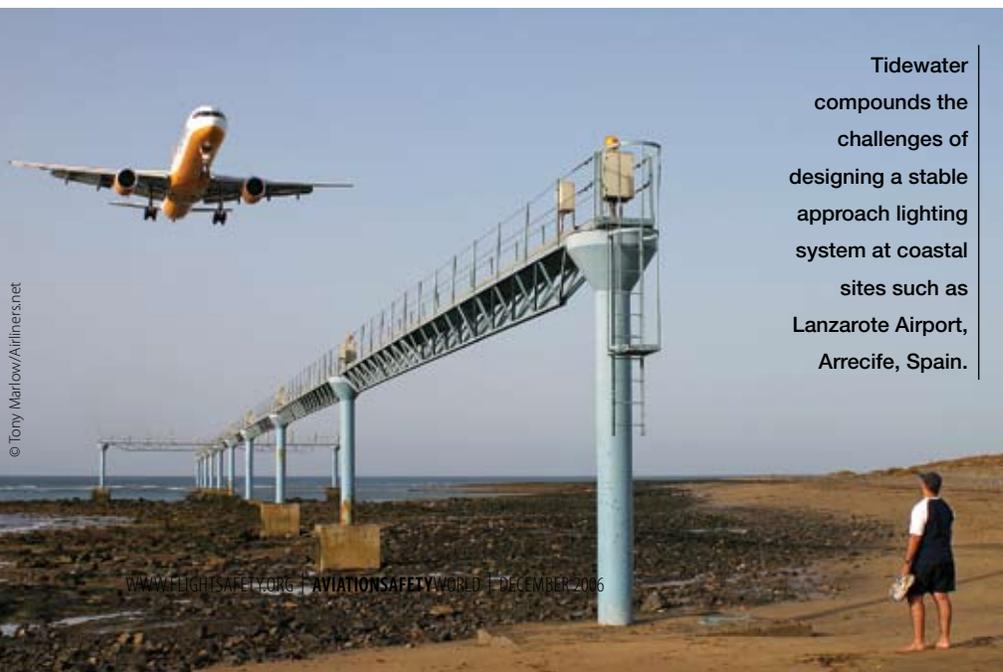
Tidewater compounds the challenges of designing a stable approach lighting system at coastal sites such as Lanzarote Airport, Arrecife, Spain.
