**A new concept in understanding in-flight icing gathers believers.**

# Rough Ice

# Is Bad Ice

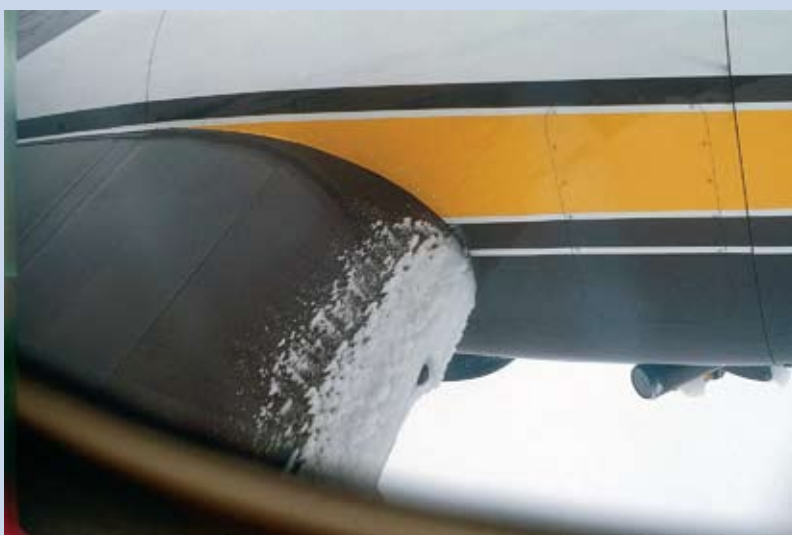
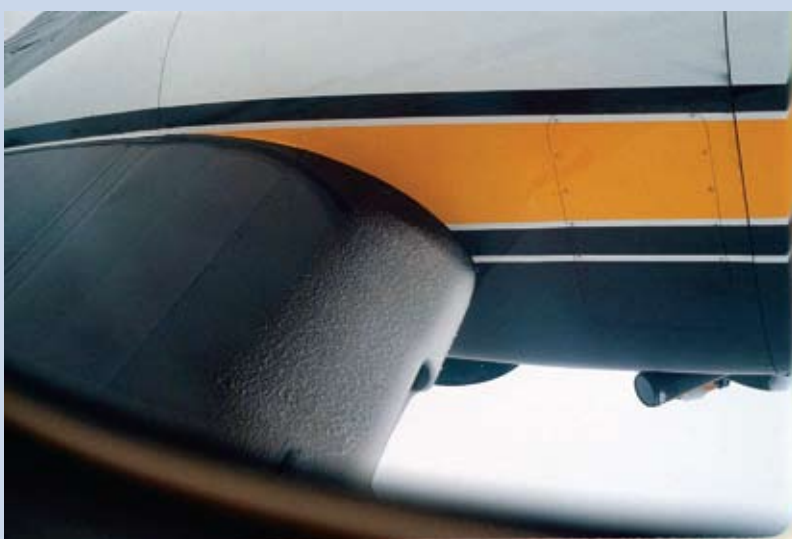
Two views of distributed-roughness icing, showing the thin layers involved.

The visual appearance of distributed-roughness icing formation may be innocuous, with a thickness or element height less than 1/8 in (0.32 cm). If this occurs on a black deicing boot, part of this formation may appear gray. There may be other ice formed at the leading edge as well. While this icing forms quickly and usually is not effectively removed by deicing boots, once outside the cloud, the adverse effects of the small elements, disproportionate to their size, tend to diminish as quickly as they occurred.
