BY LINDA WERFELMAN

Crackdown on Fatigue

The FAA aims for new inspection programs to keep airplanes with widespread fatigue damage out of the air.

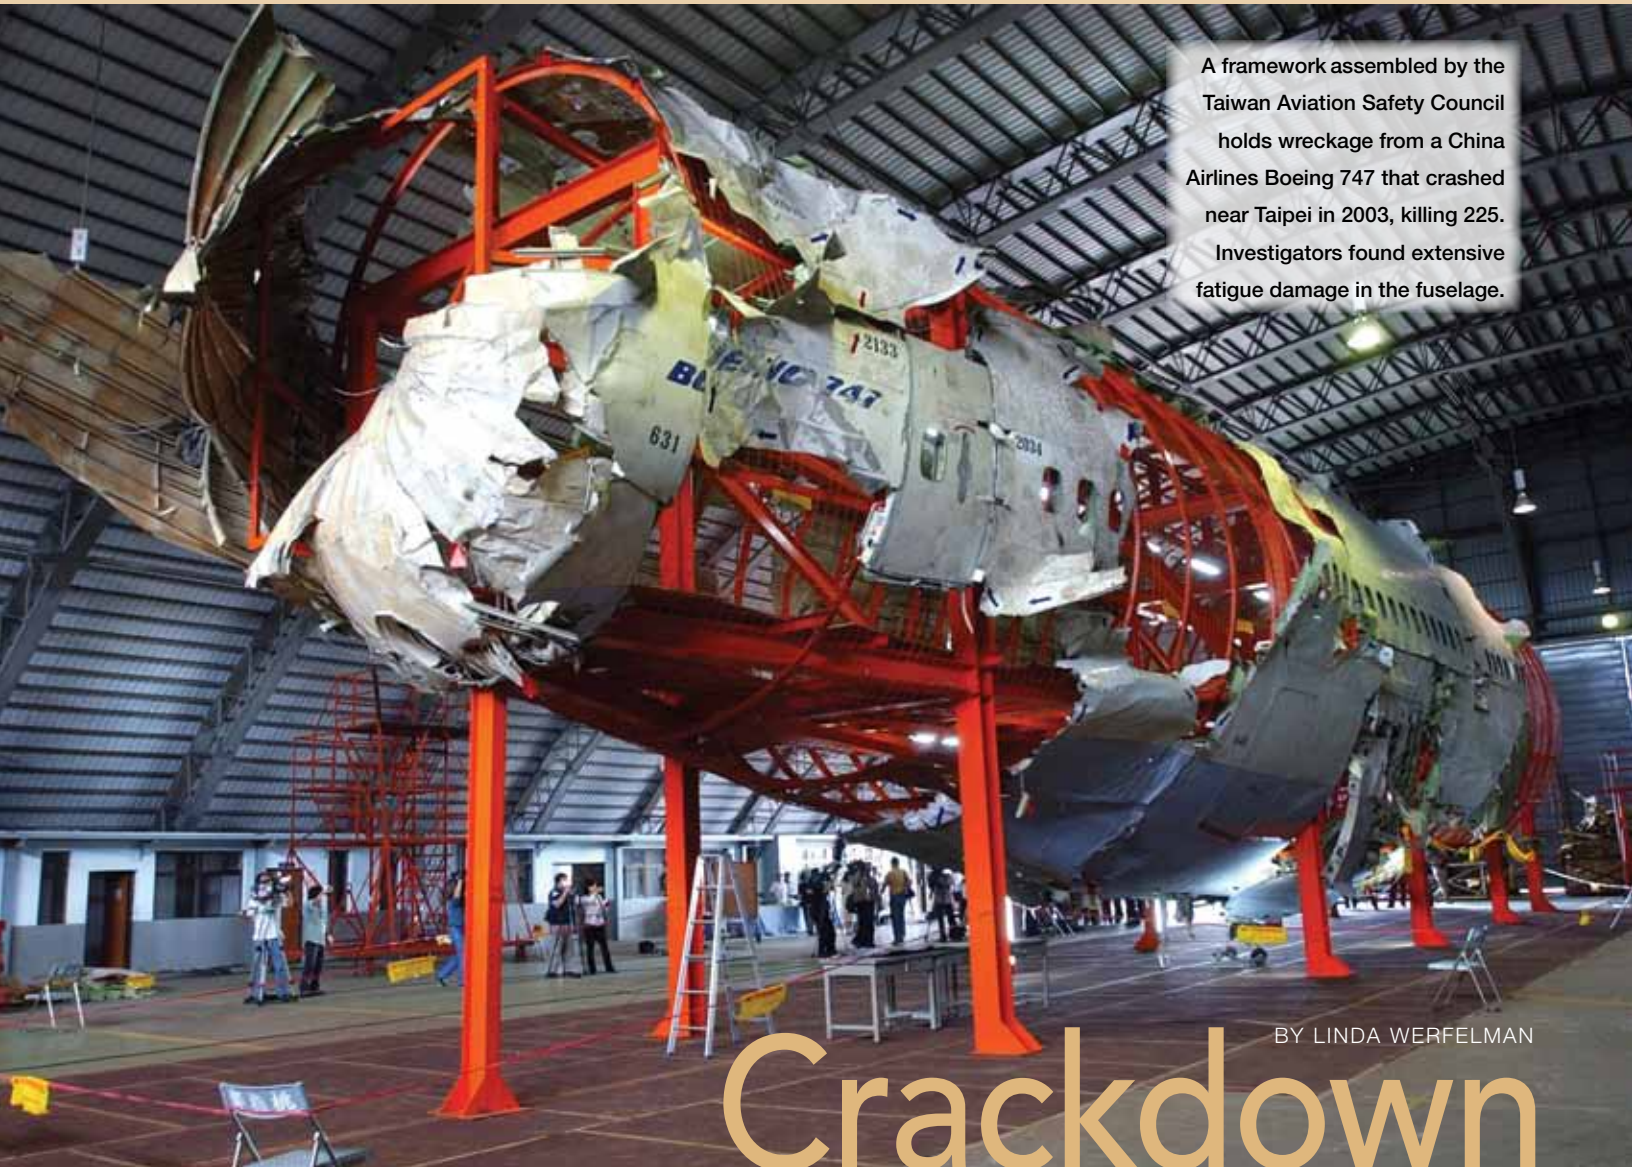
A framework assembled by the Taiwan Aviation Safety Council holds wreckage from a China Airlines Boeing 747 that crashed near Taipei in 2003, killing 225. Investigators found extensive fatigue damage in the fuselage.

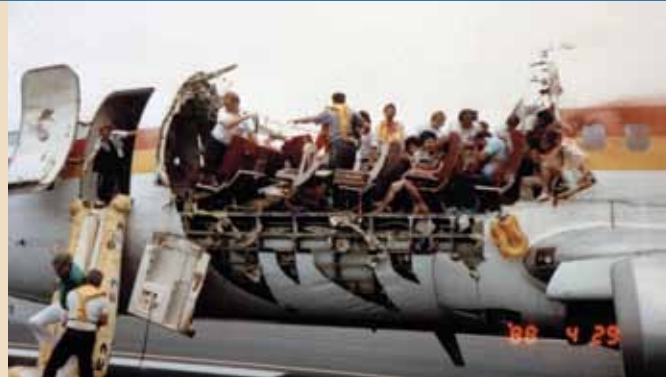
A post-accident examination of the airplane revealed that the fuselage skin had separated along a line that followed the upper rivet line.

The NTSB cited as the probable cause of the accident “the failure of the Aloha Airlines maintenance program to detect the presence of significant disbonding and fatigue damage which ultimately led to failure of the lap joint at S-10L and the separation of the fuselage upper lobe.”

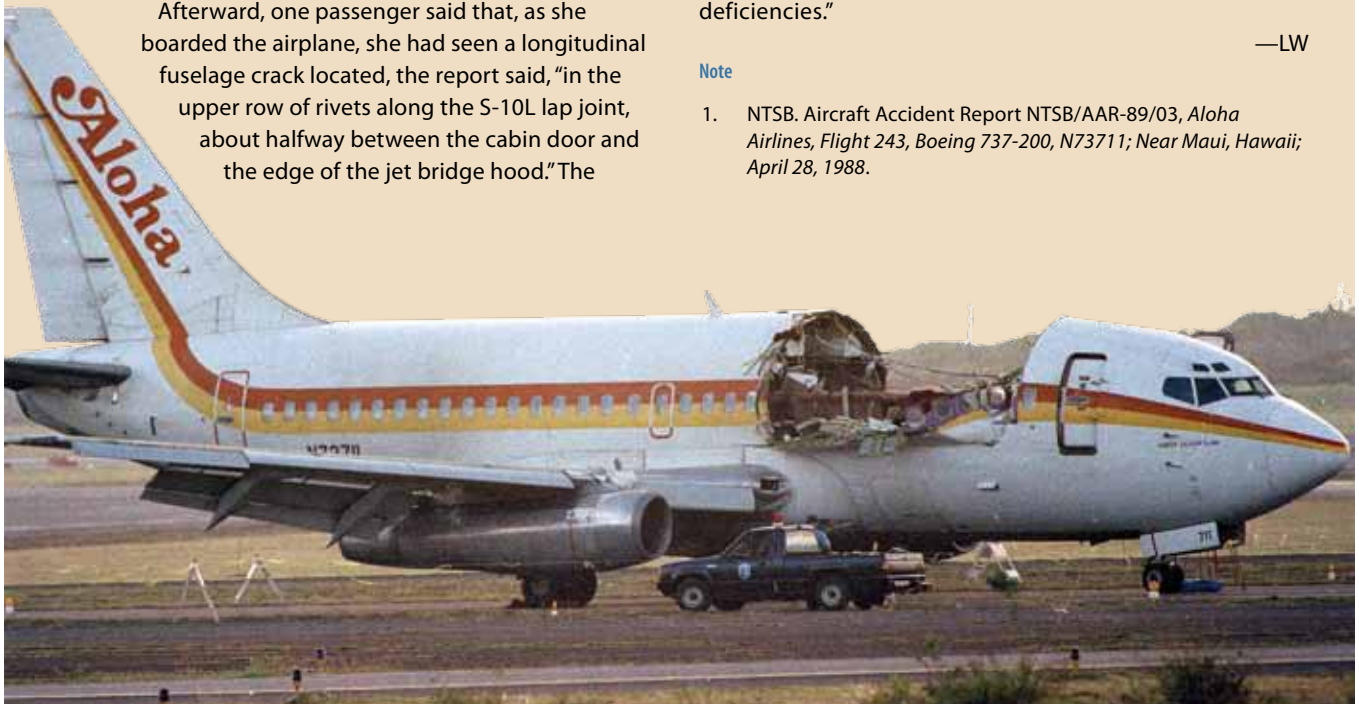
The final report on the accident by the U.S. National Transportation Safety Board (NTSB) noted that the two pilots had said that they heard a loud clap or “whooshing,” followed by the sound of wind behind them and that the captain had said that, when he looked back, he saw that the cockpit entry door was gone and “there was blue sky where the first-class ceiling had been.”¹

Afterward, one passenger said that, as she boarded the airplane, she had seen a longitudinal fuselage crack located, the report said, “in the upper row of rivets along the S-10L lap joint, about halfway between the cabin door and the edge of the jet bridge hood.” The
