SLIDING AWAY

On the evening of March 26, 2006, an Airbus A321 operated by My Travel Scandinavia was involved in a serious landing incident at Sandefjord Airport Torp in southern Norway. Although damage was minimal, the aircraft stopped about 65 degrees off the runway heading with the nose-wheel against the concrete base of an antenna and the right main wheel approximately 2 m (7 ft) from the end of the runway (ASW, 4/10, p. 56).

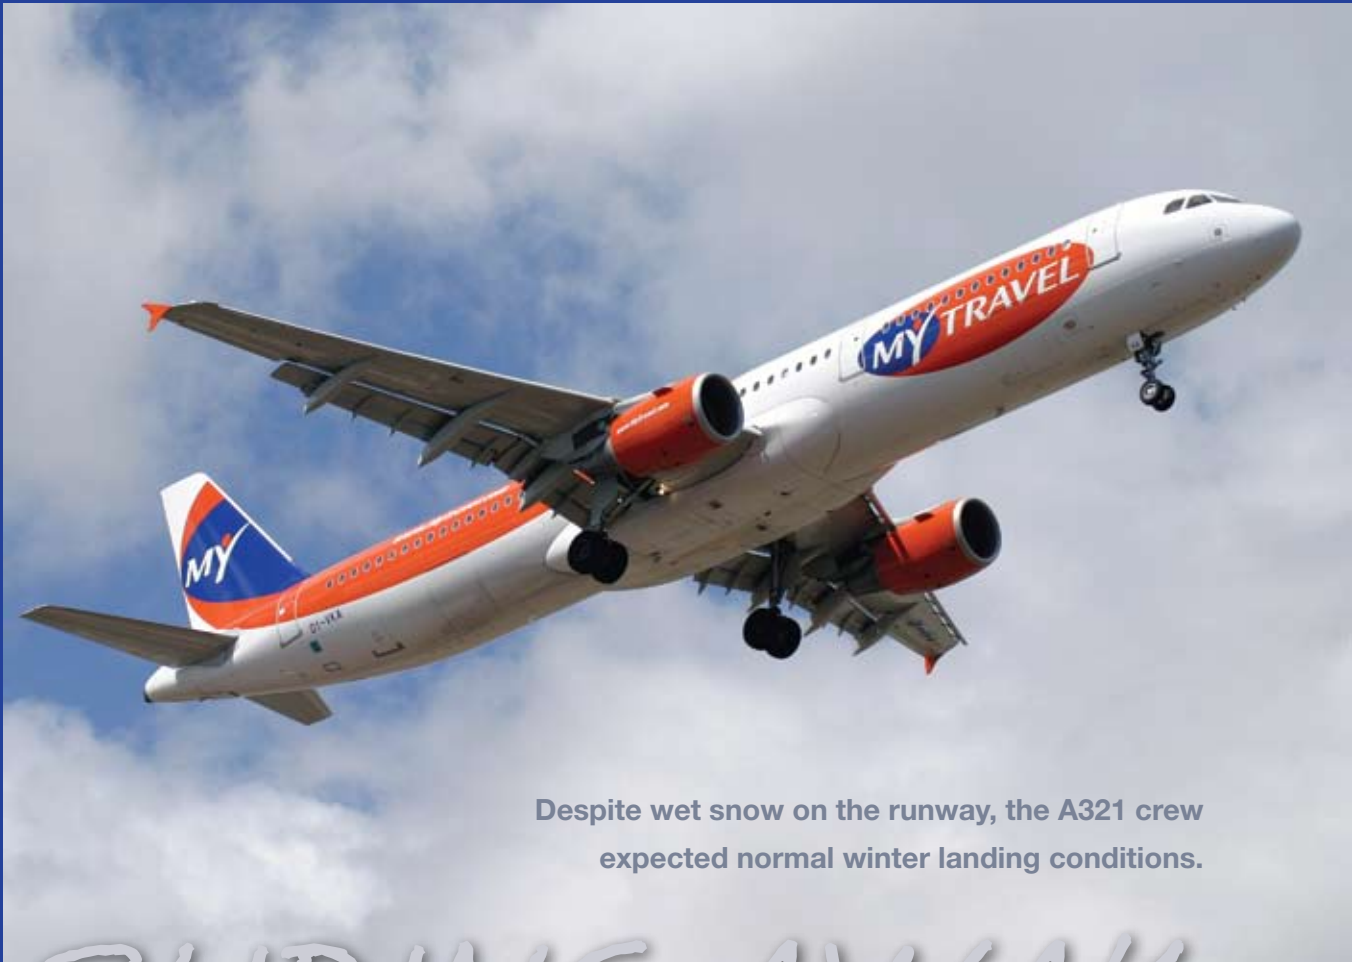
Despite wet snow on the runway, the A321 crew expected normal winter landing conditions.

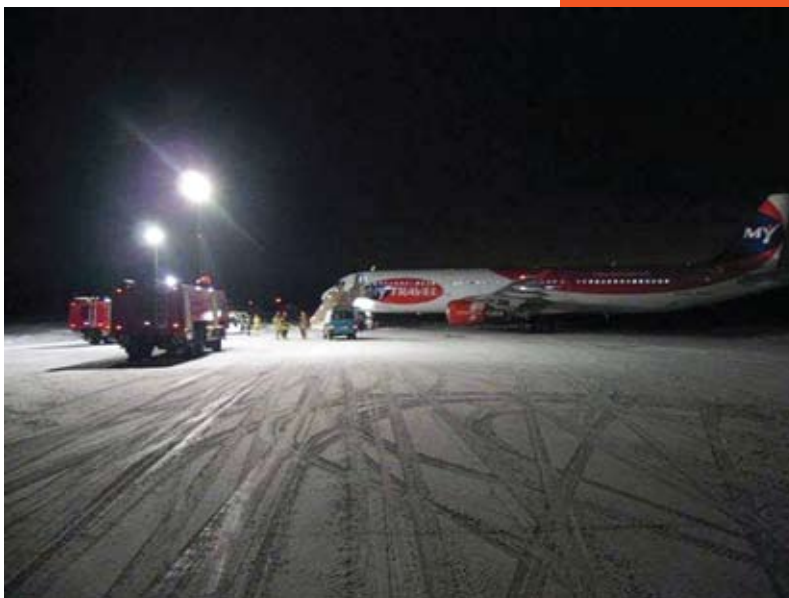
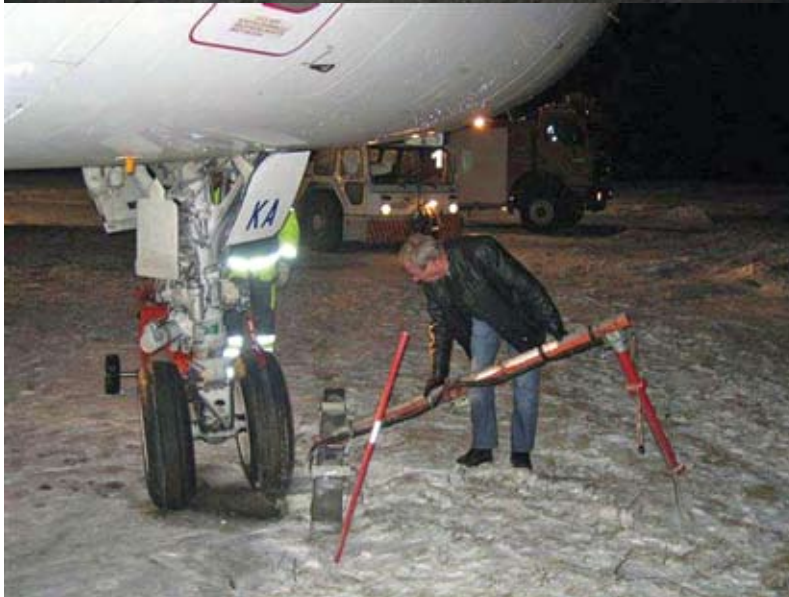
After landing on a snow-covered runway in Torp, Norway, the A321 stopped with its nosewheel against an antenna's concrete base.
