Precious Lives

Japan Airlines Safety Promotion Center compels reflection on solemn responsibilities of aviation professionals.

BY WAYNE ROSENKRANS | FROM TOKYO

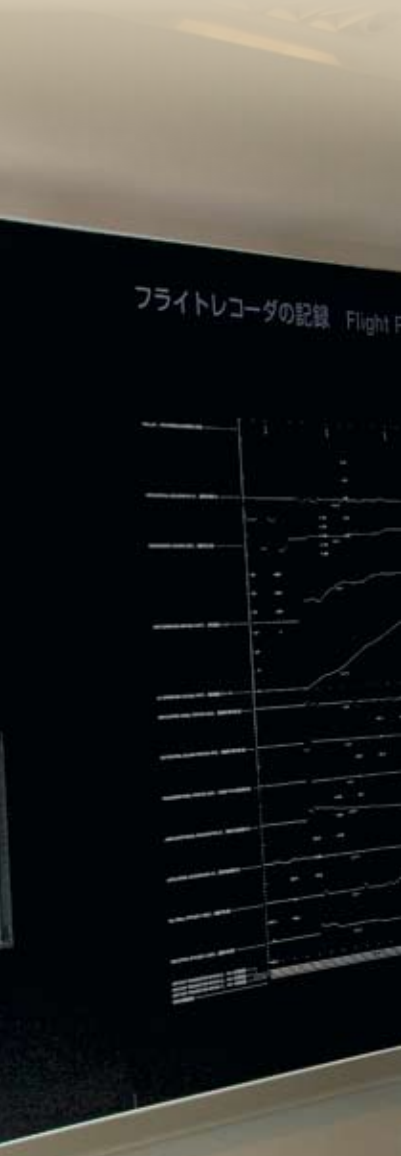
Introductory panels about JAL Flight 123 include the "black boxes" recovered from the crash site.

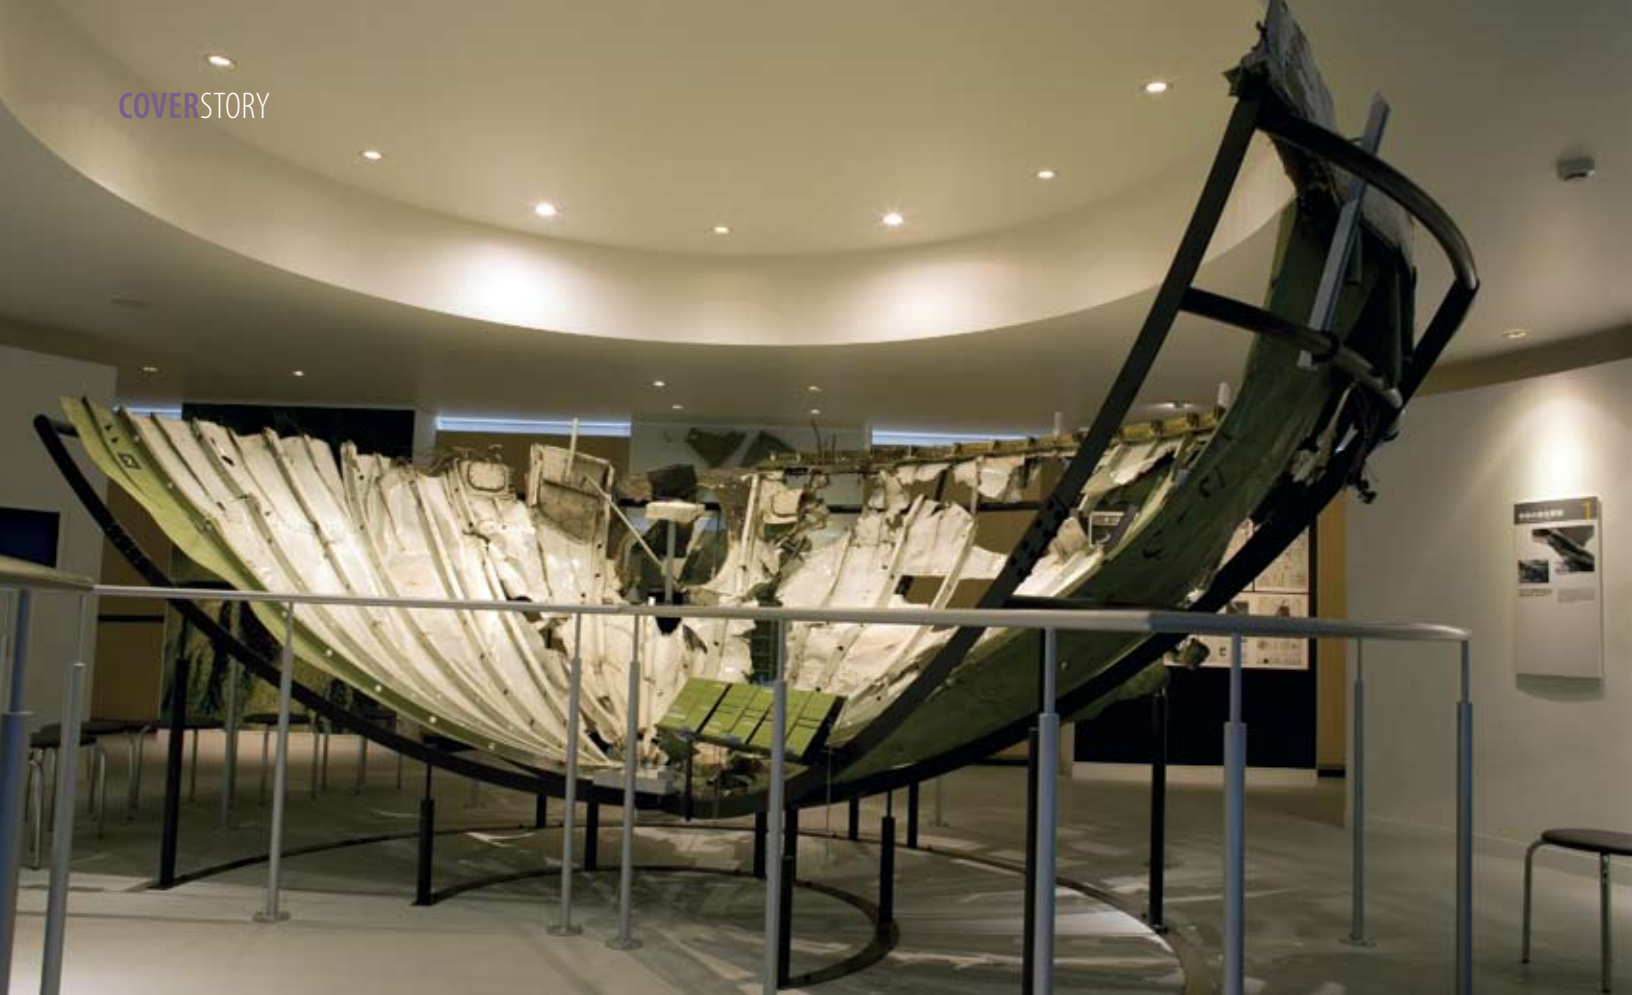
The lower half of the complete aft pressure bulkhead exhibited helps explain the catastrophic in-flight failure.

The Display Room is the largest area. Its centerpiece is both halves of the recovered aft pressure bulkhead. They are mounted horizontally for close inspection because of the

bulkhead’s critical role in the accident. Surrounding panels explain the causes of the accident and measures taken to prevent a recurrence.

On the tour, the exhibit of the upper and lower halves of the aft pressure bulkhead, combined with a video and scale models of repairs conducted after the 1978 tail strike, explain how the instantaneous failure along the joint caused cabin air to open a hole of about 2 to 3 sq m (22 to 32 sq ft) in the bulkhead.

Explaining this catastrophic failure of the aft pressure bulkhead, Kanasaki said that the splice plate repair — as designed by the Boeing aircraft-on-ground team and approved by JAL and aviation authorities — would have provided a continuous load path except for changes during installation that did not conform to the approved design.

“The stress between the upper and lower halves of the bulkhead was concentrated in the

center row of the three rows of rivets,” he said. “An excessive load was applied in the center row and made a small crack around the rivet holes. Due to the repeated application of cabin pressurization during every takeoff and landing, the crack propagated little by little, and seven years later — at the 12,319th flight after the repair — the aft pressure bulkhead ruptured from this repaired area.” A tail compartment pressure-relief vent door functioned as designed “but was too small to relieve the high pressure from the big hole in the aft pressure bulkhead,” he added.
