# In a Fog

**Witnesses saw the AS 350B news-gathering helicopter fly into dense fog off the coast of Japan before they heard the sounds of a crash.**

BY LINDA WERFELMAN

*This article is based on Japan Transport Safety Board Aircraft Accident Investigation Report AA2009-5, Ogawa Air Inc., Aerospatiale AS 350B (Rotorcraft), JA9755, Sea Surface off Cape Omasaki, Oma-Cho, Shimokita-Gun, Aomori Prefecture, at about 11:45 JST, July 6, 2008. Adopted June 12, 2009, by the Japan Transport Safety Board aircraft subcommittee.*

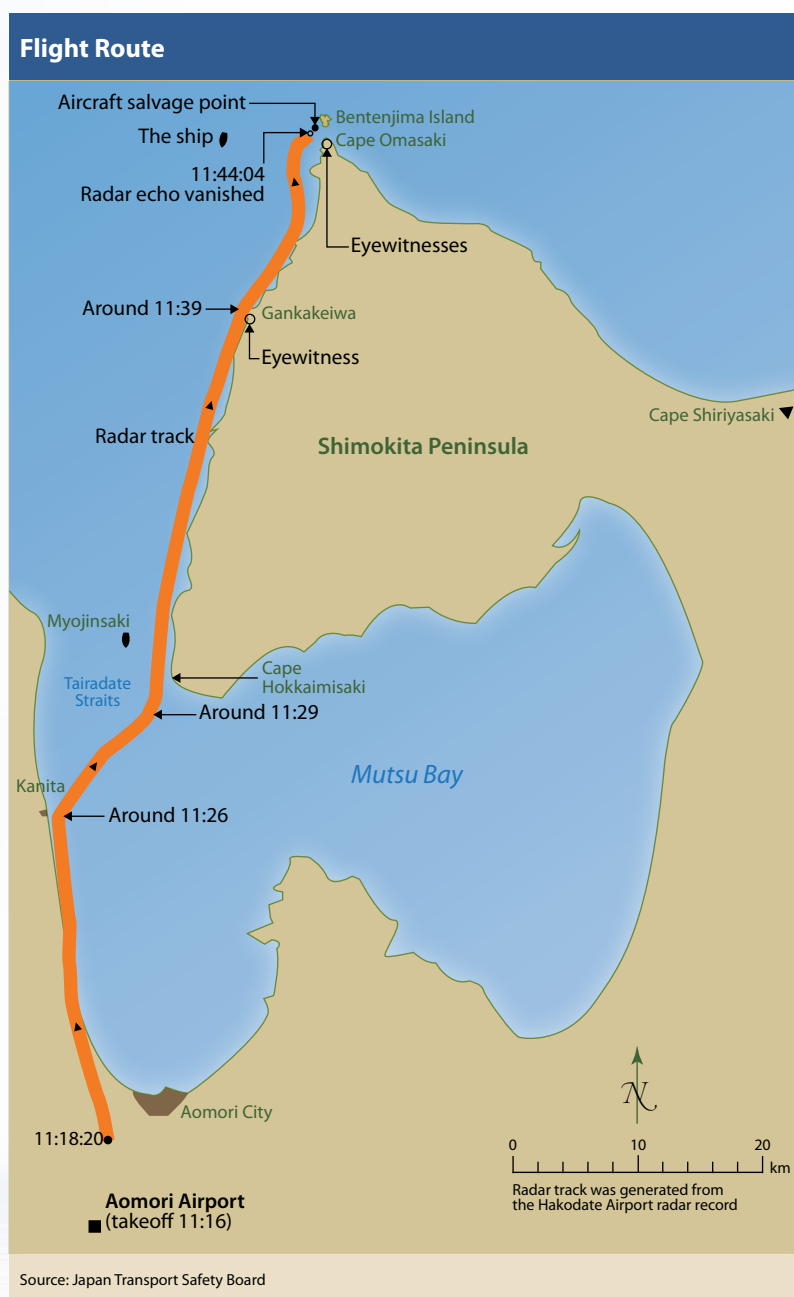
Figure 1

The morning of the accident, the helicopter left its base in Akita and flew north to Aomori Airport (Figure 1). The helicopter was refueled at Aomori, and took off at 1116 local time, carrying the two pilots, a television reporter and

Air traffic control radar recorded the helicopter's flight path and altitude beginning at 1118 until 1144; the radar showed that the aircraft flew along the east coast of the Tsugaru Peninsula, north toward the ship.

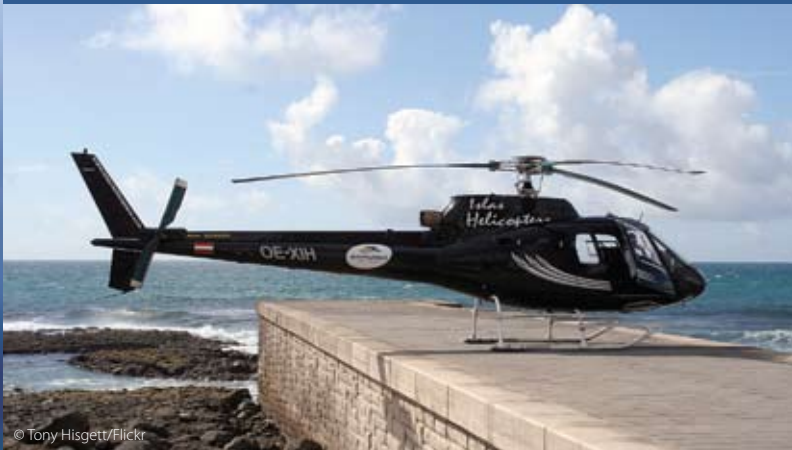
The Eurocopter AS 350B is a light utility helicopter with a Turbomeca Arriel 1B turboshaft engine and a rotor of three fiberglass blades that rotate clockwise as viewed from above.

First produced by Aerospatiale in October 1977, the AS 350B has two standard bucket seats at the front of the cabin and two two-place bench seats aft.

The helicopter’s maximum normal takeoff weight is 1,950 kg (4,300 lb) or 2,100 kg (4,630 lb) with a maximum sling load. Maximum rate of climb is 1,575 fpm. The AS 350B has a maximum cruise speed at sea level of 125 kt and a service ceiling of 15,000 ft. Hovering ceiling in ground effect is 8,200 ft; hovering ceiling out of ground effect is 5,900 ft. It has a range of 700 km (378 nm) with maximum fuel of 535 L (141 gal).

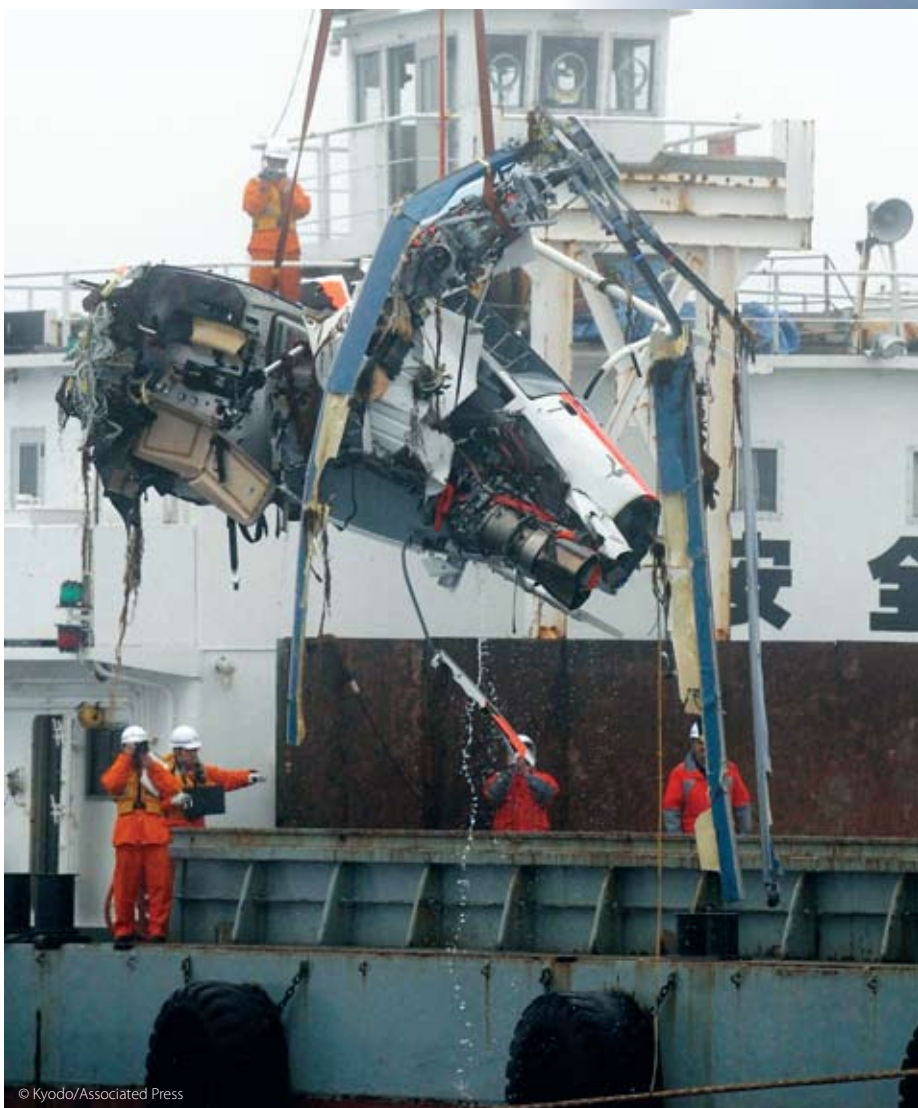
**Wreckage of the AS 350B news helicopter is hauled onto a ship off the coast of Japan, near Cape Omasaki.**

Search and rescue operations began about 1209, after the Tokyo Rescue Coordination Center was informed of the crash. The wreckage was found about 700 m southwest of the Omasaki–Bentenjima lighthouse and was recovered from a rocky seabed beneath about 13 m (43 ft) of water.

Investigators said that an analysis of the wreckage indicated that the helicopter had hit the water nose-first, slightly banked left and while traveling at a high speed, and that Pilot A probably had been flying the helicopter at the time.
