Departure Deviations

Problems arise when the assigned SID differs from the one in the FMS.

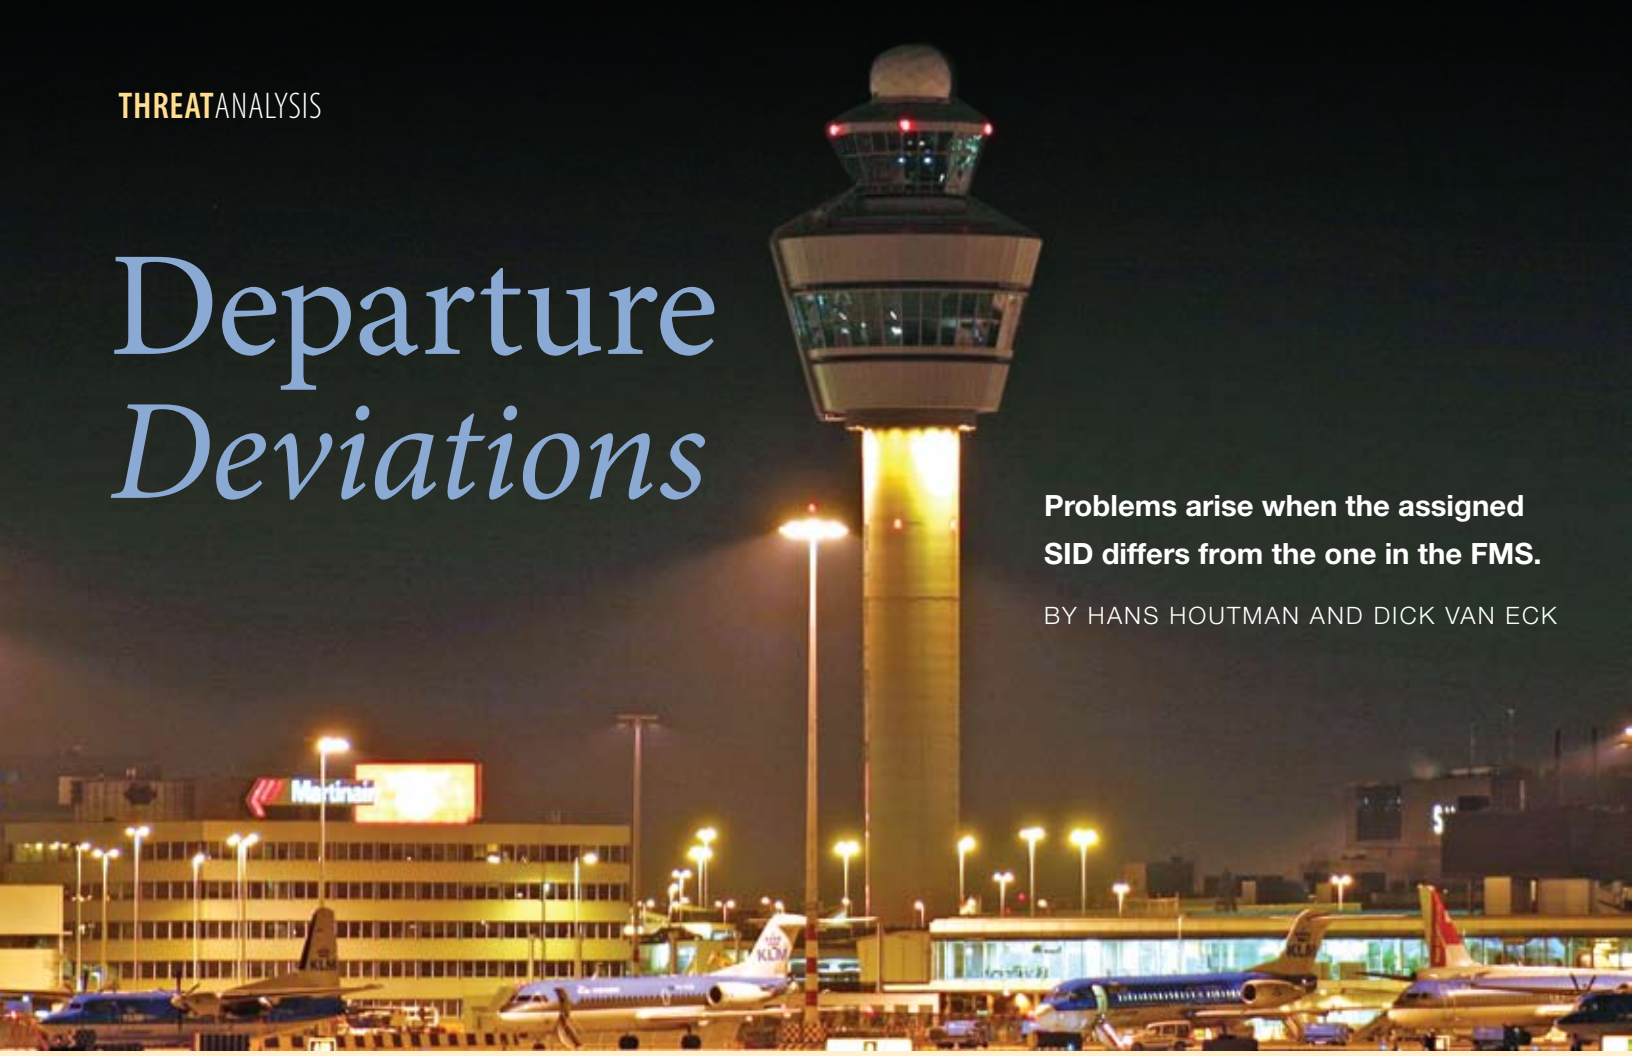
Schiphol has six runways, some of which converge. Pertinent to this discussion are Runway 24, which is the primary runway for departures, and Runway 18R, the primary runway for landings, under southerly wind conditions. In addition, there is Runway 18L, which also is used occasionally for departures (Figure 1).

For aircraft departing from Schiphol’s Runway 24, there are two

SIDs. They are identified as Spijkerboor 1S and Andik 1S. Although they prescribe different initial turns, both lead toward the same northern airway point. The need for the two different routes is created by tactical use of the runway system. In one runway configuration, the right-turn departure from Runway 24 — Spijkerboor 1S — is preferable; in another configuration, the left-turn departure — Andik 1S — is favored.

used for departures, aircraft departing from Runway 24 to the north will use the Spijkerboor 1S departure (right turn).
