# DISTRACTED

The pilots of two TV news helicopters were busy with news-reporting duties in the seconds before their midair collision in Phoenix.

Five television news-gathering helicopters were maneuvering to cover a police chase in Phoenix on July 27, 2007, when two of the aircraft — both Eurocopter AS 350B2s — collided over a downtown park as their pilot-reporters were describing the events occurring on the ground.

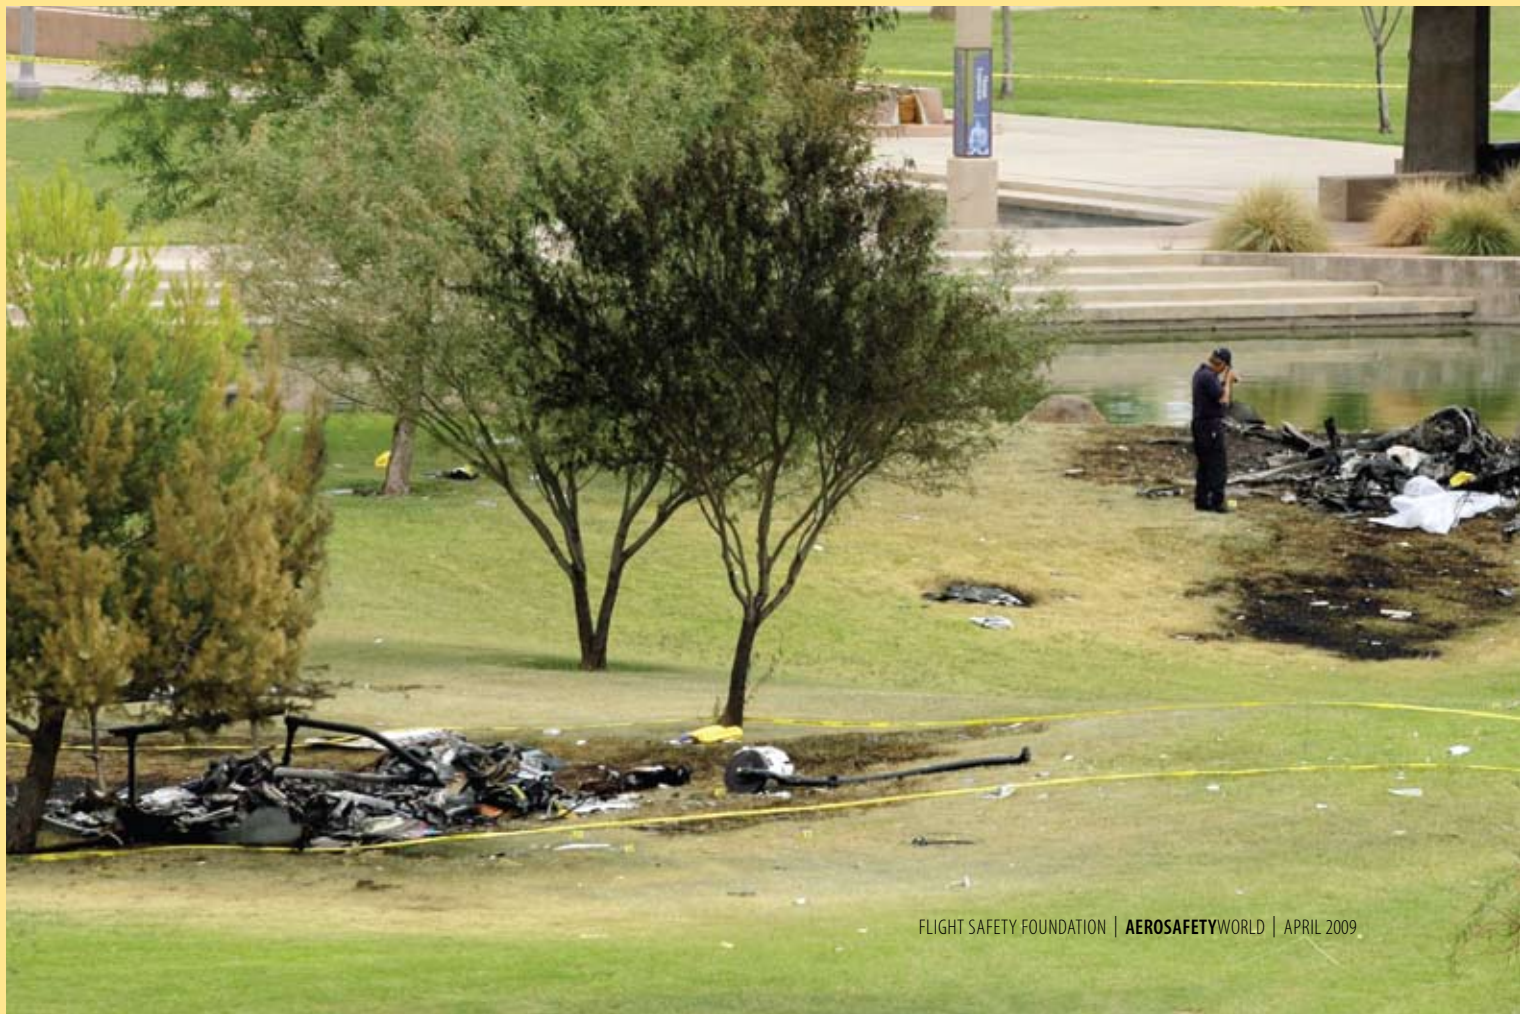
An accident investigator photographs the wreckage of one of two TV news helicopters that crashed to the ground in a downtown Phoenix park after a midair collision. Four people were killed in the 2007 crash.

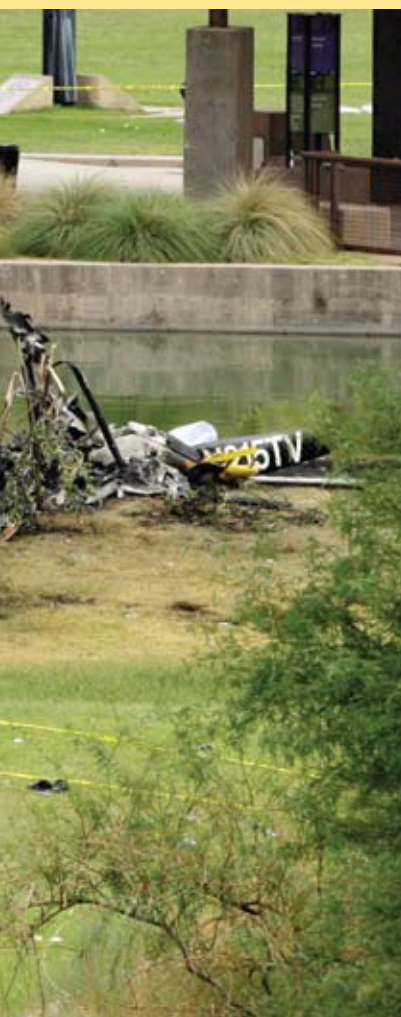
Figure 1

In accordance with informal procedures, the six helicopter pilots shared an air-to-air radio frequency to report their positions and their intentions. The accident helicopters — from Channel 3 and Channel 15 — had audio-video recording systems, and the information recorded by those systems was analyzed in the accident investigation. At 1238, the Channel 15 pilot was recorded telling the other pilots that he was flying at 2,200 ft, and the Channel 3 pilot said that his helicopter was at 2,000 ft (Figure 1).

Radar data showed that the Channel 15 helicopter had been between 2,000 and 2,200 ft and entered a climbing right turn in the seconds before the crash; the last radar return showed the helicopter at 2,300 ft. At the same time, the Channel 3 helicopter, which had been at 2,000 ft, turned right; the last radar return showed the helicopter at 2,100 ft.

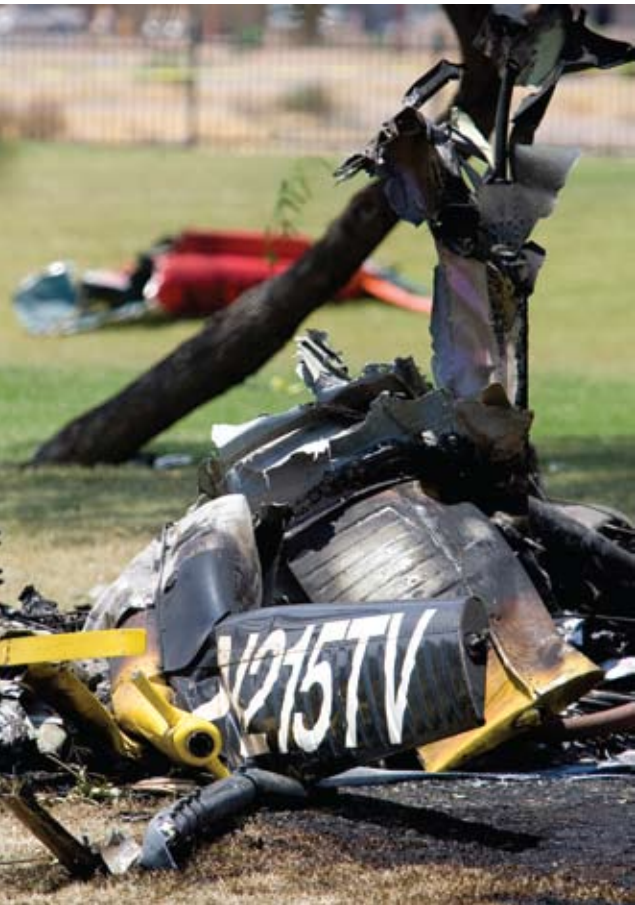
**Pilots of the two TV news helicopters had traded information about the positions of their aircraft several times, but investigators say the last exchange came about four minutes before their midair collision.**

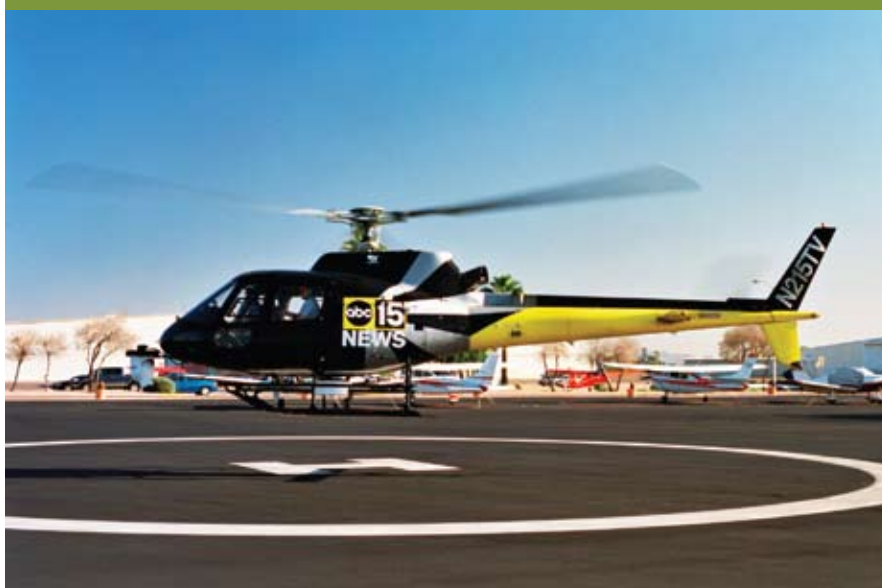
## Eurocopter AS 350

The Eurocopter AS 350 is a light five/six-seat utility helicopter first produced in October 1977 by Aerospatiale as the AS 350B. The Aerospatiale helicopter division and the MBB (Messerschmitt-Bolkow-Blohm) helicopter division merged to form Eurocopter in 1992.

Several versions have been produced since the first AS 350Bs, which were powered by a 478 kw (641 shp) Turbomeca Arriel 1B turboshaft engine and a main rotor system comprising three fiberglass blades. The next version was the AS 350BA, with larger main rotor blades and an increased takeoff weight.

Current versions include the AS 350B2, certified in 1989, and the AS 350B3, first certified in France in 1997. The AS 350B2 has a 546 kw (732 shp) Arriel 1D1 engine, a maximum cruise speed of 134 kt at sea level and a maximum takeoff weight of 2,250 kg (4,960 lb) or 2,500 kg (5,512 lb) with an external load. The AS 350B3 has a 632 kw (847 shp) Arriel 2B engine, maximum cruise speed of 140 kt at sea level and a maximum takeoff weight of 2,250 kg, or 2,800 kg (6,173 lb) with an external load.
