AeroSafety WORLD

THE JOURNAL OF FLIGHT SAFETY FOUNDATION

JANUARY 2008

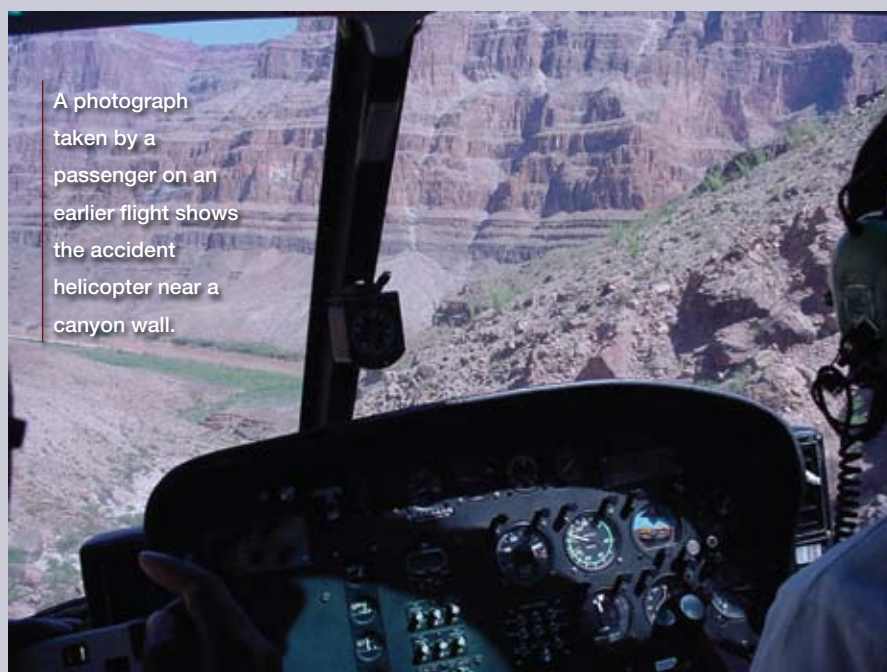
A photograph taken by a passenger on an earlier flight shows the accident helicopter near a canyon wall.

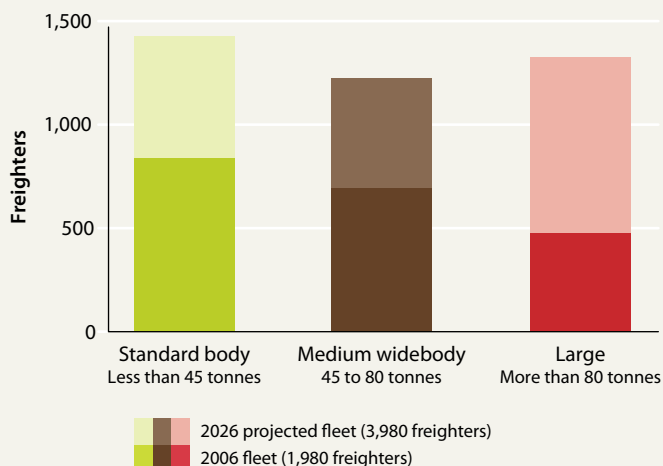
Figure 1

Freighter Fleet Projection

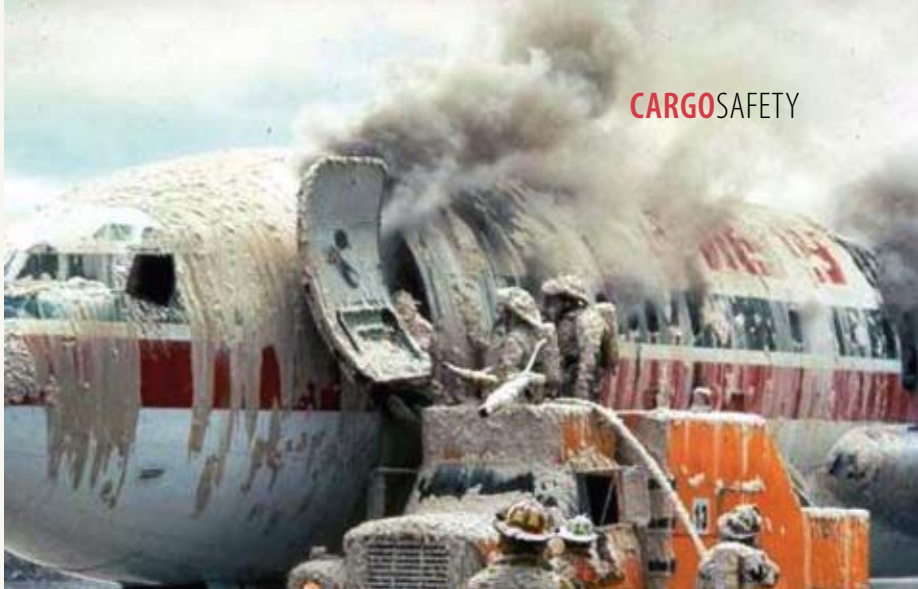
Firefighters in Windsor Locks, Connecticut, U.S., in May 1991 extinguish a fuel-fed fire burning a Boeing 727-100QC freighter after shrapnel from an uncontained engine failure severed a fuel line during takeoff.

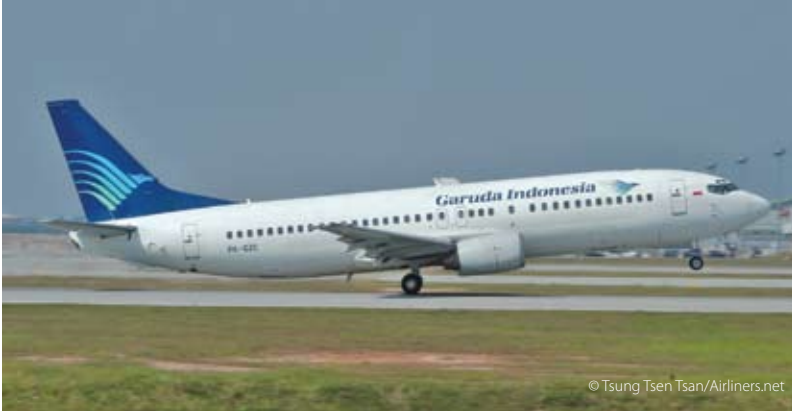
Boeing 737-400

Produced from 1988 to 2000, the 737-400 is 10 ft (3 m) longer than the 737-300, has strengthened landing gear and can accommodate 146 to 168 passengers. Powered by CFM56-3B2 or -3C turbofan engines, maximum operating speed is 0.82 Mach, and maximum range is 2,808 nm (5,200 km). Maximum standard weights are 138,500 lb (62,824 kg) for takeoff and 121,000 lb (54,886 kg) for landing.

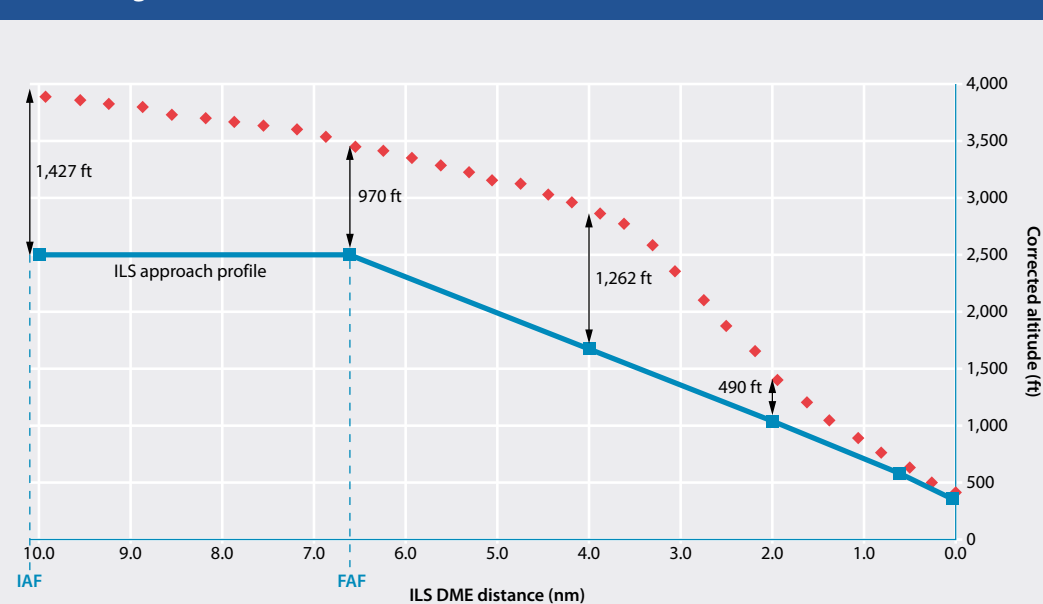
Aircraft Flight Path

DME = distance measuring equipment ; FAF = final approach fix; IAF = initial approach fix; ILS = instrument landing system

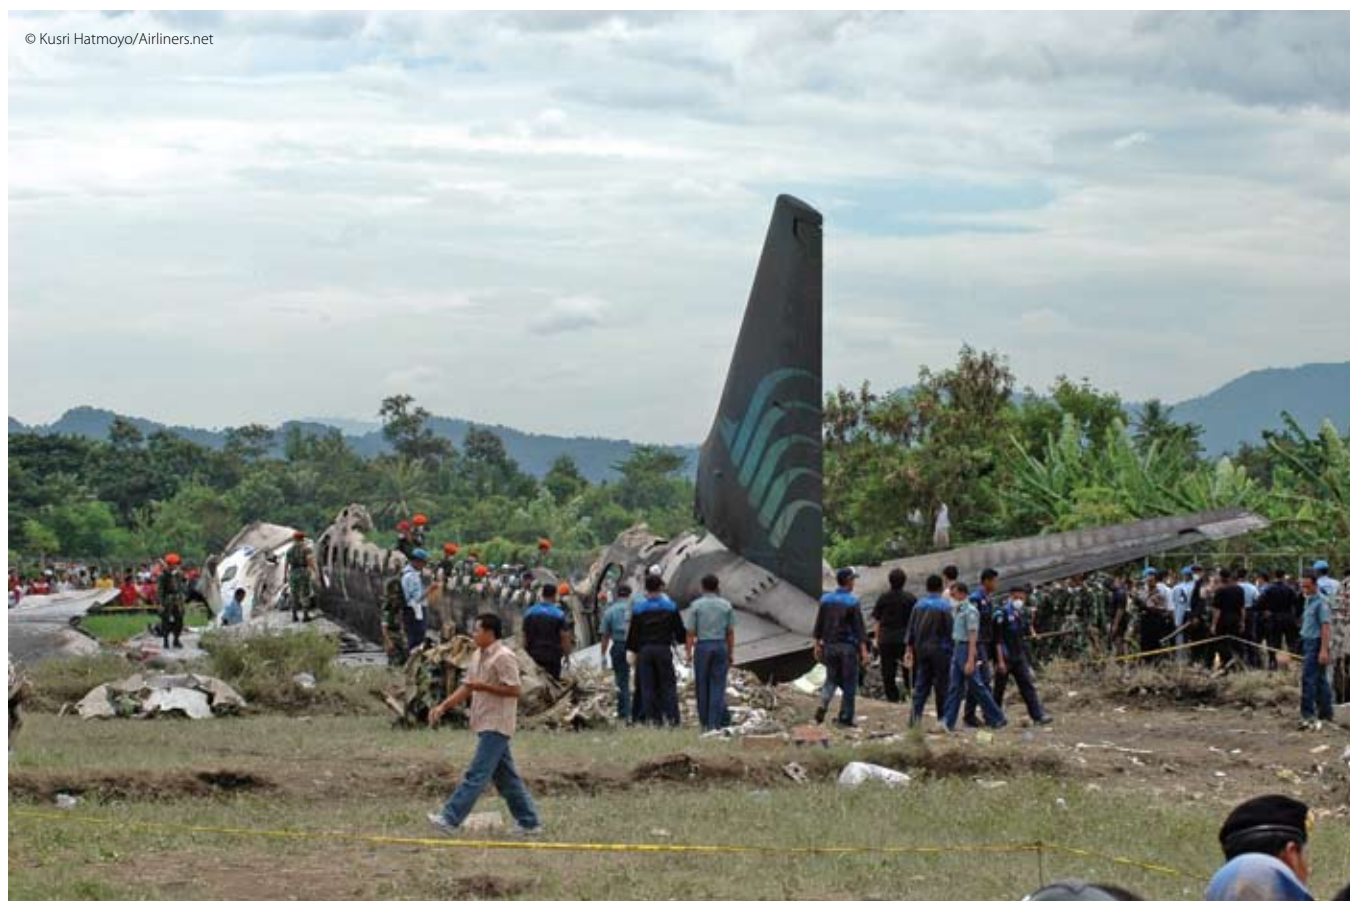
The 737 was 10 m (33 ft) right of the centerline when it overran the runway at 110 kt at 0658. It crossed three ditches and a road, and struck two fences and an embankment before stopping in a rice paddy 252 m (827 ft) from the end of the runway. The nosewheel assembly had separated from the aircraft on the runway. “The engines and landing gear separated from the aircraft and were destroyed,” the report said. “The right wing was severed from the fuselage, swung around the fuselage and came to rest on top of the left wing.”
