A safety analysis of remotely piloted aircraft systems

A rapid growth and safety implications for traditional aviation

ATSB Transport Safety Report

AR-2017-016a

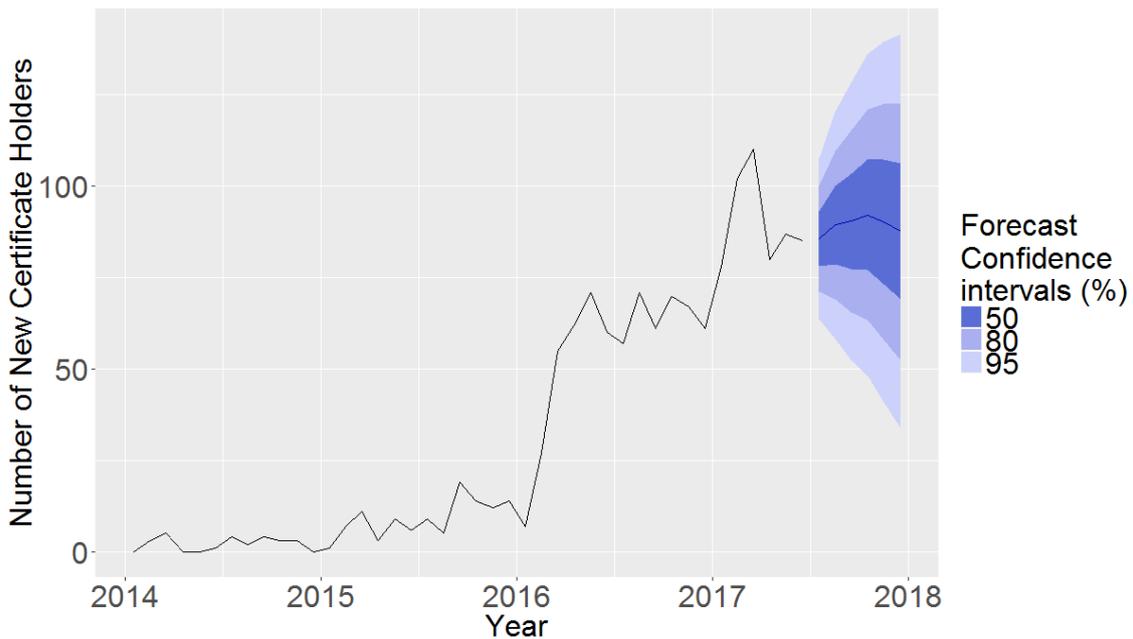
Figure 1: Number of new CASA registered RPAS certificate holders per month (Jan 2014–Jun 2017). The blue regions are the 50th, 80th and 95th per cent confidence intervals for the forecast (up to Dec 2017) calculated using an ARIMA model^{1,2}

CASA registered RPAS operators likely comprise only a proportion of the total RPAS operators in Australia. However, the growth in their number is probably a good indicator of the general growth of RPAS in Australia (Figure 1).

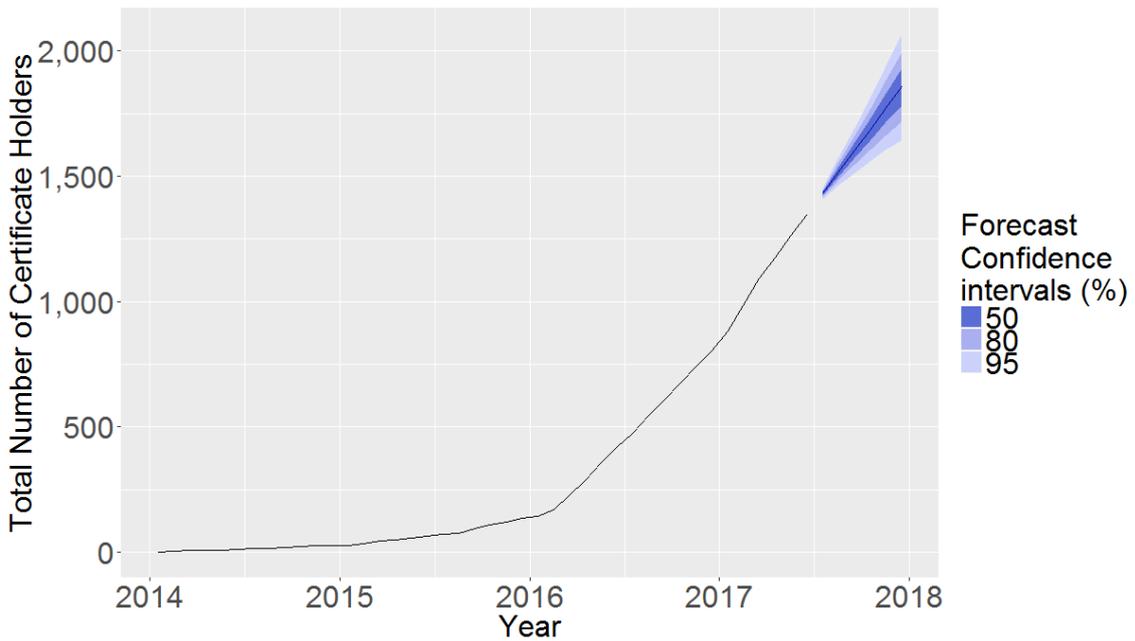
Figure 2: Total number of CASA registered RPAS certificate holders (Jan 2014–Jun 2017). The blue regions are the 50th, 80th and 95th per cent confidence intervals for the forecasts (up to Dec 2017) calculated using an ARIMA model ^{1,2}

The cumulative effect of this level of growth in the number of new CASA RPAS certificate holders, assuming the operators still maintain ownership of their aircraft, leads to a more than doubling in total RPAS certificate holders at the end of 2017 compared to 2016 (Figure 2).

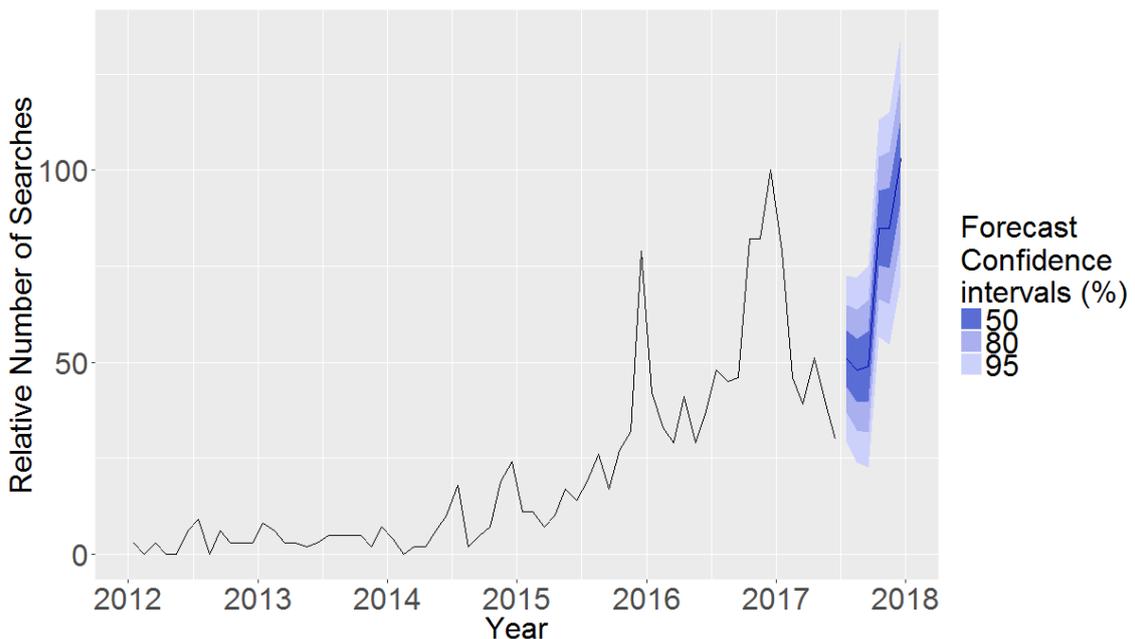
Figure 3: Number of Google shopping RPAS searches (Jan 2012–Jun 2017) normalised to 100 at peak demand (Dec 2016). The blue regions are the 50th, 80th and 95th per cent confidence intervals for the forecasts (up to Dec 2017) calculated using an ARIMA model ^{1,2}

Peaks in the number of searches can be seen in December each year. Similar to the number of CASA RPAS certificate holders, it can be seen that demand has increased significantly in 2016. Figure 4 shows the cumulative effect—assuming a constant proportion of people searching online then purchase an RPAS, showing an expected exponential growth in the number of RPAS in Australia.

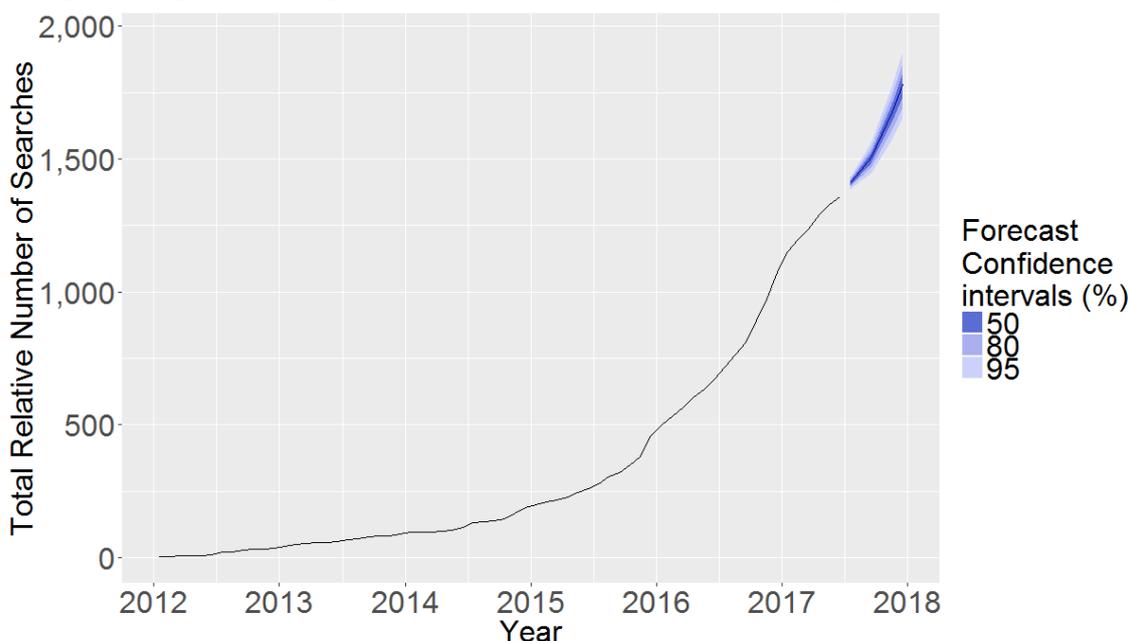
Figure 4: Total number of Google shopping RPAS searches in Australia (Jan 2012–Jun 2017) normalised to 100 at peak demand (Dec 2016). The blue regions are the 50th, 80th and 95th per cent confidence intervals for the forecasts (up to Dec 2017) calculated using the weighted average of ARIMA and Exponential smoothing state space models^{1,2}

Unlike data from the CASA register, the growth in number of searches has significantly decreased over the last six months. The total relative number of searches in the first half of 2017 was only 35 per cent greater than the first half of 2016, with the total for 2017 expected to be around 65 per cent greater than 2016—this is almost half of the previous year’s growth rate. Non-commercial growth in RPAS in Australia has possibly begun to level-off compared to rapid growth of previous years. However, the uncertainty in the forecast is high, as seen by the size of the confidence interval. Due to this, the forecasts are considered indicative only and are not intended to be accurate predictions of the growth of RPAS in Australia.³

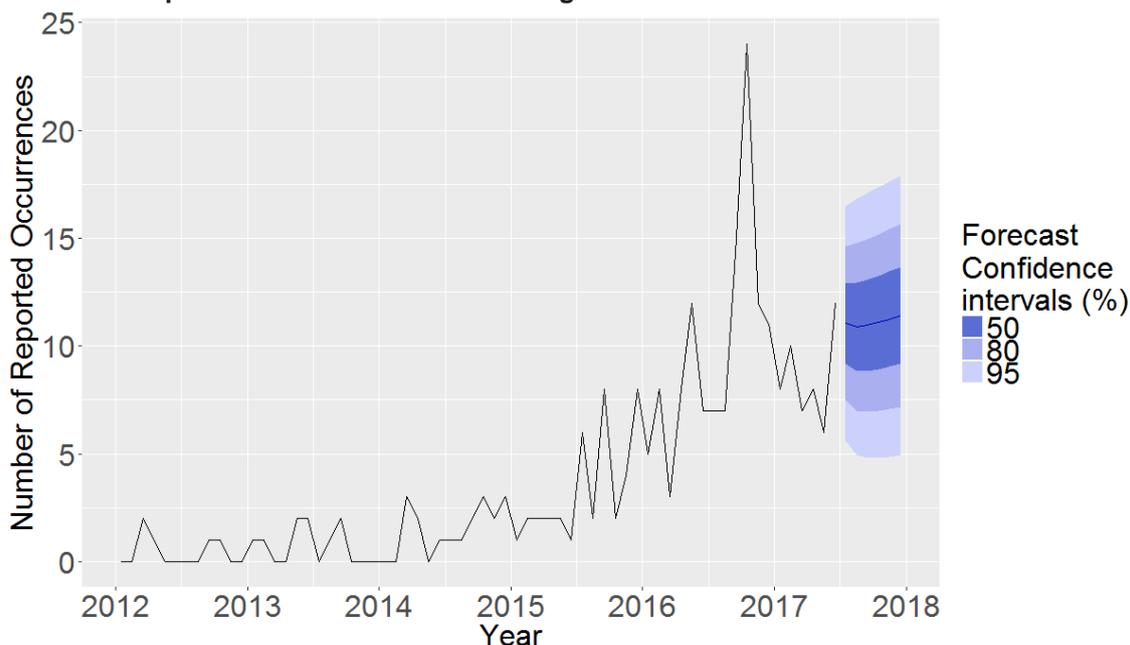
Figure 5: All occurrences involving an RPAS reported to the ATSB (Jan 2012–Jun 2017). The blue regions are the 50th, 80th and 95th per cent confidence intervals for the forecasts—up to Dec 2017—calculated using an ARIMA model^{1,2}

The number of reported RPAS occurrences (51 occurrences) in the first half of 2017 was about 20 per cent more than the first half of 2016 (43 occurrences).

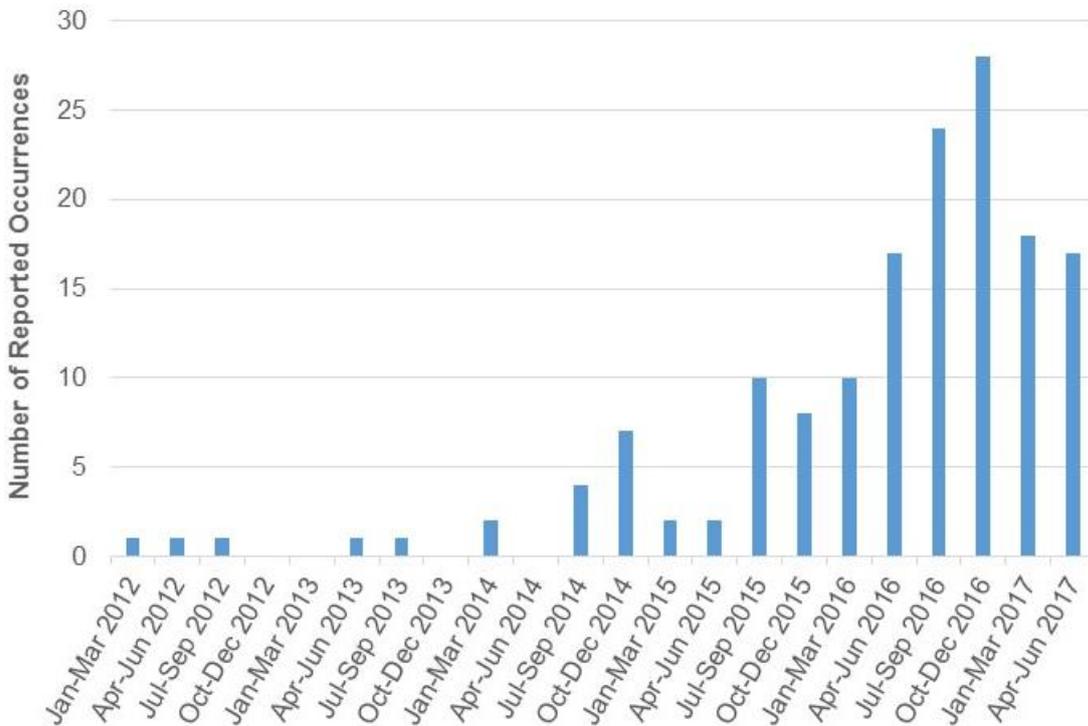
Figure 7: Near encounters with manned aircraft involving an RPAS reported to the ATSB (Jan 2012–Jun 2017)

The forecasts predict the number of near encounters reported to the ATSB in 2017 to be comparable to 2016. Due to the level of uncertainty underlying these forecasts, they are indicative of an increase only and are not intended to be accurate predictions of future RPAS near encounters.

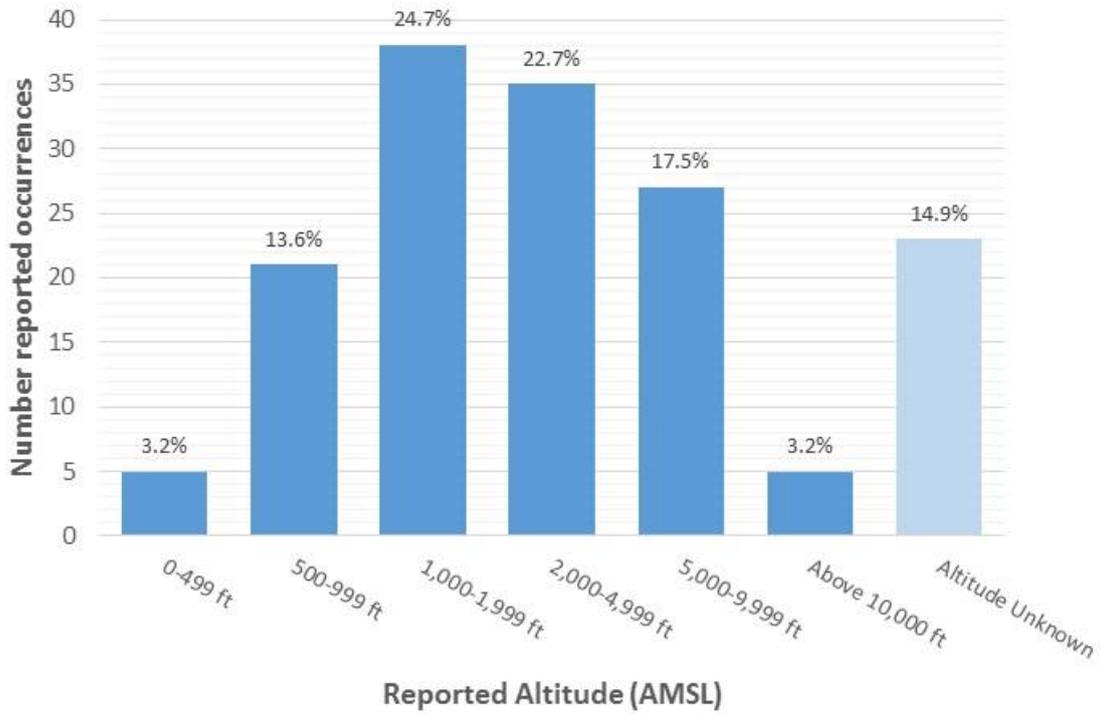
Figure 11: Reported altitude of RPAS involved in a near encounter with manned aircraft occurrences (Jan 2012– Jun 2017). When RPAS altitude is unknown other aircraft altitude is used

Figure 11 shows the reported altitude of RPAS involved in near encounters. Most encounters were above 1,000 ft above mean sea level (AMSL). Five encounters were above 10,000 ft. Very few (less than 4 per cent of encounters with a known altitude) were under 500 ft.

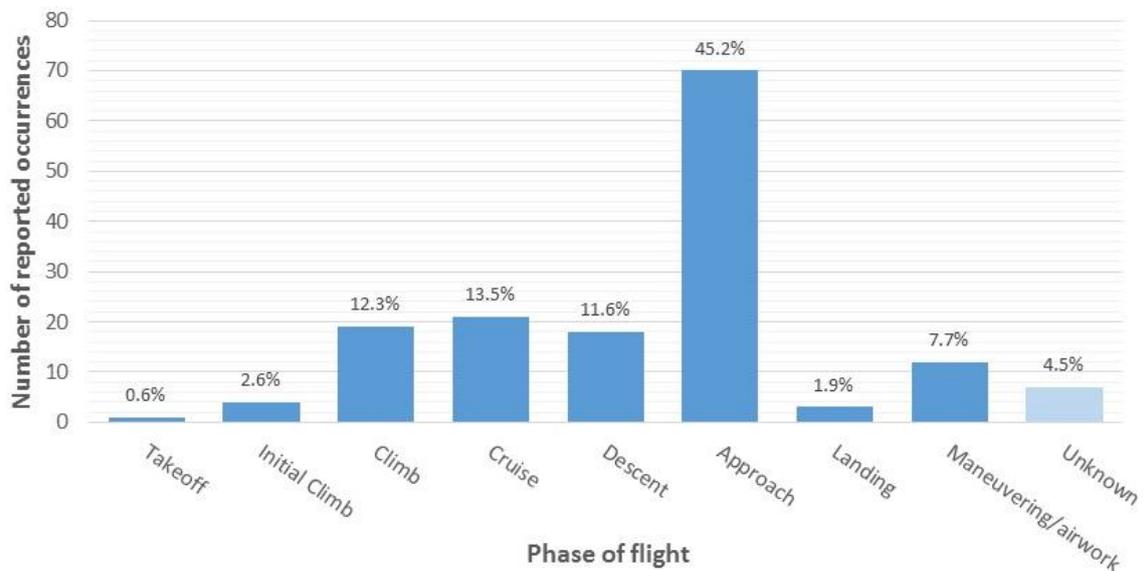
Figure 15: Affected aircraft's phase of flight at time of an RPAS near encounter (Jan 2012–Jun 2017)

Over 45 per cent of near encounters occurred when the affected manned aircraft was on the approach phase of flight. A lower proportion involved aircraft climbing after take-off (nearly 15 per cent were in the initial climb or climb phases). Nearly 14 per cent involved manned aircraft during the cruise. Where the operation type was known (12 occurrences), all manoeuvring/airwork occurrences were within general aviation with four within the aerial work sub-operation type (Figure 15).

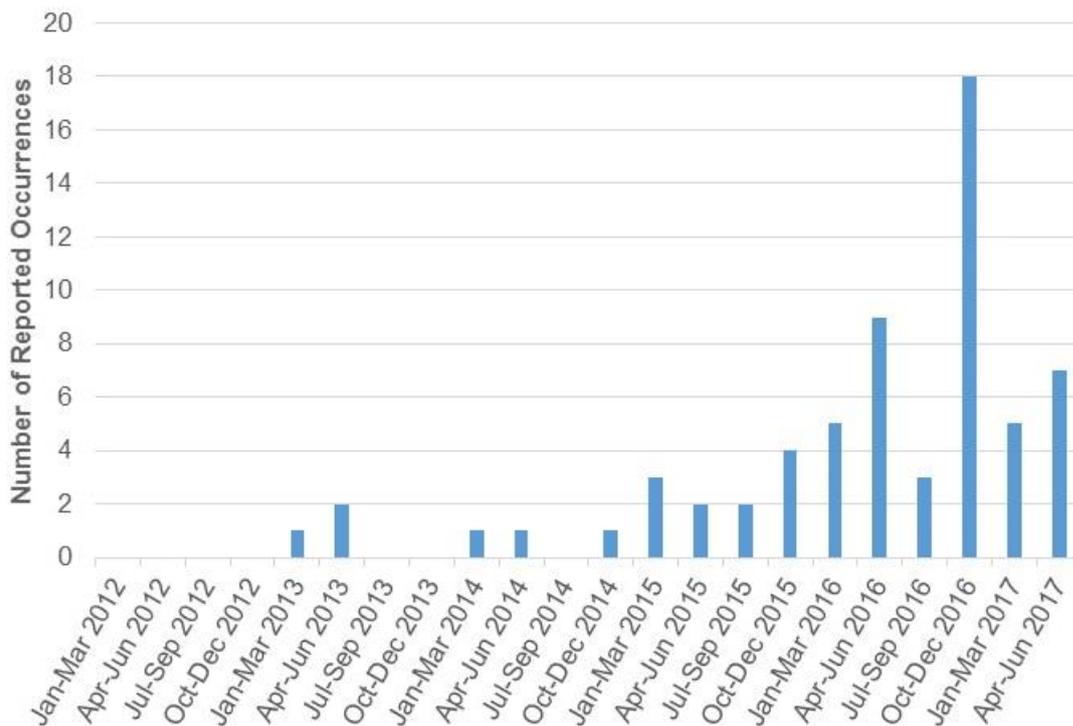
Figure 19: Terrain collisions involving an RPAS reported to the ATSB (Jan 2012–Jun 2017)

There were 47 terrain collisions involving an RPAS reported to the ATSB between January 2016 and June 2017, while only 17 were reported in the previous four years. The majority (about 84 per cent) of all reported RPAS terrain collisions were accidents (where the aircraft was either destroyed or significantly damaged), and 13 per cent were serious incidents (almost an accident).

Forecast predict the total number of terrain collisions involving an RPAS reported to the ATSB by in 2017 to be comparable to 2016. Due to the level of uncertainty underlying these forecasts, they are indicative only and are not intended to be accurate predictions of future RPAS occurrences.

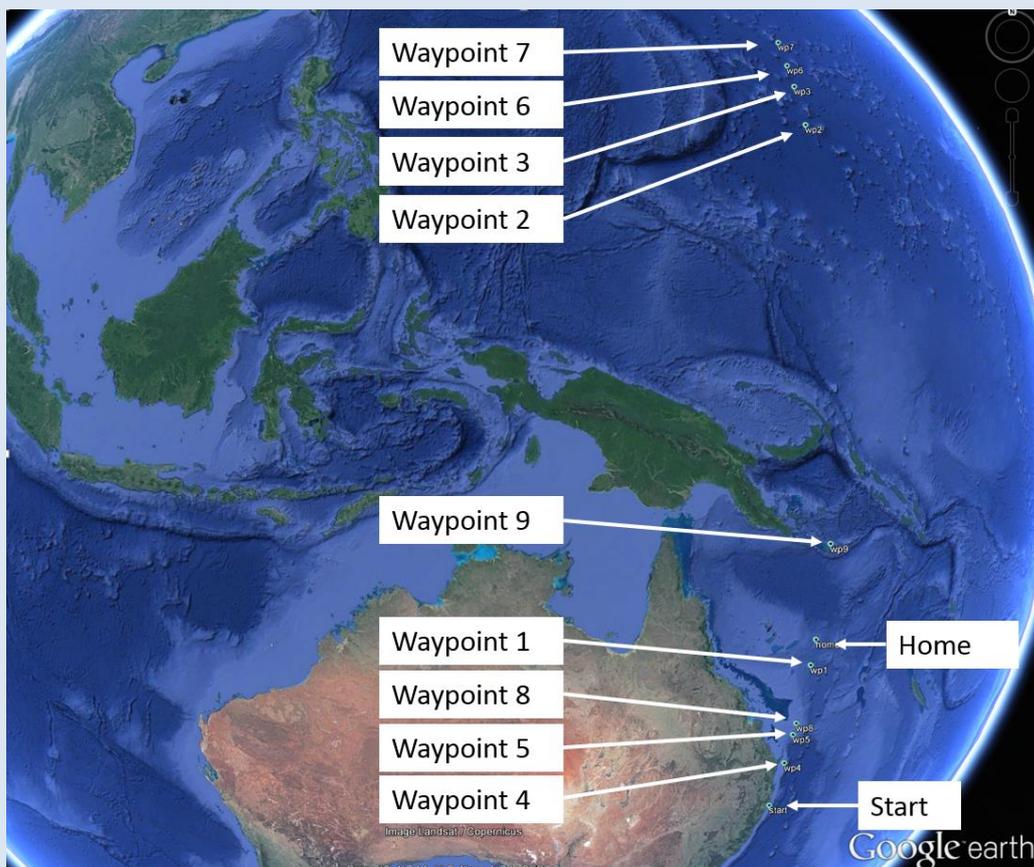
The investigation found that during the pre-flight programming, the south-eastern point used to georeference the image on the ground control station map was selected to a northern hemisphere latitude. This resulted in incorrect waypoints and home position for the mission. When the data-link signal to the ground control station was lost, the aircraft commenced tracking to the programmed home position, which was in the Coral Sea Islands about 1,200 km north of the start position.

Location of waypoints programmed in the ground control station pre-flight from AO-2016-128. Source: Google Earth annotated by ATSB

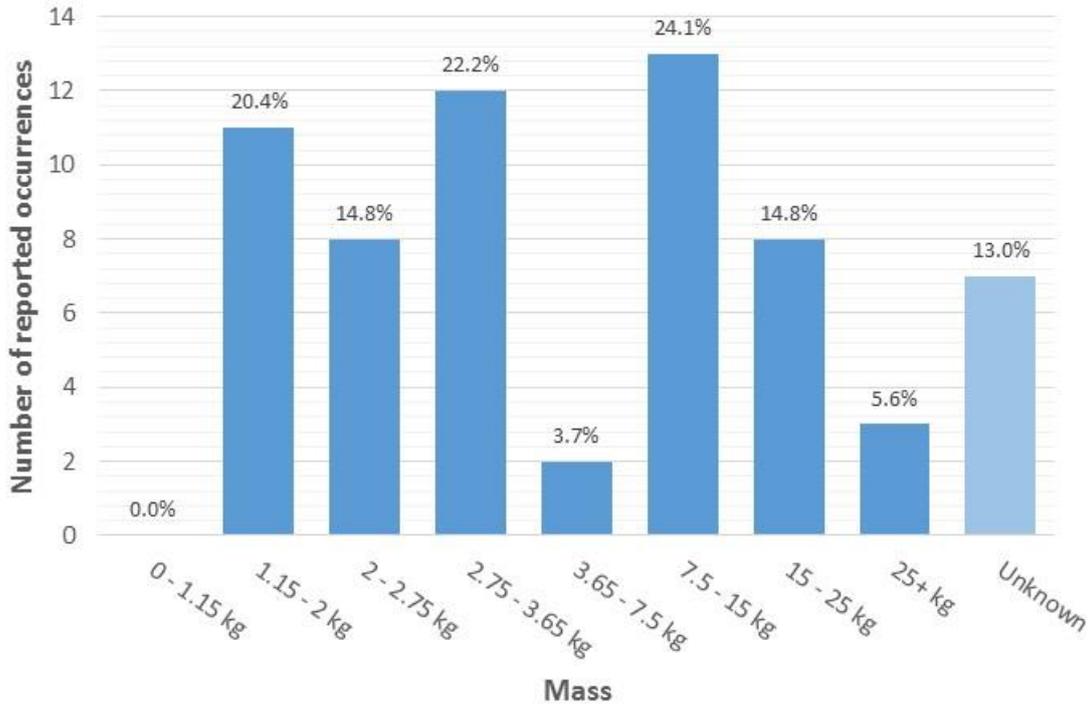
Figure 22: Mass of RPA involved in terrain collisions reported to the ATSB (Jan 2012–Jun 2017)⁹

The majority of terrain collisions reported to the ATSB had detail concerning the RPAS involved. Figure 22 displays the mass of the RPA where information regarding the model was reported. The average mass was 11.6 (± 5.6) kg. The most common mass was 2.9 kg (around 19 per cent of occurrences).

The average mass from an RPAS involved in a terrain collision in a built-up location (6.8 kg) was less than that for remote locations (14.8 kg). However, the most common mass was 2.9 kg for both built-up and remote locations.

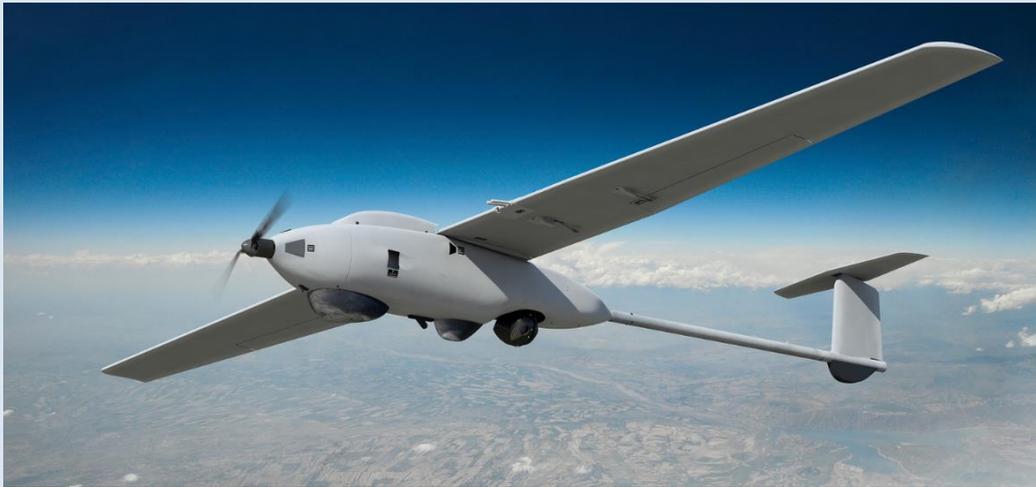
Following a normal take-off involving bungee launch procedures, the Lockheed Martin Stalker XE tracked and climbed to two pre-programmed waypoints. About 20 seconds into the flight, however, the aircraft entered an uncontrolled descent from about 225 ft above ground level, and collided with the ground. The aircraft sustained substantial damage.

After the accident, the aircraft’s negative main power cable was found to have separated from its pin in the connector. Due to the total loss of electrical power, the aircraft was unable to maintain normal flight or conduct a safe glide landing, therefore collided with the ground.

Lockheed Martin Stalker XE remotely piloted aircraft from AO-2016-041. Source: RPAS operator

As a result of this occurrence, the aircraft manufacturer has advised the ATSB that all battery connectors are being replaced and sacrificial pigtailed are being added to the connectors, to be replaced after a number of connections. In addition, the aircraft battery circuitry is being modified to prevent arcing during connection and disconnection. ([ATSB investigation AO-2016-141](#)).

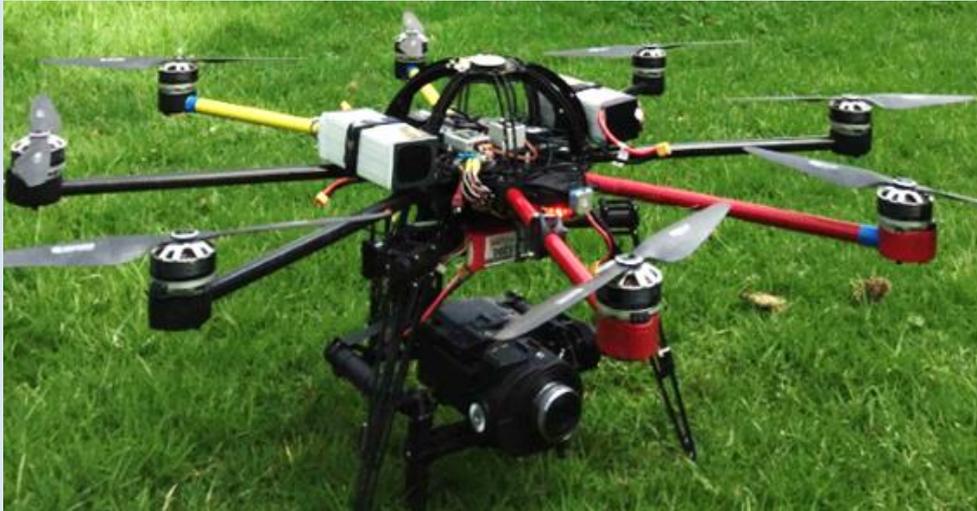
The RPAS was operating as part of the media coverage of the International Cricket Council World Cup Final at the Melbourne Cricket Ground. About 2 minutes into the flight, with the Aeronavics SkyJib 8 RPAS over the northern roof of Hisense Arena, the operating crew lost control of the aircraft. The crew commenced alternate recovery procedures, but were unable to re-establish control. The aircraft ultimately collided with terrain just to the south of Rod Laver Arena. There were no injuries to people on the ground, and no damage to other property, but the aircraft and associated equipment were substantially damaged

Radio frequency interference was the most likely cause of the accident. The volume of radio frequency traffic at the time of the accident was probably substantial, and perhaps sufficient to override RPAS control signals under the prevailing conditions. ([ATSB investigation AO-2015-035](#)).

Aeronavics SkyJib 8 remotely piloted aircraft from AO-2015-035. Source: RPAS operator

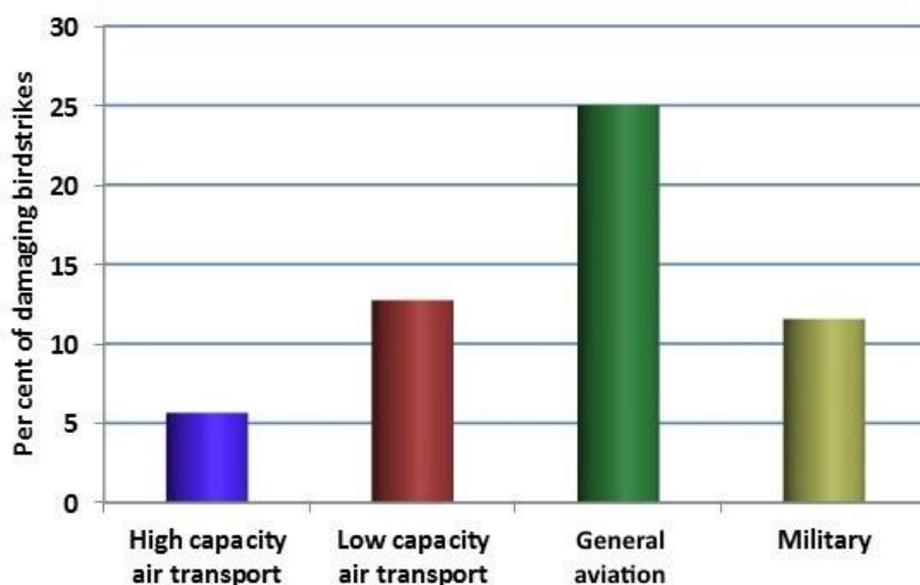
Figure 26: Proportion of birdstrikes resulting in damage in each operation type over the 2006 - 2015 period

It should be noted that while only 6 per cent of high capacity aircraft birdstrikes result in damage, 25 per cent of birdstrikes to general aviation aircraft result in damage. This is a result of more fragile parts in general aviation aircraft including wings and windscreens.

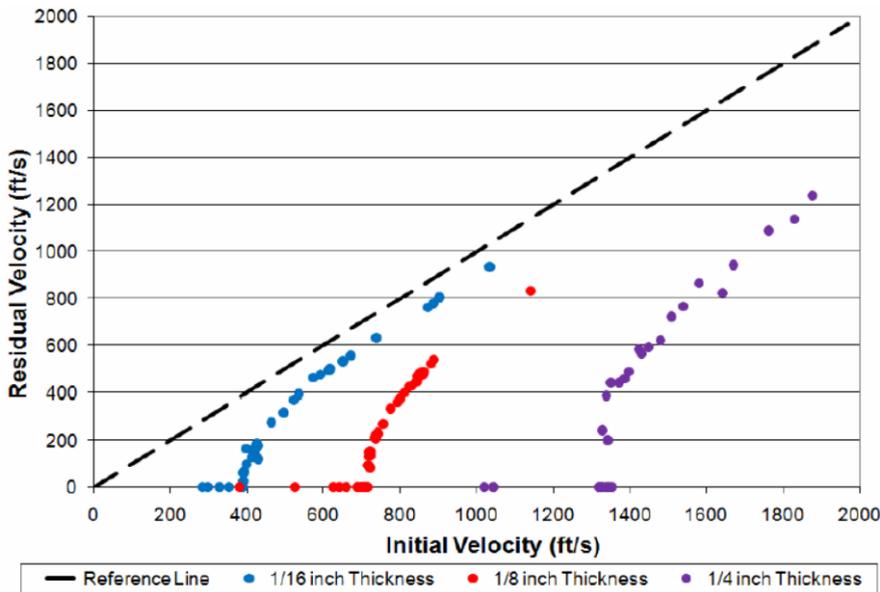
Figure 27: Impact testing involving a 0.5 inch steel sphere striking aluminium plates of different thicknesses.

A collaborative report between Monash University and the Civil Aviation Safety Authority (CASA) used this methodology for a theoretical study on the possibility of aircraft penetration by RPAS components.²¹ Table 6 lists the components that were used in the study, which were based off actual RPAS parts.

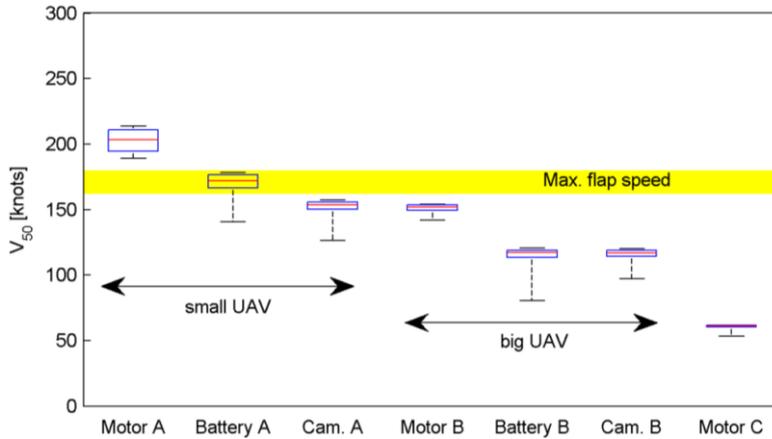
Figure 28: Ballistic limits of drone components impacting 1/8 inch thick aluminium

As the figures show, all components are expected to penetrate 1/16 inch thick aluminium at an impact speed lower than speeds reasonably expected by a commercial air transport aircraft on take-off or landing. All components except for the small quadcopter motor are predicted to penetrate 1/8 inch thick aluminium under the same conditions.

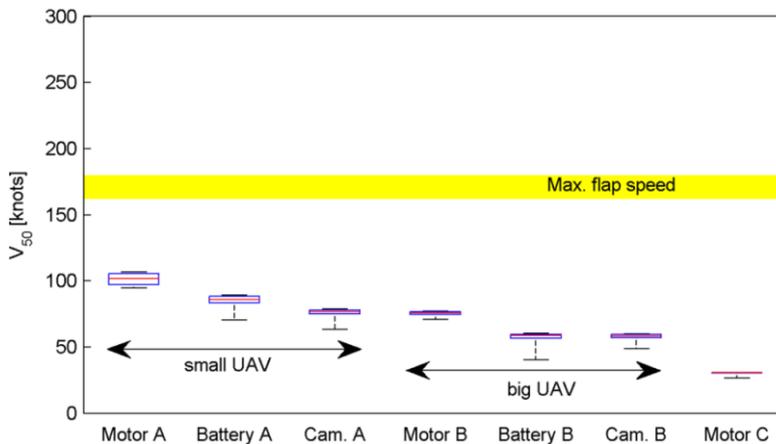
Figure 29: Ballistic limits of drone components impacting 1/16 inch thick aluminium

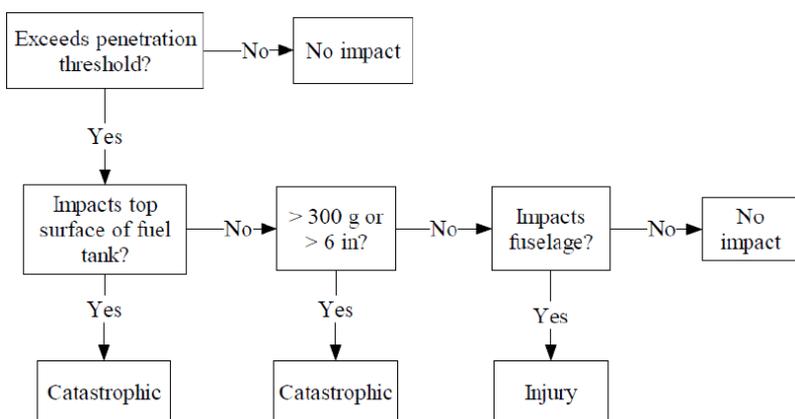
Figure 30: Analysis of penetration consequences from falling satellite/rocket debris
