Non-destructive testing for airframes repairs

SASS Singapore – March 28th, 2018

Steven Crummack
HO Testia Asia Pacific
Testing Training & Services

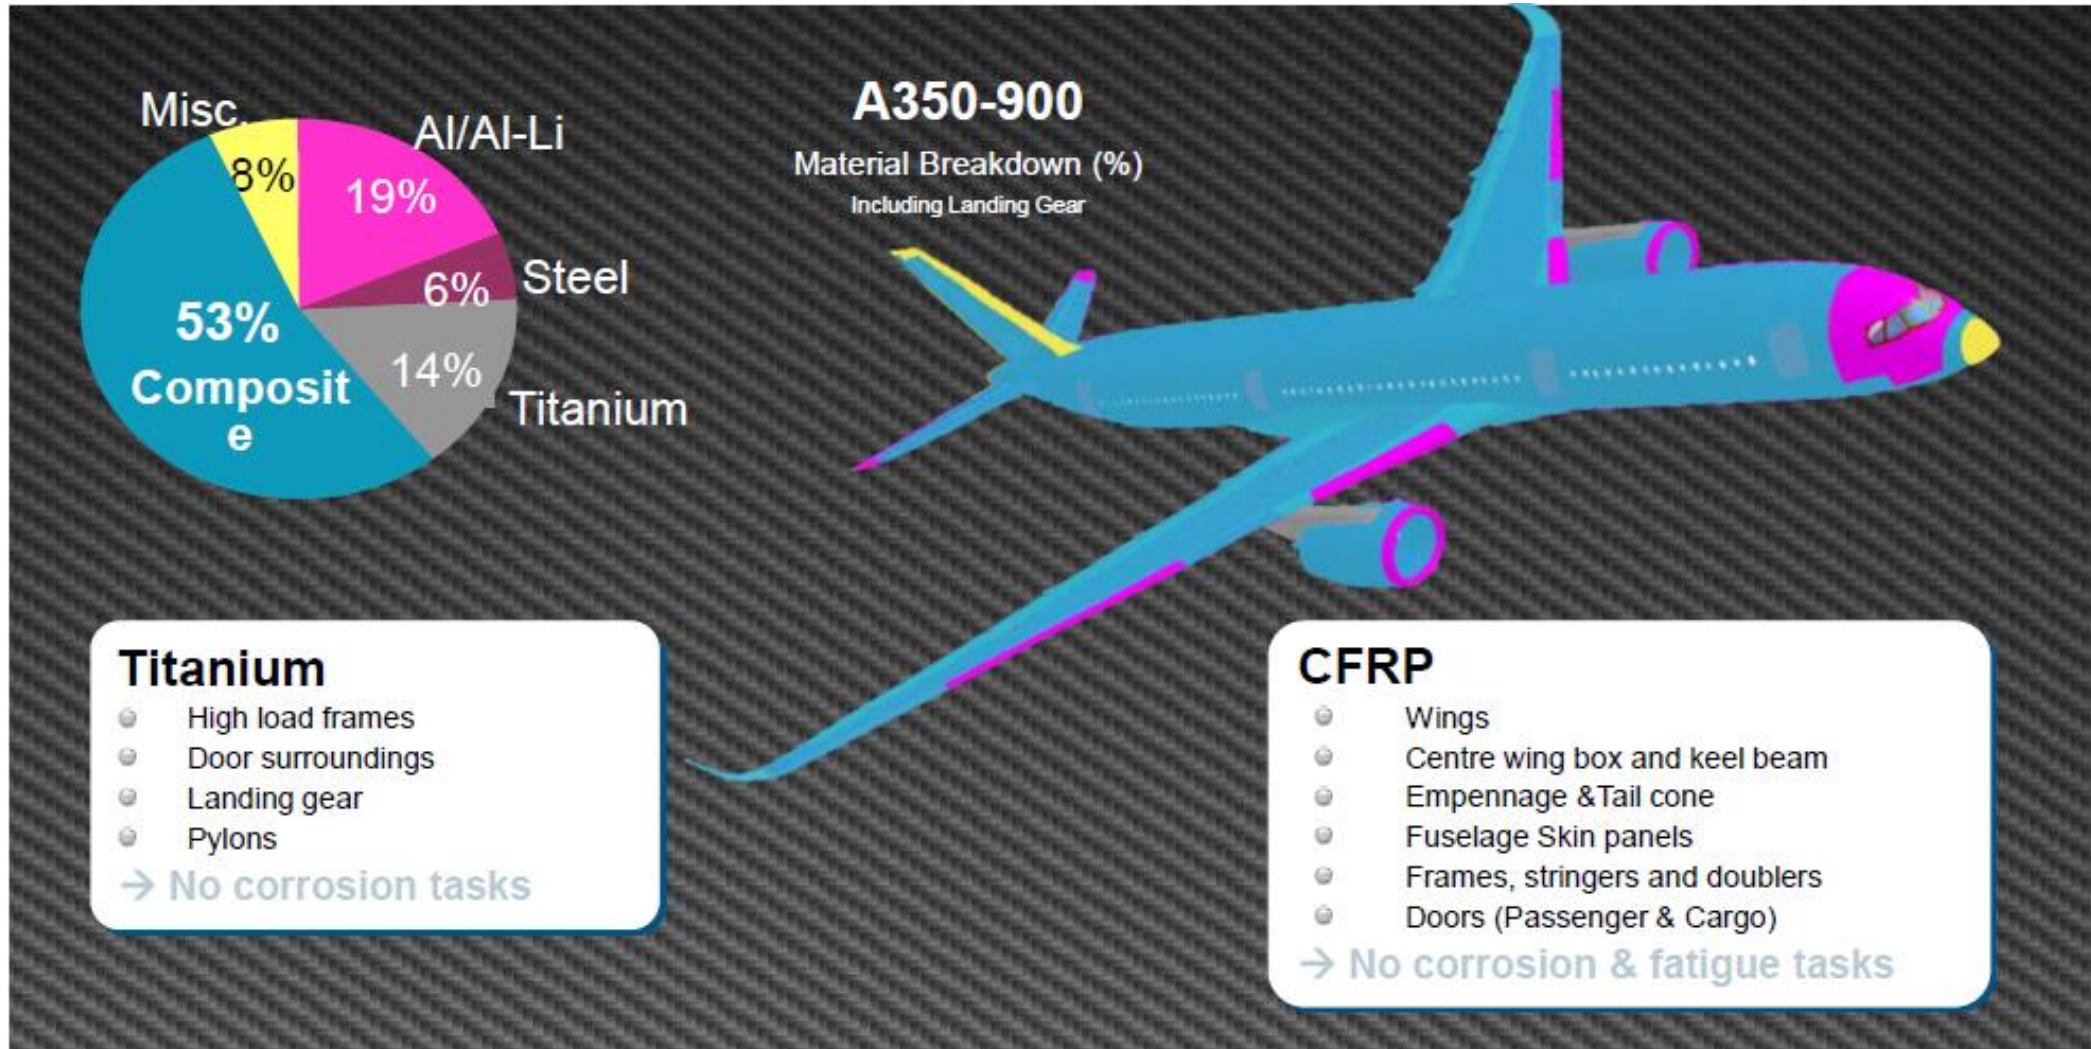
Structural Composites in A350 Aircraft

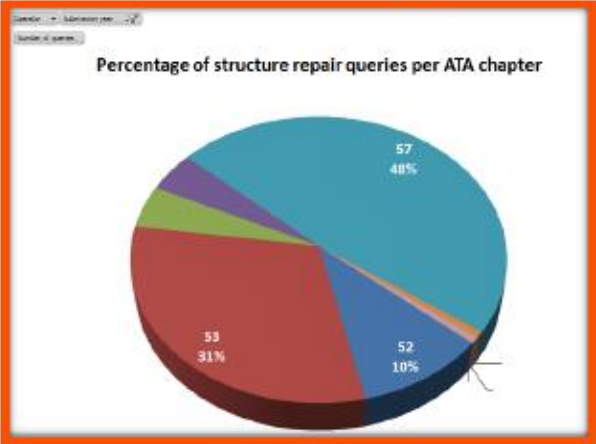
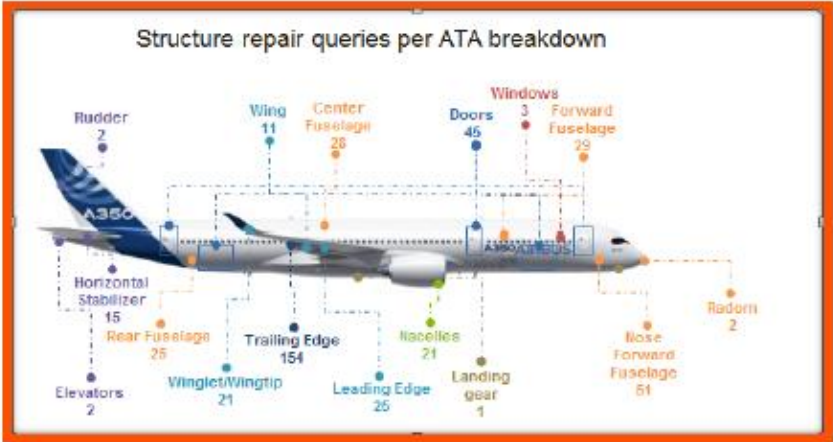
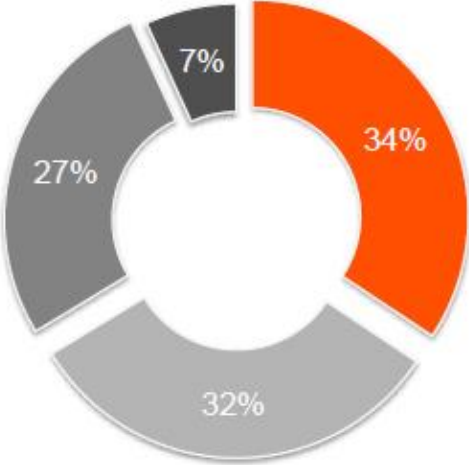
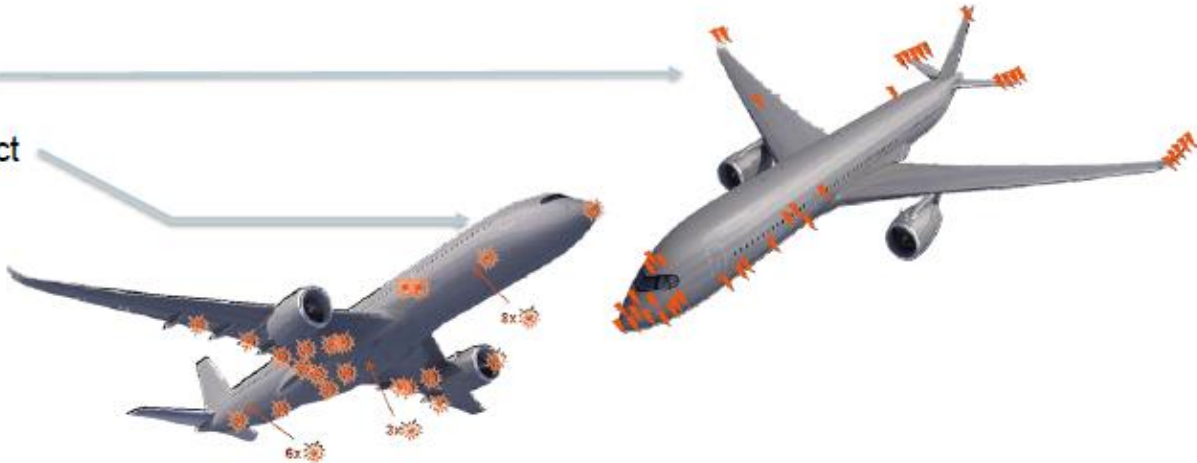
In-Service Damage

- Lightning strike
- Mechanical impact
- Other
- Bird strike

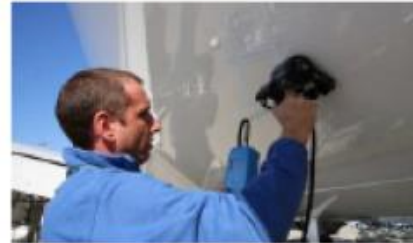
LineTOOL: go/no go composite delamination assessment tool

- Prevent flight delay and cancellation due to lack of Non Destructive Testing expert personnel availability
- Provide quick and reliable statement
- Already available and used by several Operators

LineTool is developed for automatic detection of delamination after impact on A350 fuselage by non-certified personnel à sold by AIRBUS GSE only

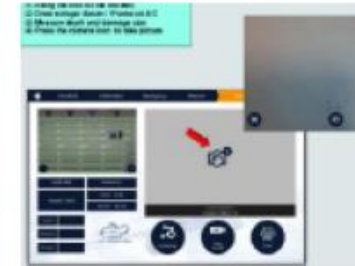
LineMAP: Damage Localisation

- Accurate location of damage on A/C fuselage, automatic integration in A/C DMU (Digital Mock-Up)
- Damage location tracking and report generation
- Already available and used by several operators

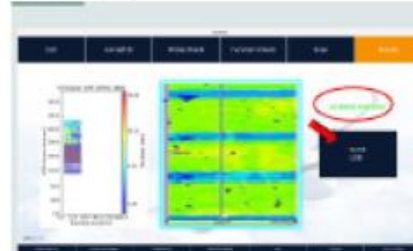
LineSIZING: Damage sizing and reporting

- Easy to use device, enable B1 or equivalent mechanics to perform damage sizing on A350 monolithic CFRP.
- Ultrasonic C-scan , automatic damage size measurement.
- Enhanced damage tracking and automatic report creation.

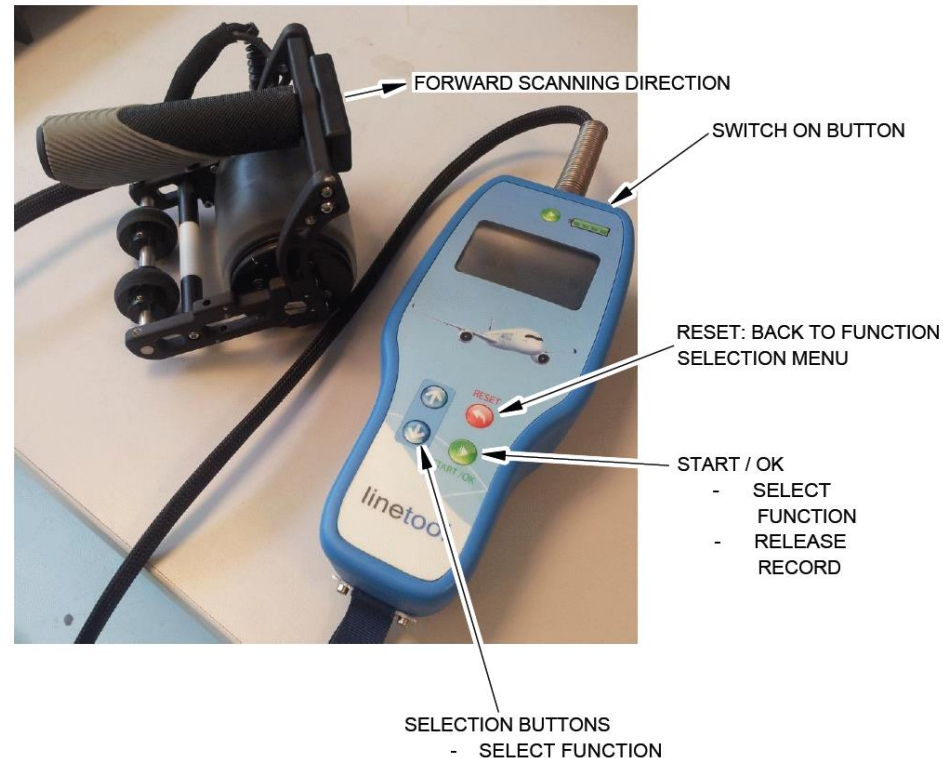
D-LamTool

Equivalent to LineTool but for other customers than Airbus' (armies, helicopters, others A/C manufacturers...) sold by TESTIA

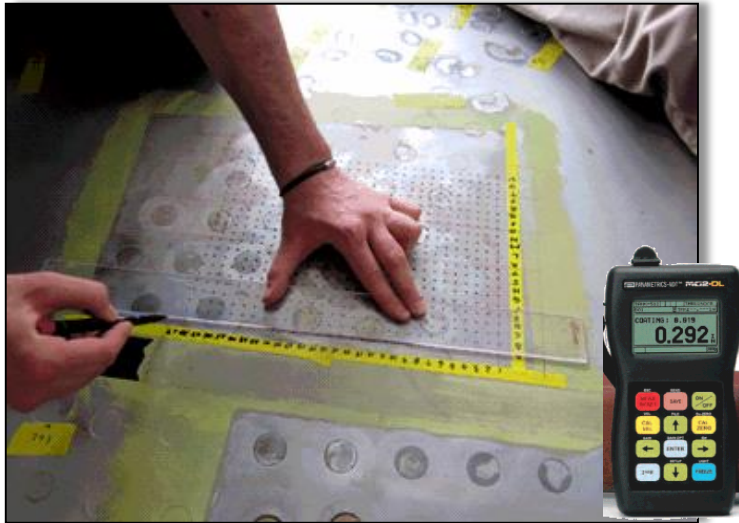
NTM 51-10-04

Thickness measurements after blending corrosion in the wing skin

Currently: 5 hours

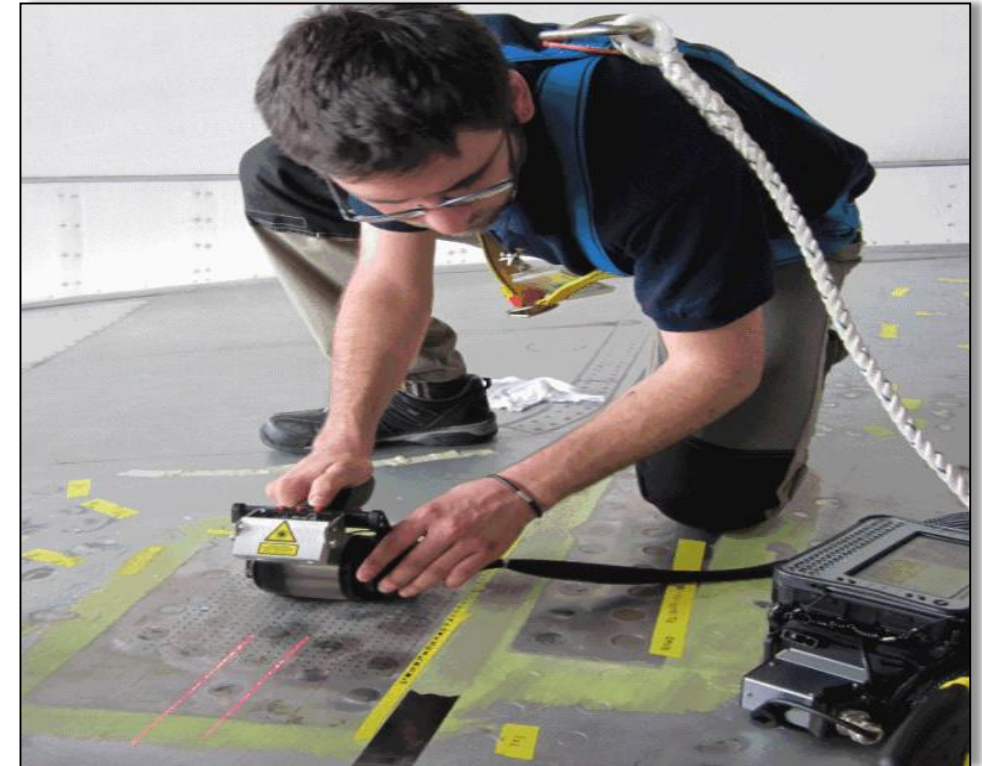
Alternative: 10 min

- ThicknessTool is developed for automatic thickness measurement of large plane or slightly curved areas (basically for A320 wing skin thickness measurement after corrosion blend out)

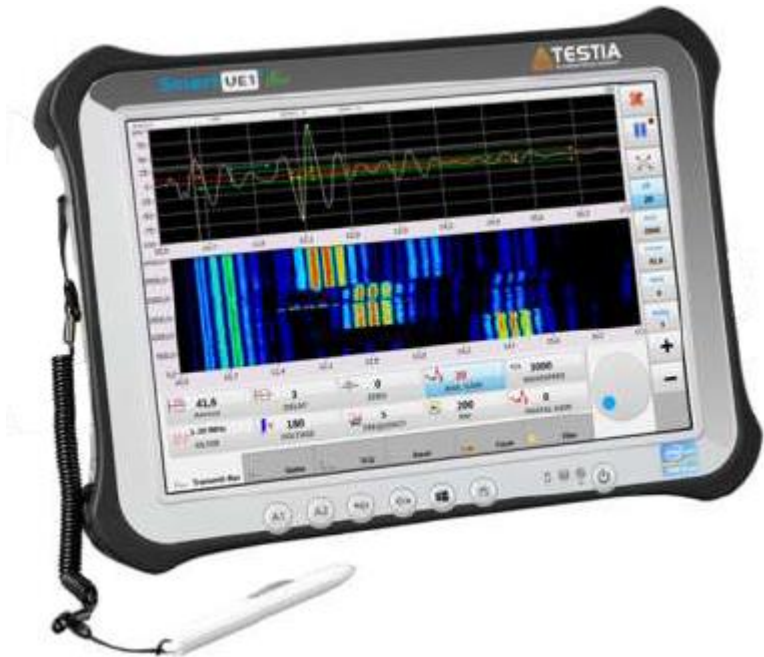
SmartUE1®
The Ultrasonic and Eddy current instrument

- X Compatible with any transducers, EC sensor & resonant probes
- X Available adaptators for connectors

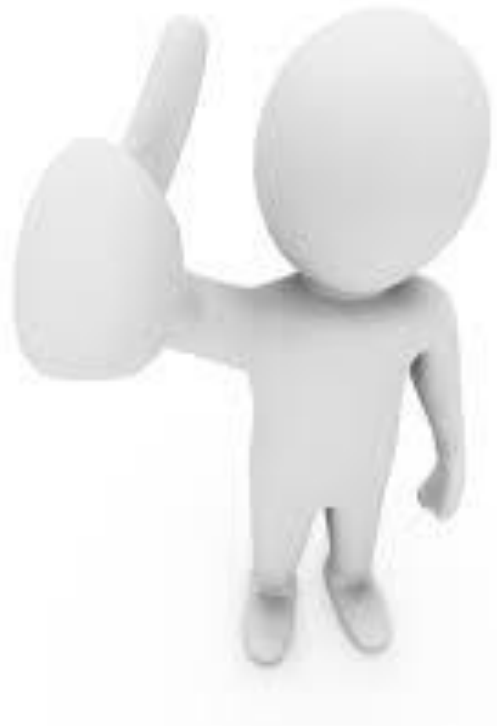
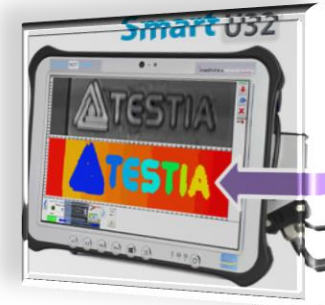
- **Tablet (plug & play) providing**
 - **The exact task location**
 - **Current Documentation**
 - **Real time direct Expert support**
 - **Real time Expert Intervention**
 - **Modifications as they are defined.**
 - **Direct reporting from location**
 - **Clears task at location**
 - **Verification of time place and completion**
