Pilot of Cessna 441 Incorrectly Taxis onto Active Runway and Aircraft Is Struck by McDonnell Douglas MD-82 on Takeoff Roll

FSF Editorial Staff

The U.S. National Transportation Safety Board (NTSB) concluded in its final accident report that the probable cause of this accident was “the Cessna 441 pilot’s mistaken belief that his assigned departure runway was Runway 30R, which resulted in his undetected entrance onto Runway 30R, which was being used by the MD-82 for its departure.”

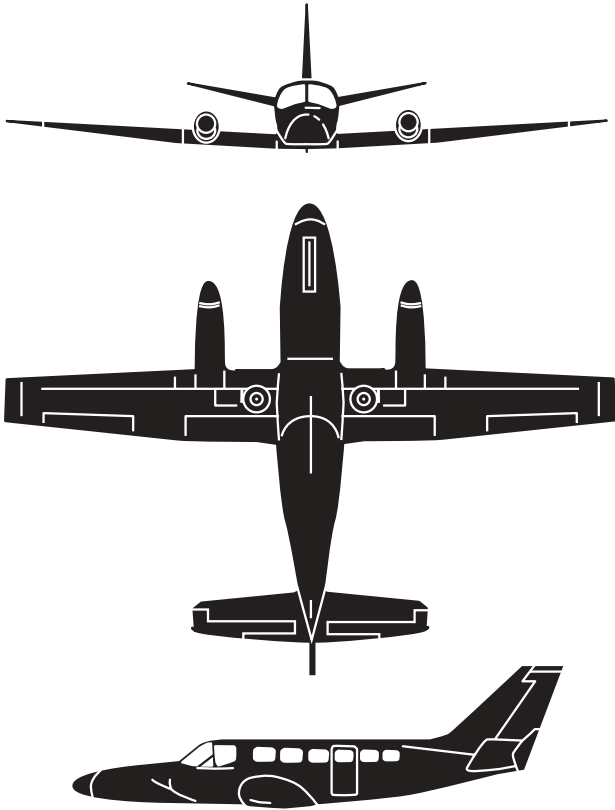
Cessna 441

The report described the wreckage of the Cessna: "The airplane remained on its extended landing gear, with the two main-gear tires inflated. The nose-gear tire was deflated, and its strut was bent slightly aft. The left engine had pulled forward slightly from its mounts, and rested with its propeller blades and spinner on the pavement. Two of the engine's propeller blades were bent forward and exhibited severe leading-edge damage and chordwise scratches. The right engine remained in its normal position on the wing, and was still running when ARFF [airport rescue and fire fighting] personnel arrived at the airplane after the collision. [Fire fighters applied fire-retardant foam to the right engine until it shut down, applied foam to the leaking fuel and shut off electrical power to the Cessna by disconnecting the battery in the nose compartment.] Jagged leading-edge damage was evident on all three propeller blades on the right engine, with two blades bent forward."

The report continued: "The upper fuselage was sheared off approximately two inches [five centimeters] above the bottom of the cabin windows from the tail section to the windscreen. The outboard 7.5 feet [2.3 meters] of the left wing had separated. Separations at the left wing, all window frames and cabin structure exhibited forward bending. ... The aft empennage was buckled and bent to the right; the entire empennage showed compression damage from the aft direction. The rudder was separated from the airplane. The vertical and horizontal stabilizers were fractured at their main attach points."

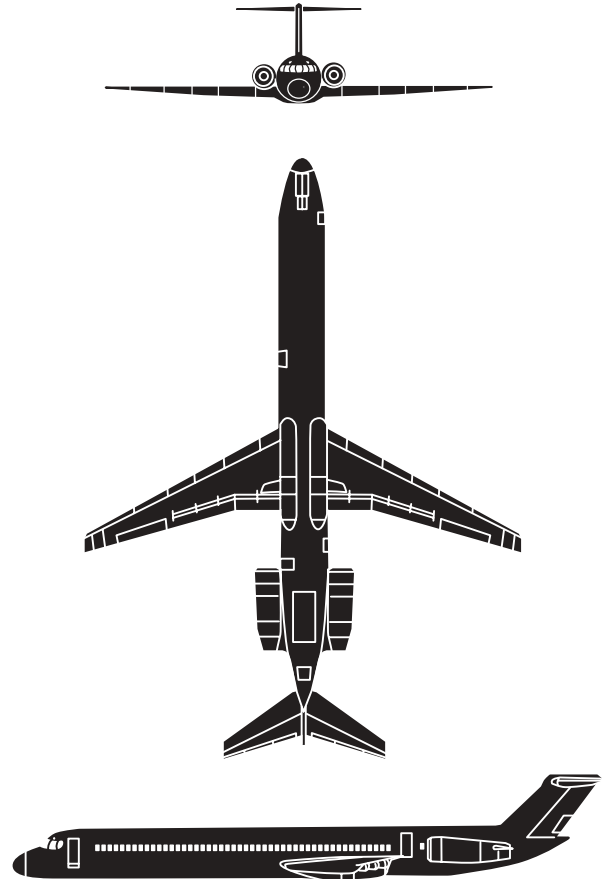
McDonnell Douglas MD-82

When investigators reviewed the damage on the MD-82, they found that the aircraft had “sustained damage to the right-wing leading-edge devices, flaps, upper surfaces, lower surfaces and forward spar,” the report said. “The wing damage area included numerous lateral slashes, surface scratches and red, white and blue paint smears similar to the color scheme of the Cessna 441. Scratches and smears were parallel to the longitudinal axis of the airplane. Wing damage resulted in approximately 600 [U.S.] gallons [2,271 liters] of fuel spilled.”

The report continued: “The right main landing gear, the right lower fuselage and the no. 2 engine were also damaged. Plexiglas and metal debris from the Cessna [were] embedded in the MD-82. The largest piece of Cessna debris directly associated with the MD-82 was the on-board section of the [Cessna’s] left wing, which was wrapped around the right main landing gear strut.”
