Windshield Weakness

The S-76 crashed, killing eight people, after a hawk shattered the windshield and curtailed fuel flow to both engines.

A Sikorsky S-76C++ that crashed into a Louisiana marsh after an en route bird strike was equipped with lightweight acrylic windshields — installed in place of the original bird-strike-resistant laminated glass, the U.S. National Transportation Safety Board (NTSB) said in its final report on the Jan. 4, 2009, accident.

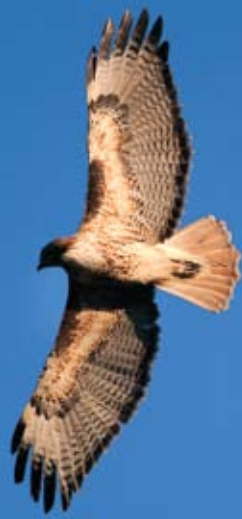
In addition — noting that the impact had initiated a chain of events that jarred the T-handles that held engine fire extinguishers in place and pushed the engine control power levers (ECLs) aft, reducing fuel flow to the engines — the NTSB cited the “lack of protections that would prevent the T-handles from inadvertently dislodging out of their detents” and the “lack of a master warning light and audible system to alert the flight crew of a low-rotor-speed condition.”

The impact of a bird strike caused a chain reaction that forced the engine control power levers — shown at the top of the photo — aft and reduced fuel flow.
