Short on Speed

An ATR 42 with split flaps stalled during an unstabilized night approach in icing conditions.

BY MARK LACAGNINA

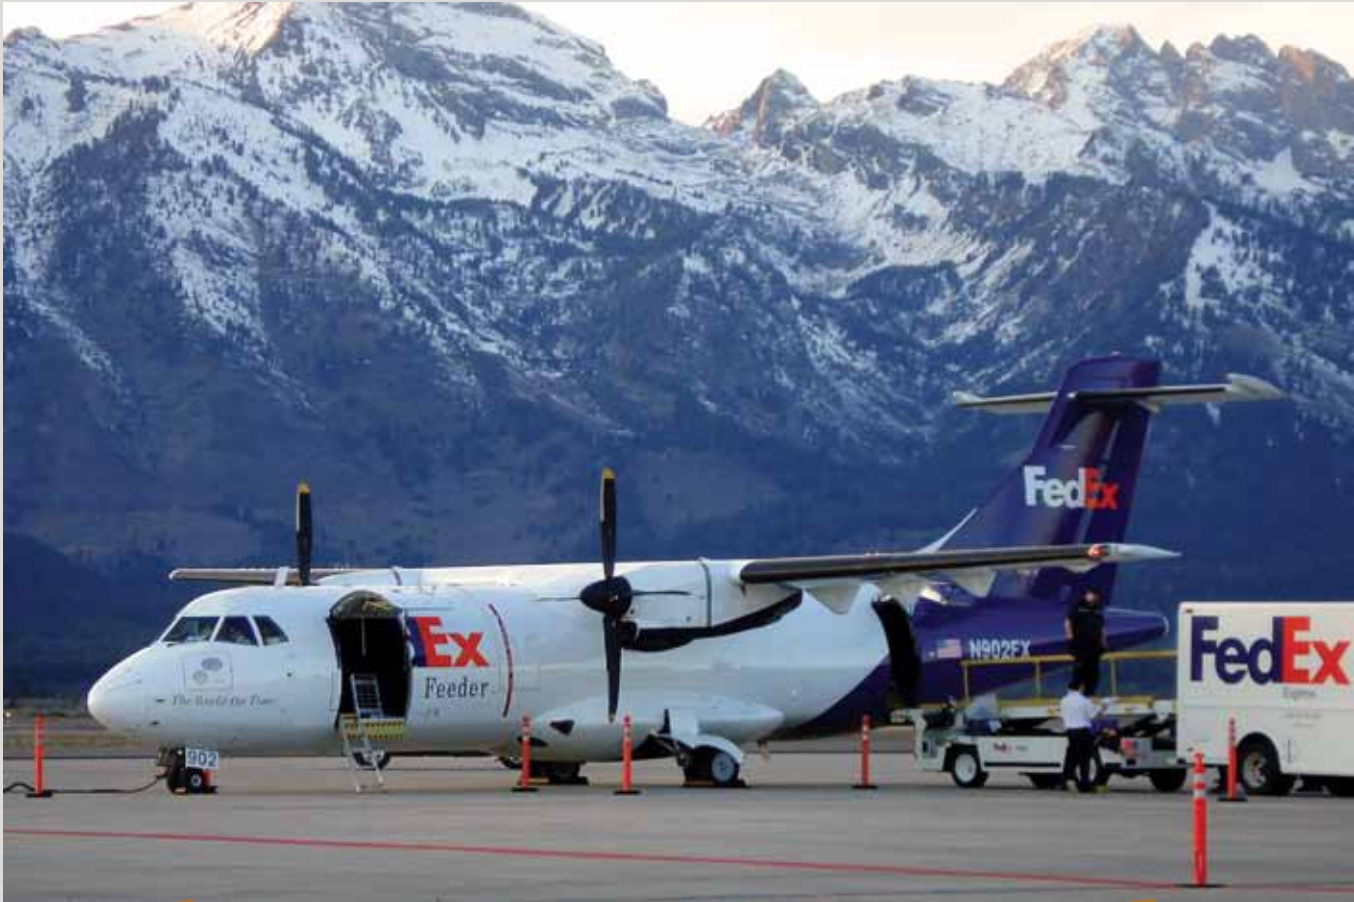
The right main landing gear separated on impact, and the right wing and a large section of the upper fuselage were destroyed by fire. The right engine and propeller also were damaged by the impact and fire.
