Engineering and Metallographic Aspects of Gas Turbine Engine Failure Investigation: Identifying the Causes

*Robert E. Dundas, Principal Engineer
Factory Mutual Engineering & Research*

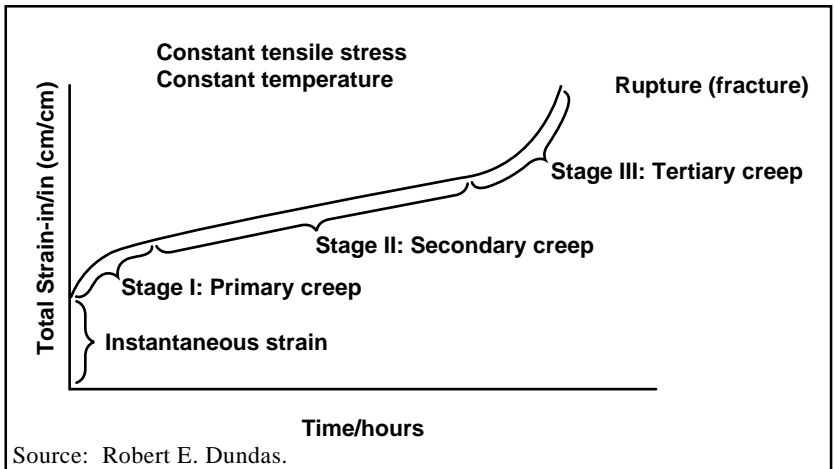
The phenomenon of creep occurs in a component subject to stress and high temperature over time. The curve in Figure 6 shows strain of a material at constant stress and temperature; it is characterized by creep rate and time to rupture. Failure is taken as the initiation of tertiary creep, after which the component stretches unstably to rupture. The rupture life is the number of hours at which the rupture occurs.

Figure 6. Creep vs. time for a material under constant stress and temperature.
