## Bird Strike during de Havilland Dash 8's Approach Disables Left-engine Instruments, Brakes and Nose-wheel Steering

*The flight crew shut down the left engine after the aircraft struck an eagle. They continued flying near the destination airport for 31 minutes while troubleshooting a landing-gear-unsafe warning. The crew then lost directional control of the aircraft during an attempted single-engine, crosswind landing.*

On May 17, 1996, a de Havilland Canada Dash 8 (DHC-8) ran off the right side of Runway 10 while landing at the Broome, Australia, airport. The aircraft was damaged substantially. The final report on the accident by the Australian Bureau of Air Safety Investigation (BASI) did not say whether any of the occupants were injured.

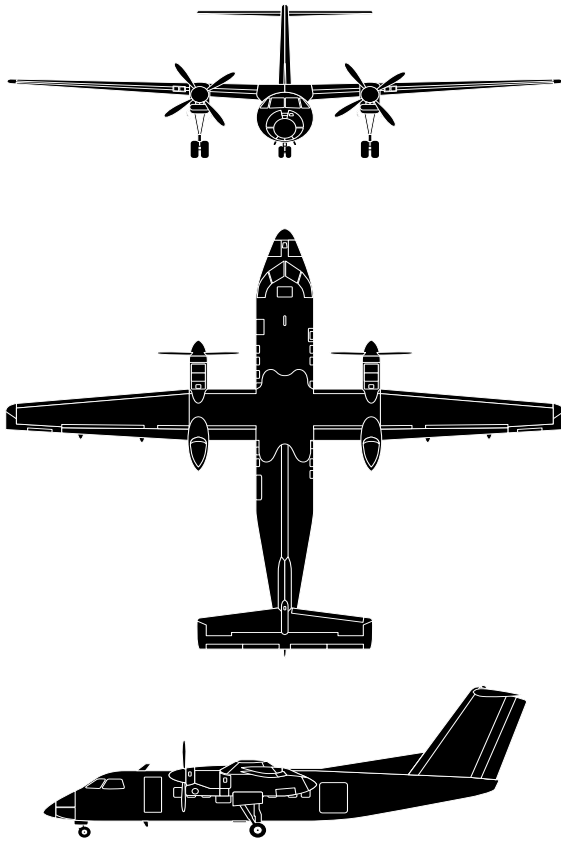
The bird strike destroyed the fairing, bent the wing spar and cracked the forward flange of the lower spar cap. All of the wires routed along the front wing spar were severed or stretched. “At least 30 of the single or twisted-pair wires from this area, as well as one of the two main electrical power cables, [were] severed during the impact,” said BASI.

“Wires [were] pulled from their respective multipin connectors, and whole connectors [were] ripped from their airframe-mounted counterparts.”
