## Hidden, Smoky Fire in MD-87 Aft Cabin Forces Emergency Evacuation After Landing

*All the passengers and crew members evacuated the aircraft at the gate without injury, but the fire would have posed a far greater safety threat if the fire had occurred in flight, the official Danish accident report said.*

### ACCIDENT PREVENTION

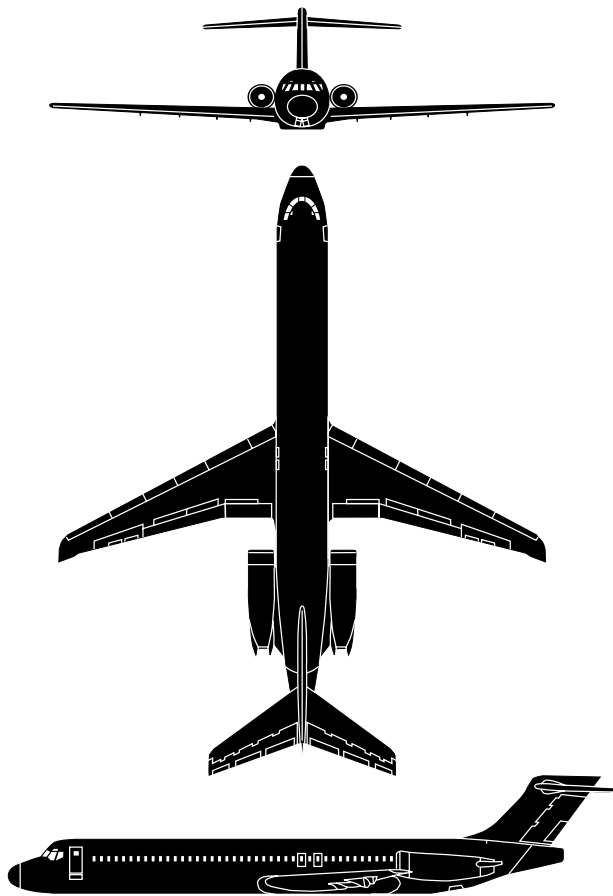
### McDonnell Douglas MD-87

The MD-87 is a short-fuselage variant of the MD-80. The MD-87 first flew in 1986 and can accommodate 130 single class passengers or 109 passengers in a mixed class configuration. It is equipped with two Pratt & Whitney JT8D-217C turbofan engines and has a maximum takeoff weight of 63,503 kilograms (140,000 pounds).
