Fatal Scenic Tour Flight Blamed on Poor Pilot Judgment, Inadequate Background Checks

Editorial Staff Report

ACCIDENT PREVENTION

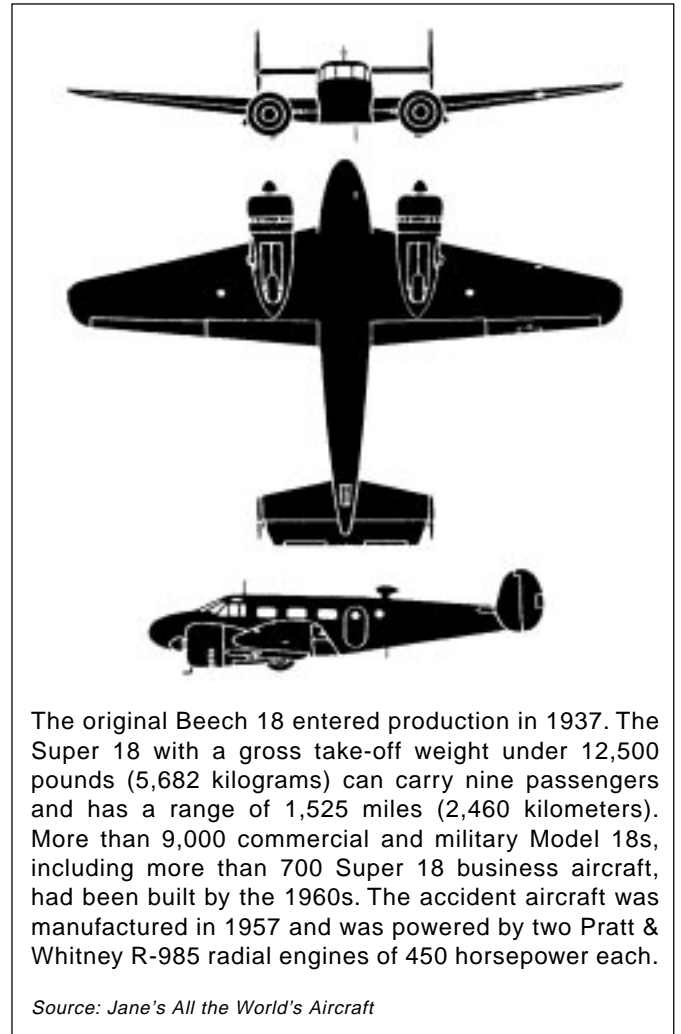
The original Beech 18 entered production in 1937. The Super 18 with a gross take-off weight under 12,500 pounds (5,682 kilograms) can carry nine passengers and has a range of 1,525 miles (2,460 kilometers). More than 9,000 commercial and military Model 18s, including more than 700 Super 18 business aircraft, had been built by the 1960s. The accident aircraft was manufactured in 1957 and was powered by two Pratt & Whitney R-985 radial engines of 450 horsepower each.
