MD-88 Has Uncontained Engine Failure on Takeoff Roll Following Fan-hub Fracture

A defect in the fan hub was not detected by blue-etch anodize inspection following manufacture, nor was the resulting fatigue crack detected in a fluorescent penetrant inspection during maintenance at the airline facility.

—
FSF Editorial Staff

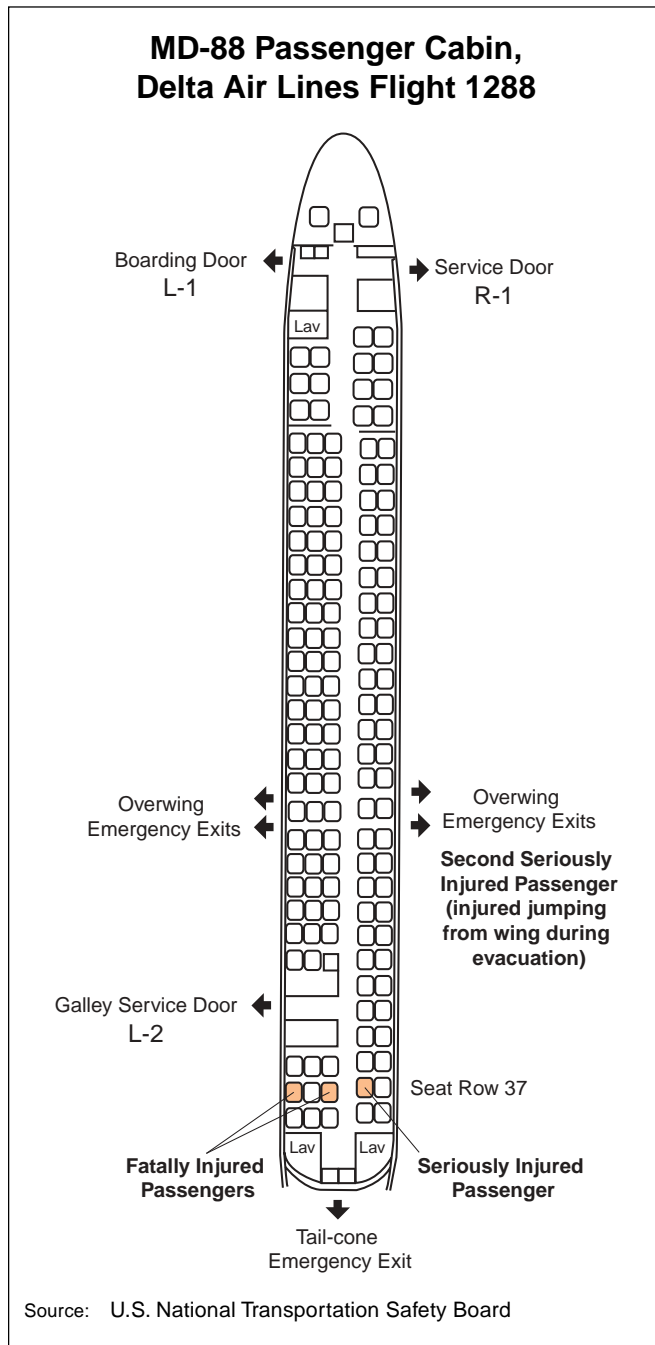
Figure 1

The L-1 (left-forward; Figure 1) flight attendant entered the cockpit to ask whether to evacuate the cabin, and the captain said that because there was no cockpit indication of fire, an evacuation should not be initiated. According to witnesses outside the MD-88, fire was visible in the left-engine cowling

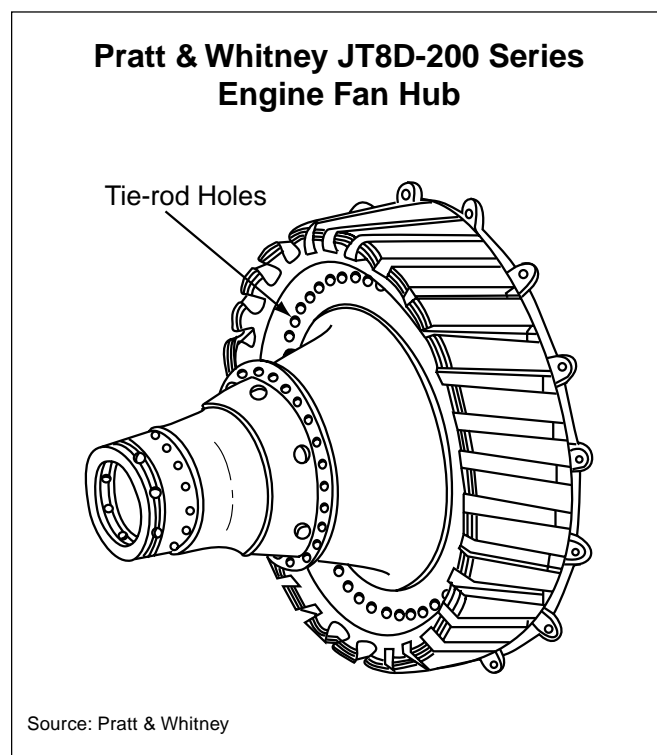
Figure 2

The titanium-alloy fan hub (Figure 2) was forged by Ladish Co., Milwaukee, Wisconsin, U.S., and finished and inspected for Pratt & Whitney by Volvo Aero Corp., Trollhattan, Sweden, in January 1989.

The hub assembly was subjected to "heavy maintenance" on Oct. 27, 1995, in conformance with Delta's JT8D-219 engine-maintenance-management plan.

"The maintenance included [an FPI] and visual nondestructive testing (NDT), a blade-slot dimensional inspection and
