## Pilot Incapacitation by Hypoxia Cited In Fatal Five-hour Flight of Beech King Air

*The report said that the pilot apparently was unable physically to respond to air traffic control radio transmissions after the aircraft ascended above the assigned altitude, 25,000 feet. The aircraft likely continued flying on autopilot, with no input from the pilot, for several hours before it struck terrain.*

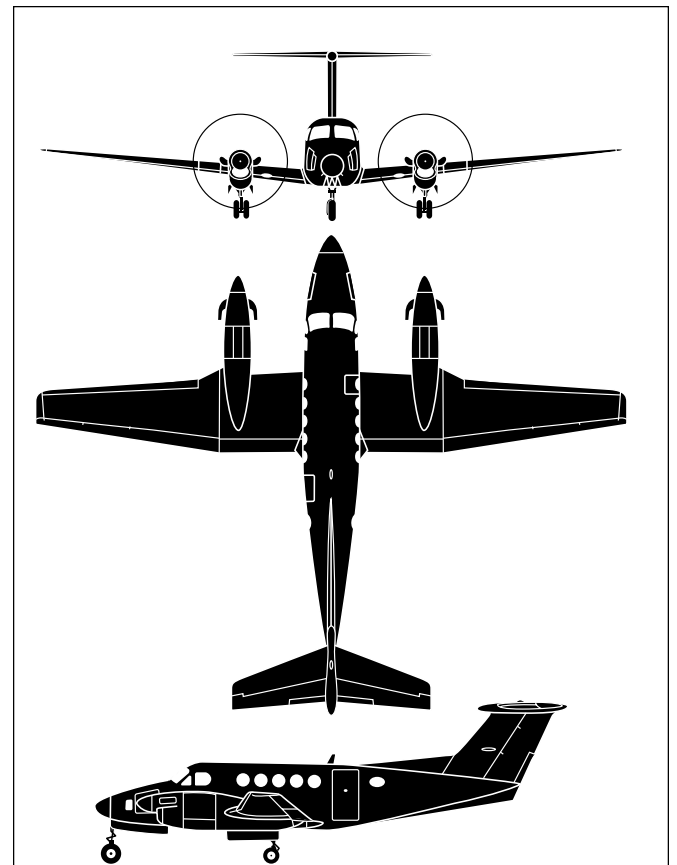
### Beech Super King Air 200

Design of the Beech Super King Air 200 business and utility twin-turboprop aircraft began in 1970. The first prototype flew in 1972. The aircraft has the same basic fuselage as the King Air 100 and has increased wingspan, more powerful engines, increased fuel capacity, increased cabin pressurization and a higher gross weight.
