Change of Plan

Learning From Experience
Incident No. 6

Sixth in a series focusing on approach and landing incidents that might have resulted in controlled flight into terrain but for timely warnings by TAWS.

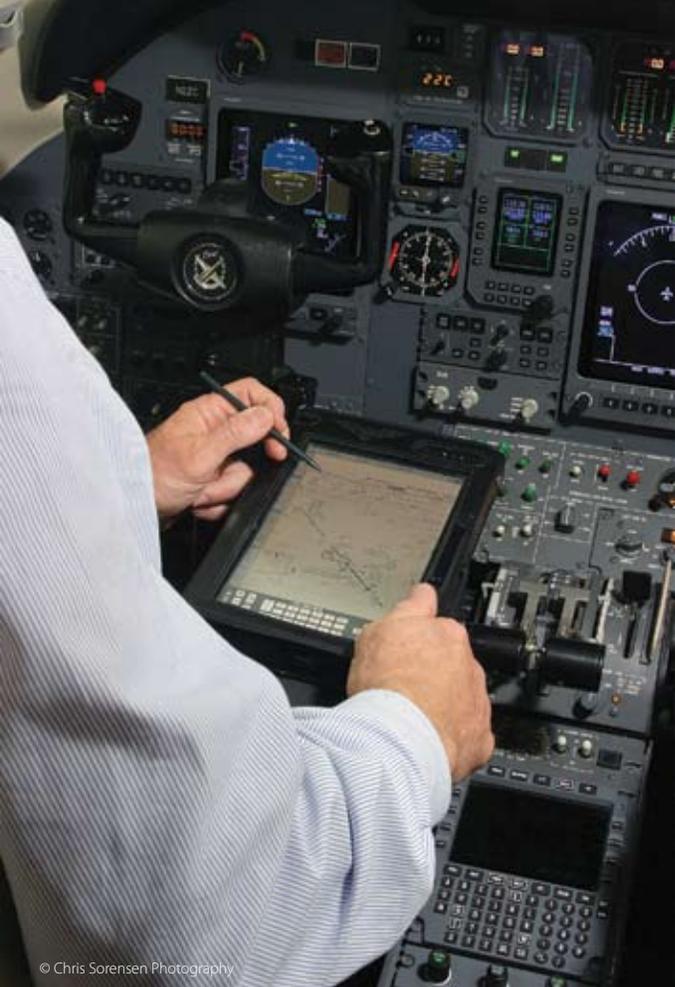
Figure 1

The chart identifies a common descent point at the final approach fix (FAF) for all three approach procedures by its distances from two DME ground stations: "D6.8 YY," or 6.8 nm from the DME ground station for the ILS/DME approach, and "D2.9 AAA," or 2.9 nm from the DME ground station for the VOR/DME approach (Figure 1). Next to each distance figure is a callout to a note identifying its respective approach procedure. The notes indicate that "D6.8 YY" should be used to identify the descent point while conducting the ILS/DME approach and that "D2.9 AAA" should be used to identify the FAF during the VOR/DME approach. The callouts are included in the chart's plan view and profile view; the notes, however, are included only in the plan view.

runway threshold. However, the positions of the ground stations are not depicted on the profile view.

than appears in Figure 1. For each range figure, an altitude and a height above touchdown (HAT) are provided. This adds visual clutter that could slow data acquisition and increase mental workload. Similarly, the “After AAA” and “Before AAA” notations for the VOR/DME ranges also add complexity.

Moreover, the table shows the range values above the altitudes. As noted in the discussion of incident no. 2 in the August 2006 *Aviation Safety World*, it is essential to check altitude before range when monitoring the flight path. Thus, the table format, which is commonly used by chart providers, could bias the crew to check range before altitude, a procedure that could result in being at a dangerously low altitude at longer ranges.
